**City of Woonsocket
Sewer Collection System**

Annual Report

2011

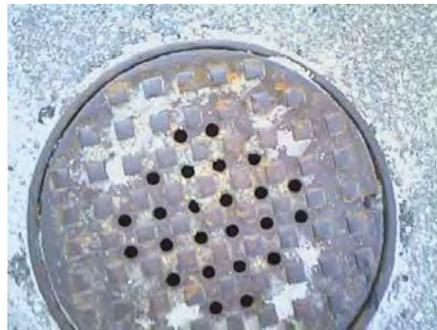
Based on VWNA report, it was determined that there were more than 477 manholes in the City which contribute to inflow as much as 690,000 gallons per day. This estimated inflow for vented manhole covers was based on study conducted by Neehan Foundry Company. The following is an example of vented manhole in Woonsocket:

VWNA already inserted more than 220 inserts in order to reduce Inflow.

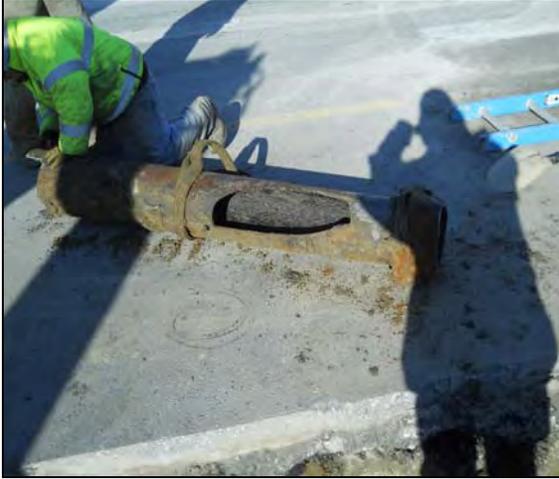
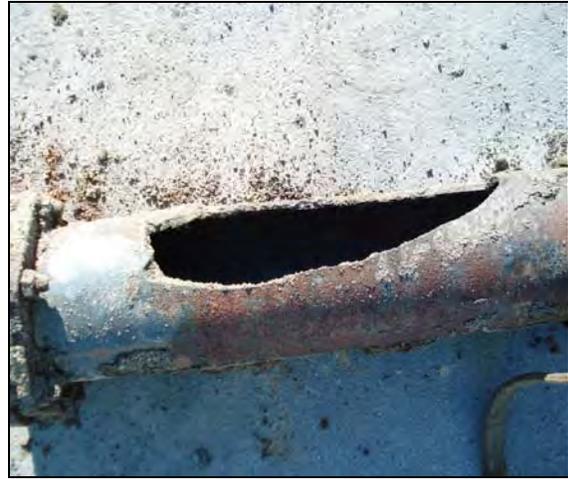
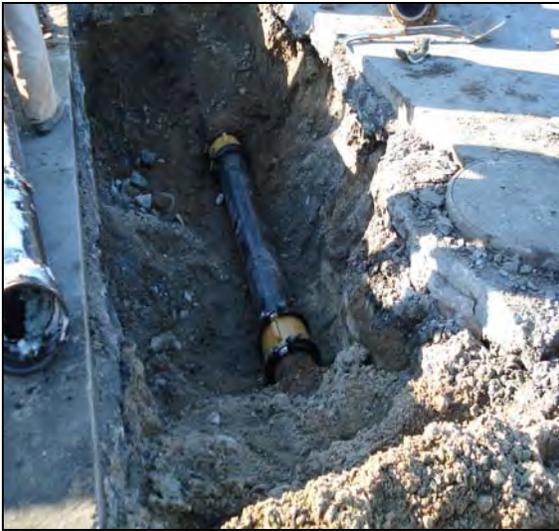
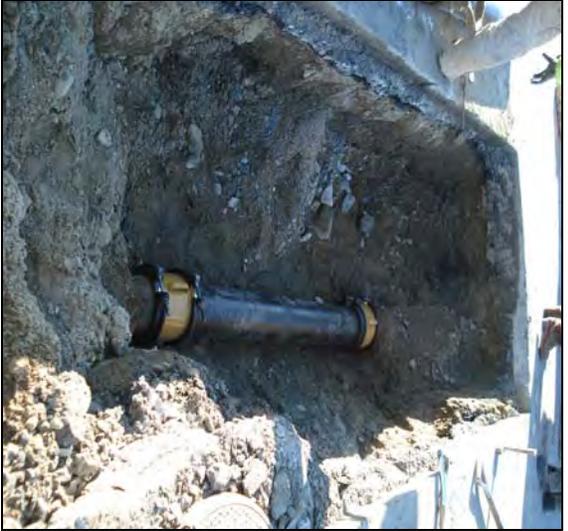
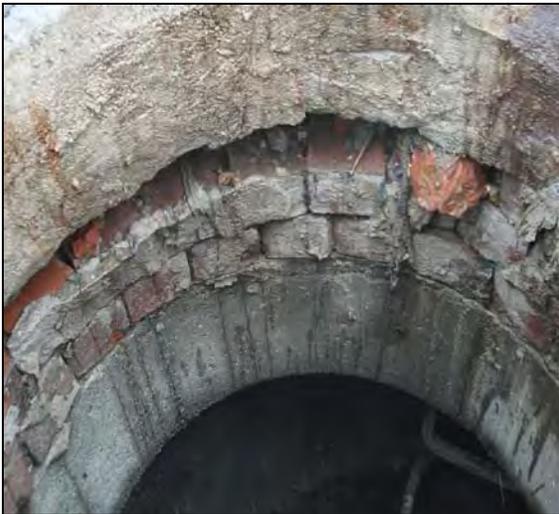
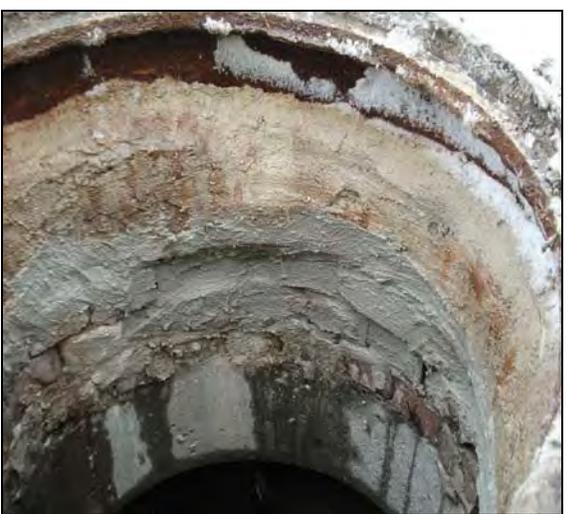
SSO occurred in this manhole

Roughly 2500 gals of sewage flowed to this catch basin which flows into the pond next to the pump station.

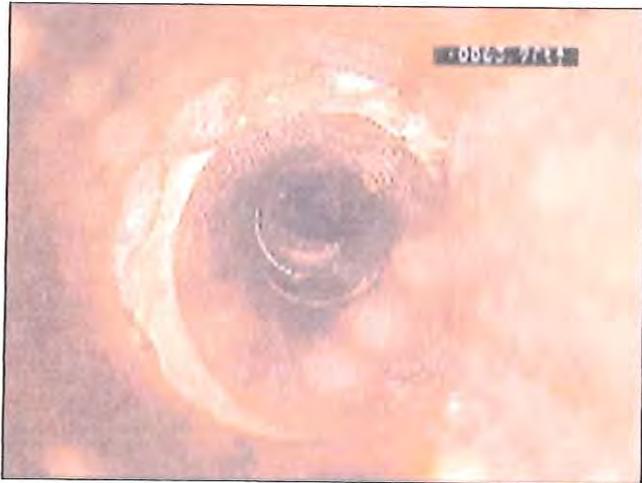
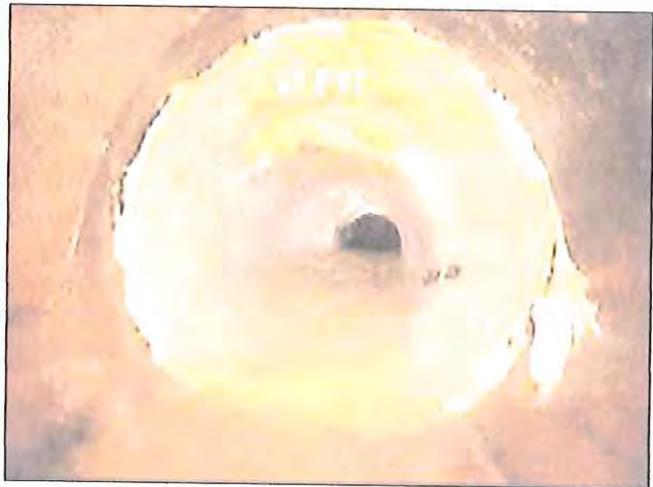
Repair ID: 1313140859_rodman		Job Number: 2020900.3501	
Status: - Completed	Defect Type: MAIN (Break In Main)	Repair Type: CIP_LINER (Cured In-Place Liner)	Cause of Failure: GROUND (Ground Movement)
Start Length (ft): 64.000	Repair Length (ft): 4.000	CCTV Required: Y	Shape: - Circular
Material: VCP (Vitrified Clay Pipe)	Lining Material: EP (Epoxy)	Lining Type: CIP (Cured in Place)	
Width (in): -	Height (in): 8.0	Notes: -

US MH 4329 – DS MH 4324		Pipe Type: Gravity
Location: Gaulin Avenue		Site Condition:
US Material: VCP	US Lining Material: None	US Lining Type: None
US Shape: CIR	US Width (in):	US Height (in): 8
DS Material: VCP	DS Lining Material: None	DS Lining Type: None
DS Shape: VCP	DS Width (in):	DS Height (in): 8
US Depth From Cover (ft):		DS Depth From Cover (ft):
Notes:

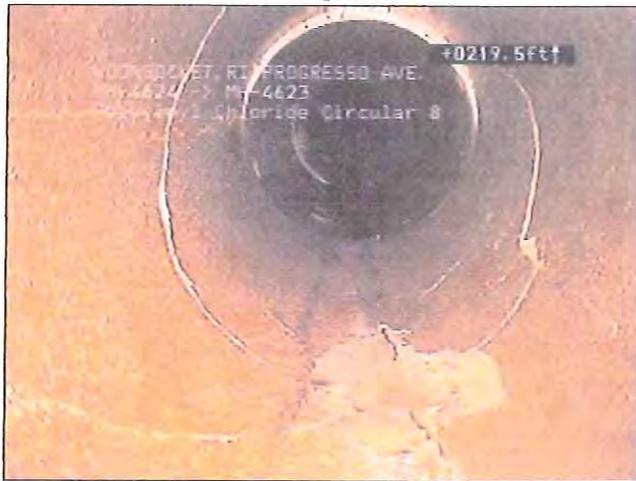
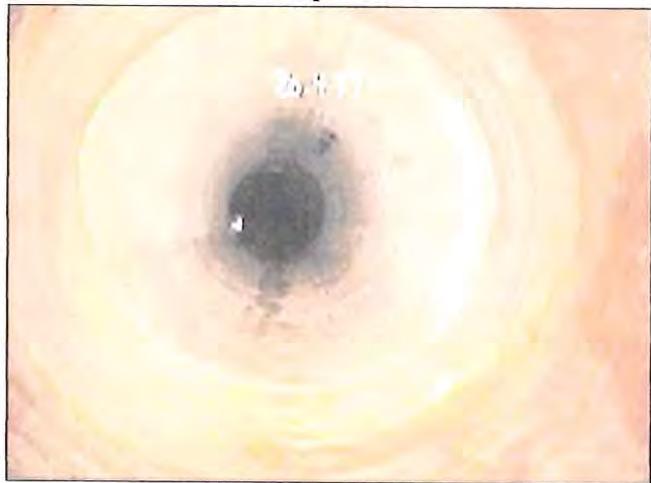
Repair ID: 1313145575_rodman		Job Number: 2020900.3501	
Status: - Completed	Defect Type: MAIN (Break In Main)	Repair Type: CIP_LINER (Cured In-Place Liner)	Cause of Failure: WORKS (Other Works)
Start Length (ft): 218.000	Repair Length (ft): 4.000	CCTV Required: Y	Shape: - Circular
Material: VCP (Vitrified Clay Pipe)	Lining Material: EP (Epoxy)	Lining Type: CIP (Cured in Place)	
Width (in): -	Height (in): 8.0	Notes: -

US MH 4624 – DS MH 4623		Pipe Type: Gravity
Location: Progresso Avenue		Site Condition:
US Material: VCP	US Lining Material: None	US Lining Type: None
US Shape: CIR	US Width (in):	US Height (in): 8
DS Material: PVC	DS Lining Material: None	DS Lining Type: None
DS Shape: CIR	DS Width (in):	DS Height (in): 8
US Depth From Cover (ft):		DS Depth From Cover (ft):
Notes:

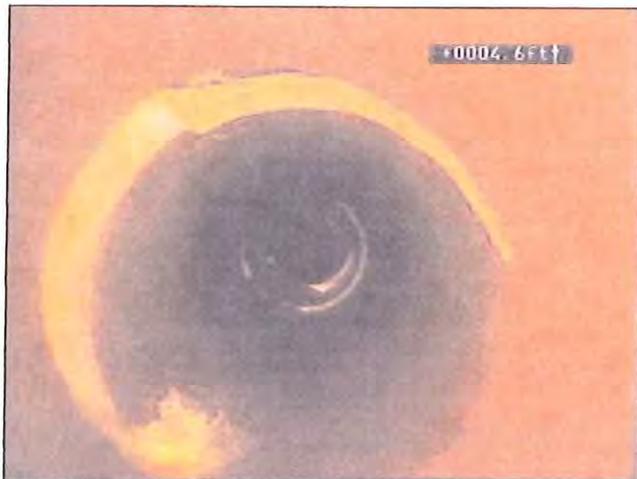
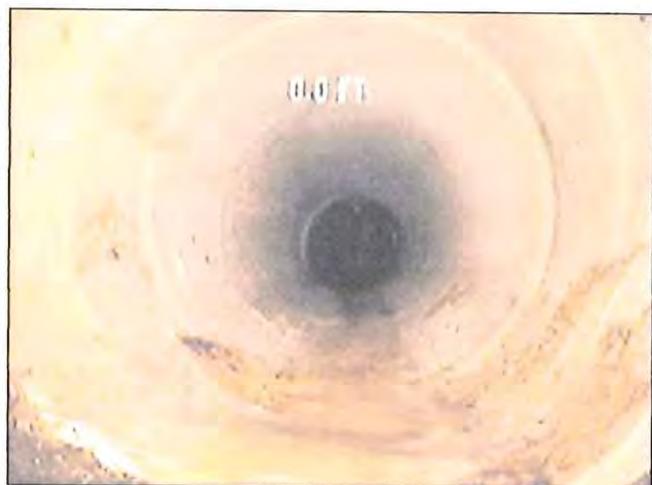
Repair ID: 1313142906_rodman		Job Number: 2020900.3501	
Status: - Completed	Defect Type: MAIN (Break In Main)	Repair Type: CIP_LINER (Cured In-Place Liner)	Cause of Failure: GROUND (Ground Movement)
Start Length (ft): 4.000	Repair Length (ft): 4.000	CCTV Required: Y	Shape: - Circular
Material: VCP (Vitrified Clay Pipe)	Lining Material: EP (Epoxy)	Lining Type: CIP (Cured in Place)	
Width (in): -	Height (in): 8.0	Notes: -

US MH 721 – DS MH 720		Pipe Type: Gravity
Location: Memorial Drive		Site Condition:
US Material: VCP	US Lining Material: None	US Lining Type: None
US Shape: CIR	US Width (in):	US Height (in): 8
DS Material: VCP	DS Lining Material: None	DS Lining Type: None
DS Shape: CIR	DS Width (in):	DS Height (in): 8
US Depth From Cover (ft):		DS Depth From Cover (ft):
Notes:

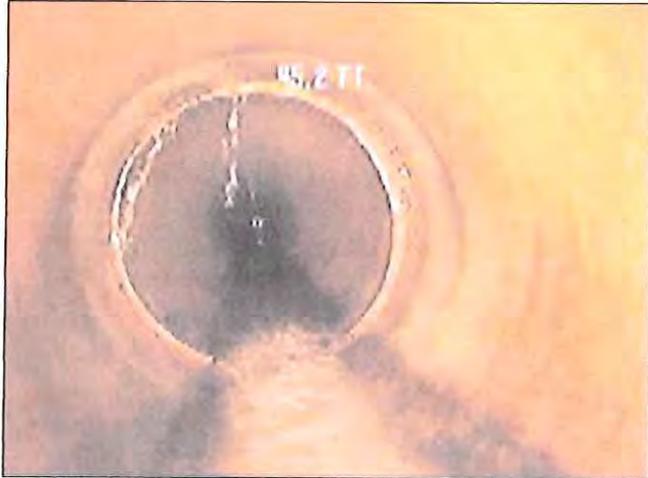
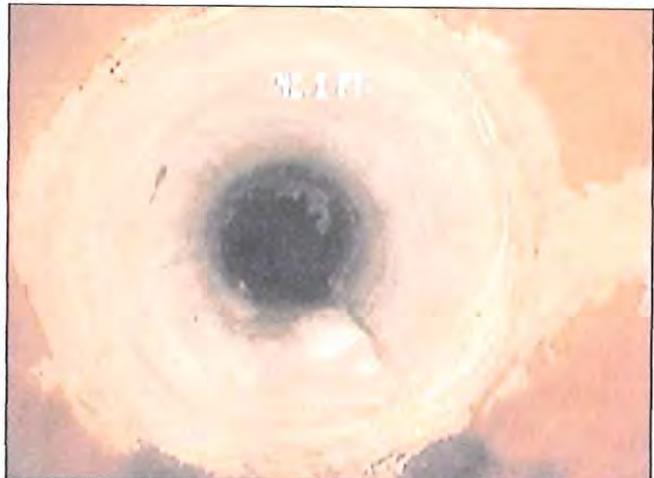
Repair ID: 1313145971_rodman		Job Number: 2020900.3501	
Status: - Completed	Defect Type: INFILT (Infiltration)	Repair Type: CIP_LINER (Cured In-Place Liner)	Cause of Failure: GROUND (Ground Movement)
Start Length (ft): 29.000	Repair Length (ft): 2.000	CCTV Required: Y	Shape: - Circular
Material: VCP (Vitrified Clay Pipe)	Lining Material: EP (Epoxy)	Lining Type: CIP (Cured in Place)	
Width (in): -	Height (in): 8.0	Notes: -

US MH 4712 – DS MH 4713		Pipe Type: Gravity
Location: Ray Avenue		Site Condition:
US Material:	US Lining Material:	US Lining Type:
US Shape:	US Width (in):	US Height (in):
DS Material: VCP	DS Lining Material: None	DS Lining Type: None
DS Shape: Cir	DS Width (in):	DS Height (in): 8
US Depth From Cover (ft):		DS Depth From Cover (ft):
Notes:

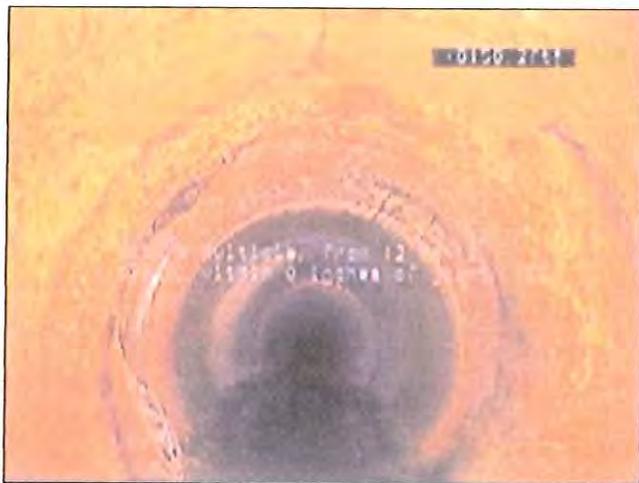
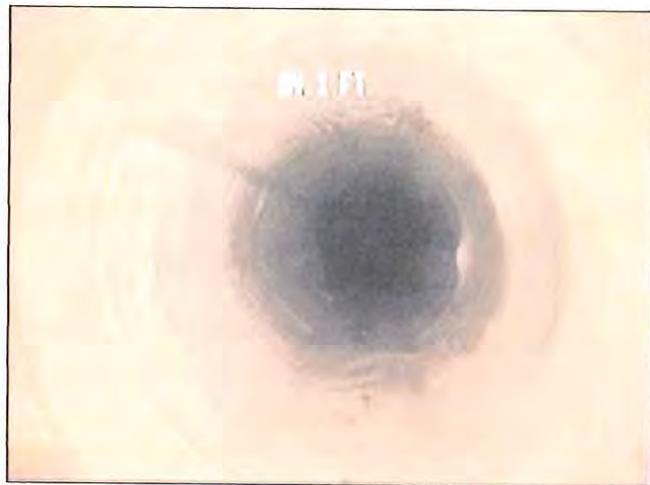
Repair ID: 1313143111_rodman		Job Number: 2020900.3501	
Status: - Completed	Defect Type: INFILT (Infiltration)	Repair Type: CIP_LINER (Cured In-Place Liner)	Cause of Failure: GROUND (Ground Movement)
Start Length (ft): 150.000	Repair Length (ft): 4.000	CCTV Required: Y	Shape: - Circular
Material: VCP (Vitrified Clay Pipe)	Lining Material: EP (Epoxy)	Lining Type: CIP (Cured in Place)	
Width (in): -	Height (in): 8.0	Notes: -

US MH 542 – DS MH 543		Pipe Type: Gravity
Location: Poplar Street		Site Condition:
US Material: VCP	US Lining Material: None	US Lining Type: None
US Shape: CIR	US Width (in):	US Height (in): 8
DS Material: VCP	DS Lining Material: None	DS Lining Type: None
DS Shape: CIR	DS Width (in):	DS Height (in): 8
US Depth From Cover (ft):		DS Depth From Cover (ft):
Notes:

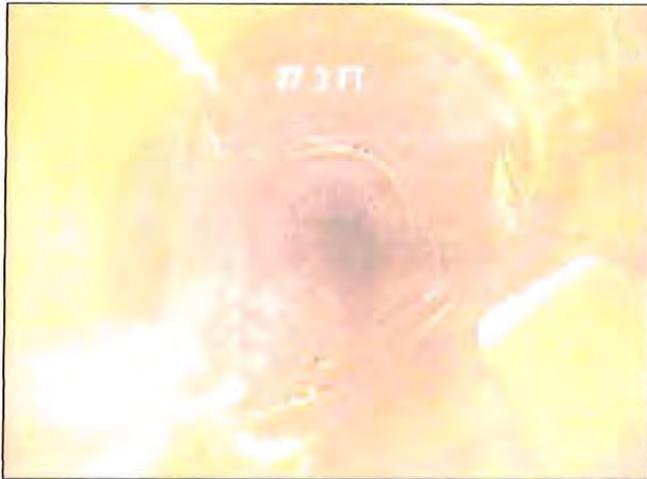
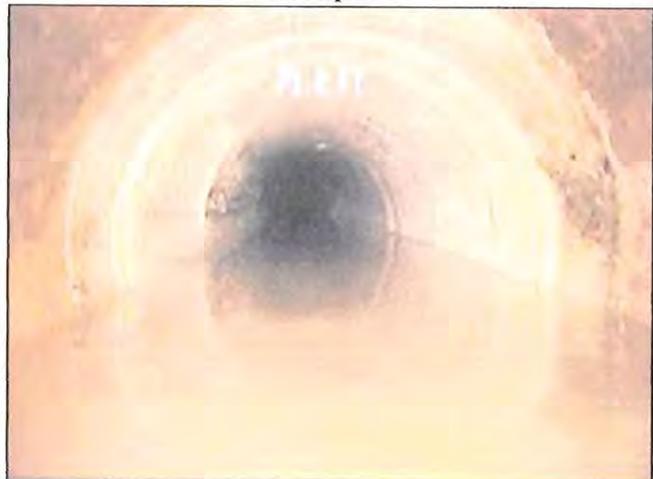
Repair ID: 1313146511_rodman		Job Number: 2020900.3501	
Status: - Completed	Defect Type: MAIN (Break In Main)	Repair Type: CIP_LINER (Cured In-Place Liner)	Cause of Failure: GROUND (Ground Movement)
Start Length (ft): 73.000	Repair Length (ft): 8.000	CCTV Required: Y	Shape: - Circular
Material: VCP (Vitrified Clay Pipe)	Lining Material: EP (Epoxy)	Lining Type: CIP (Cured in Place)	
Width (in): -	Height (in): 8.0	Notes: -

US MH 2093 – DS MH 2476		Pipe Type: Gravity
Location: Warren Avenue		Site Condition:
US Material: VCP	US Lining Material: None	US Lining Type: None
US Shape: CIR	US Width (in):	US Height (in): 8
DS Material: VCP	DS Lining Material: None	DS Lining Type: None
DS Shape: CIR	DS Width (in):	DS Height (in): 8
US Depth From Cover (ft):		DS Depth From Cover (ft):
Notes:

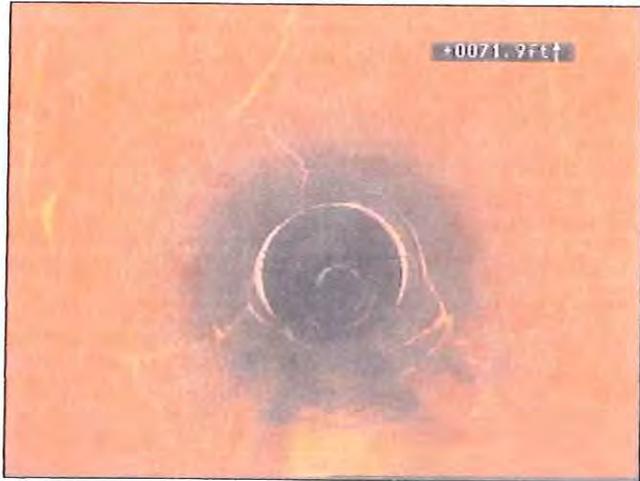
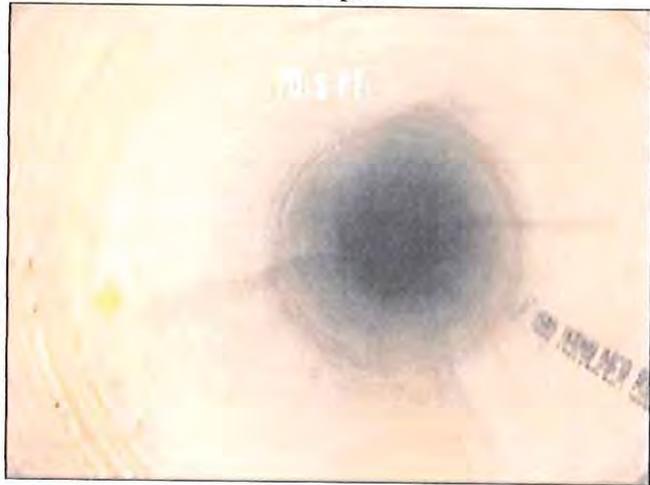
Repair ID: 1313147202_rodman		Job Number: 2020900.3501	
Status: - Completed	Defect Type: MAIN (Break In Main)	Repair Type: CIP_LINER (Cured In-Place Liner)	Cause of Failure: GROUND (Ground Movement)
Start Length (ft): 70.000	Repair Length (ft): 6.000	CCTV Required: Y	Shape: - Circular
Material: VCP (Vitrified Clay Pipe)	Lining Material: EP (Epoxy)	Lining Type: CIP (Cured in Place)	
Width (in): -	Height (in): 8.0	Notes: -

US MH 721 – DS MH 720		Pipe Type: Gravity
Location: Memorial Drive		Site Condition:
US Material: None	US Lining Material: None	US Lining Type: None
US Shape: Cir	US Width (in):	US Height (in): 8
DS Material: None	DS Lining Material: None	DS Lining Type: None
DS Shape: Cir	DS Width (in):	DS Height (in): 8
US Depth From Cover (ft):		DS Depth From Cover (ft):
Notes:

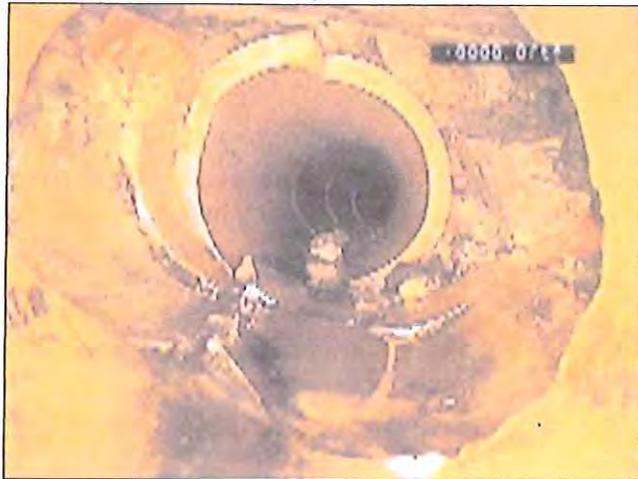
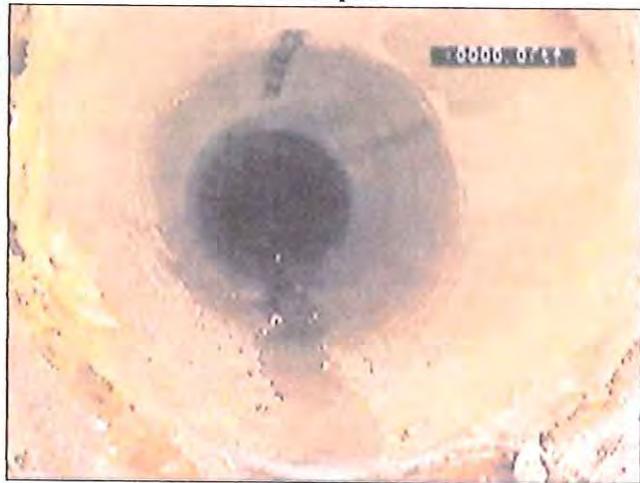
Repair ID: 1313156829_rodman		Job Number: 2020900.3501	
Status: - Completed	Defect Type: COL (Collapse)	Repair Type: CIP_LINER (Cured In-Place Liner)	Cause of Failure: WORKS (Other Works)
Start Length (ft): 1.000	Repair Length (ft): 4.000	CCTV Required: Y	Shape: - Circular
Material: VCP (Vitrified Clay Pipe)	Lining Material: EP (Epoxy)	Lining Type: CIP (Cured in Place)	
Width (in): -	Height (in): 8.0	Notes: -

US MH 3802 – DS MH 3803		Pipe Type: Gravity
Location: Castle Heights Court		Site Condition:
US Material: VCP	US Lining Material: None	US Lining Type: None
US Shape: Cir	US Width (in):	US Height (in): 8
DS Material: VCP	DS Lining Material: None	DS Lining Type: None
DS Shape: Cir	DS Width (in):	DS Height (in): 8
US Depth From Cover (ft):		DS Depth From Cover (ft):
Notes:

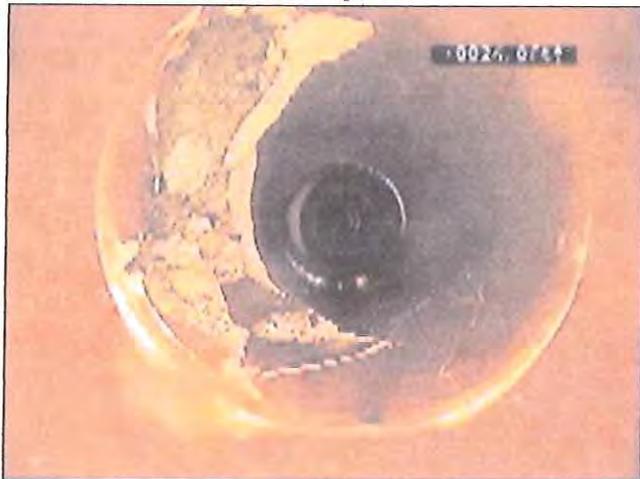
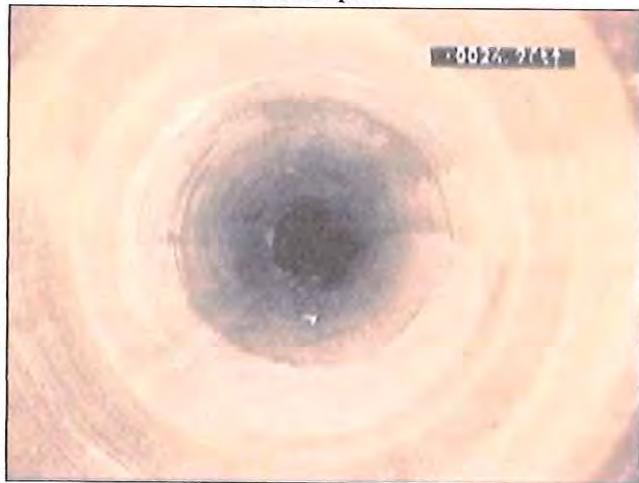
Repair ID: 1313158930_rodman		Job Number: 2020900.3501	
Status: - Completed	Defect Type: COL (Collapse)	Repair Type: CIP_LINER (Cured In-Place Liner)	Cause of Failure: WORKS (Other Works)
Start Length (ft): 23.000	Repair Length (ft): 4.000	CCTV Required: Y	Shape: - Circular
Material: VCP (Vitrified Clay Pipe)	Lining Material: EP (Epoxy)	Lining Type: CIP (Cured in Place)	
Width (in): -	Height (in): 8.0	Notes: -

US MH 4618 – DS MH 4619		Pipe Type: Gravity
Location: Merida Avenue		Site Condition:
US Material: VCP	US Lining Material: None	US Lining Type: None
US Shape: Cir	US Width (in):	US Height (in): 8
DS Material: VCP	DS Lining Material: None	DS Lining Type: None
DS Shape: CIR	DS Width (in):	DS Height (in): 8
US Depth From Cover (ft):		DS Depth From Cover (ft):
Notes:

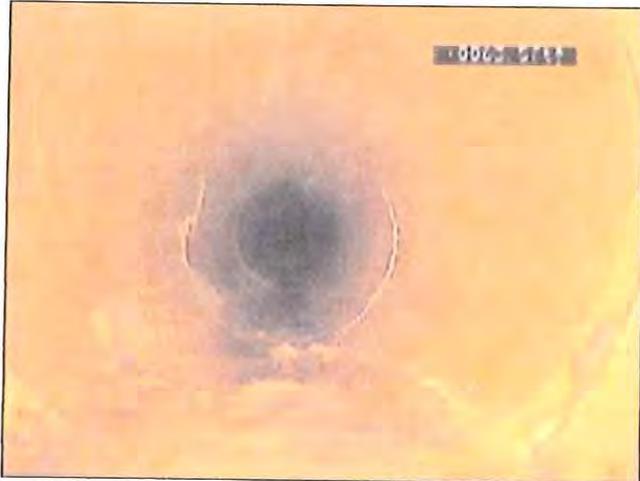
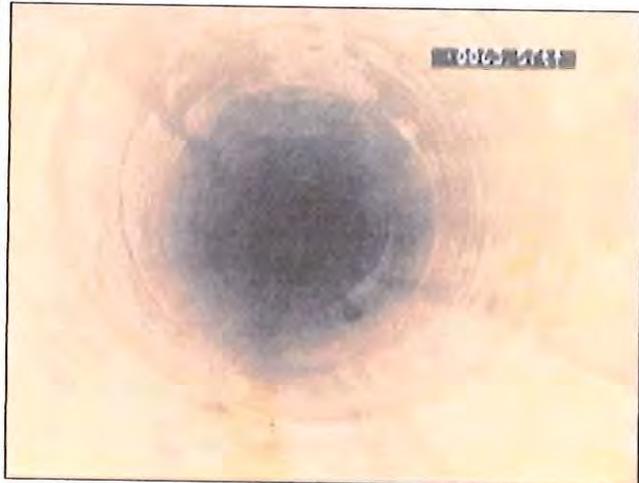
Repair ID: 1313158499_rodman		Job Number: 2020900.3501	
Status: - Completed	Defect Type: BREAK (Break)	Repair Type: CIP_LINER (Cured In-Place Liner)	Cause of Failure: GROUND (Ground Movement)
Start Length (ft): 64.000	Repair Length (ft): 4.000	CCTV Required: Y	Shape: - Circular
Material: VCP (Vitrified Clay Pipe)	Lining Material: EP (Epoxy)	Lining Type: CIP (Cured in Place)	
Width (in): -	Height (in): 8.0	Notes: -

US MH 3244 – DS MH 3245		Pipe Type: Gravity
Location: Saint Louis Avenue		Site Condition:
US Material: VCP	US Lining Material: None	US Lining Type: None
US Shape: Cir	US Width (in):	US Height (in): 8
DS Material: VCP	DS Lining Material: None	DS Lining Type: None
DS Shape: Cir	DS Width (in):	DS Height (in): 8
US Depth From Cover (ft):		DS Depth From Cover (ft):
Notes:
