## **LIMITED STRUCTURAL EVALUATION**

### **162 MAIN STREET WOONSOCKET, RHODE ISLAND**

October 18, 2012

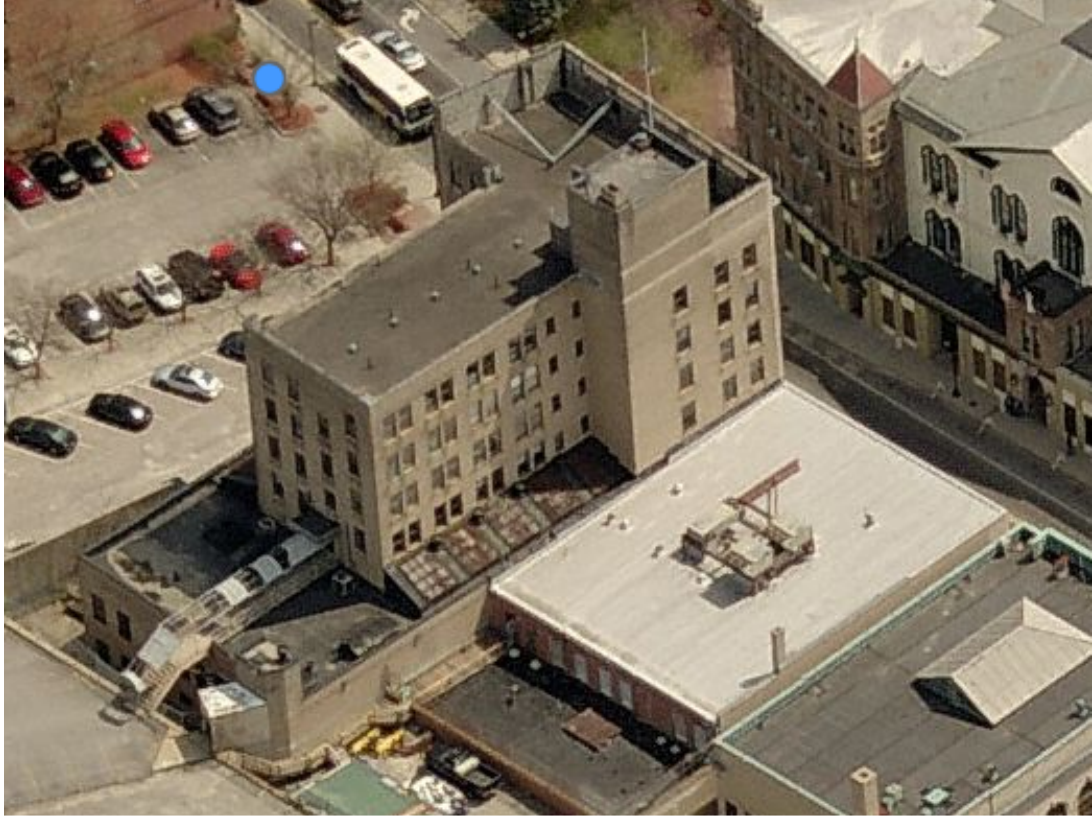
Photo #1

*This photo, looking east, shows the lower two-story plaza level structure of the former RI Hospital Trust Company building surrounding the north, northeast, and northwest sides of the six-story tower.*

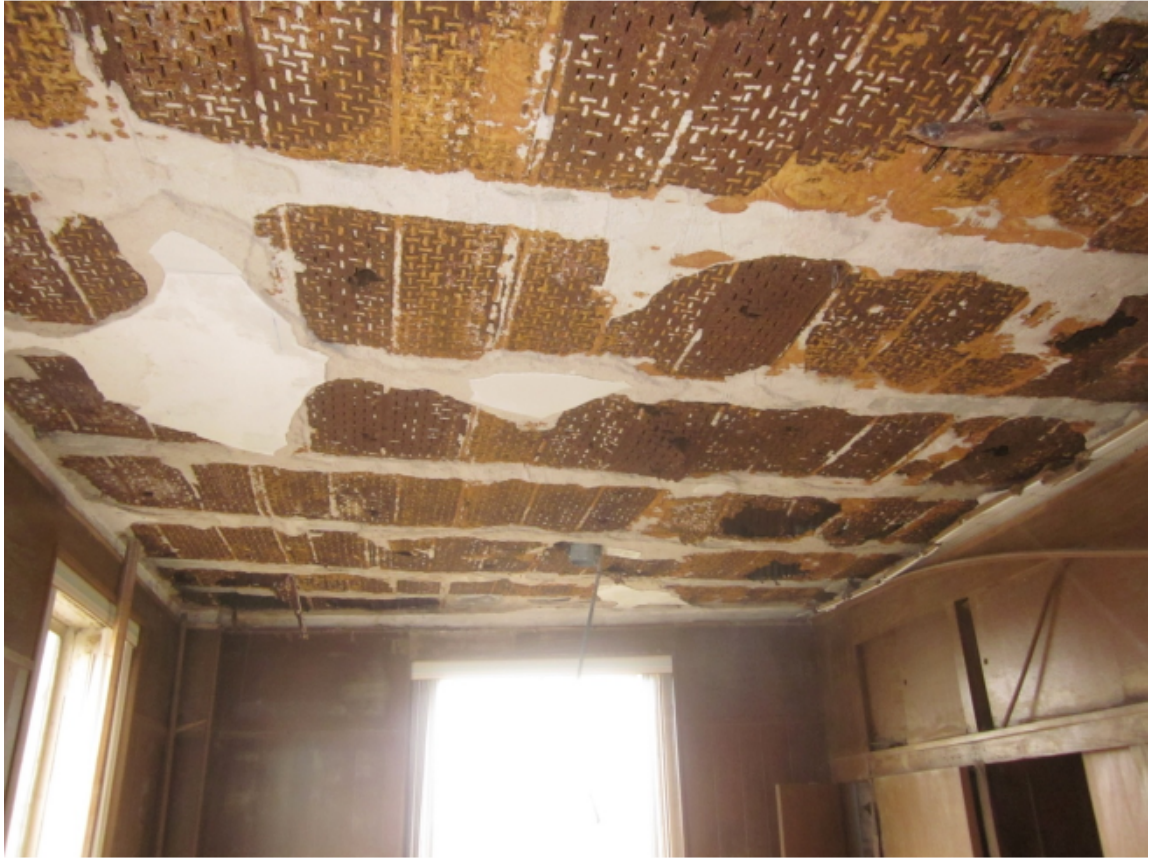
Photo #2

*This photo shows the concrete joist pan system that appears to be used typically throughout the building for the construction of the floor and roof slabs. The concrete joists span between the structural steel framing girders and beams at the floor and roof levels.*

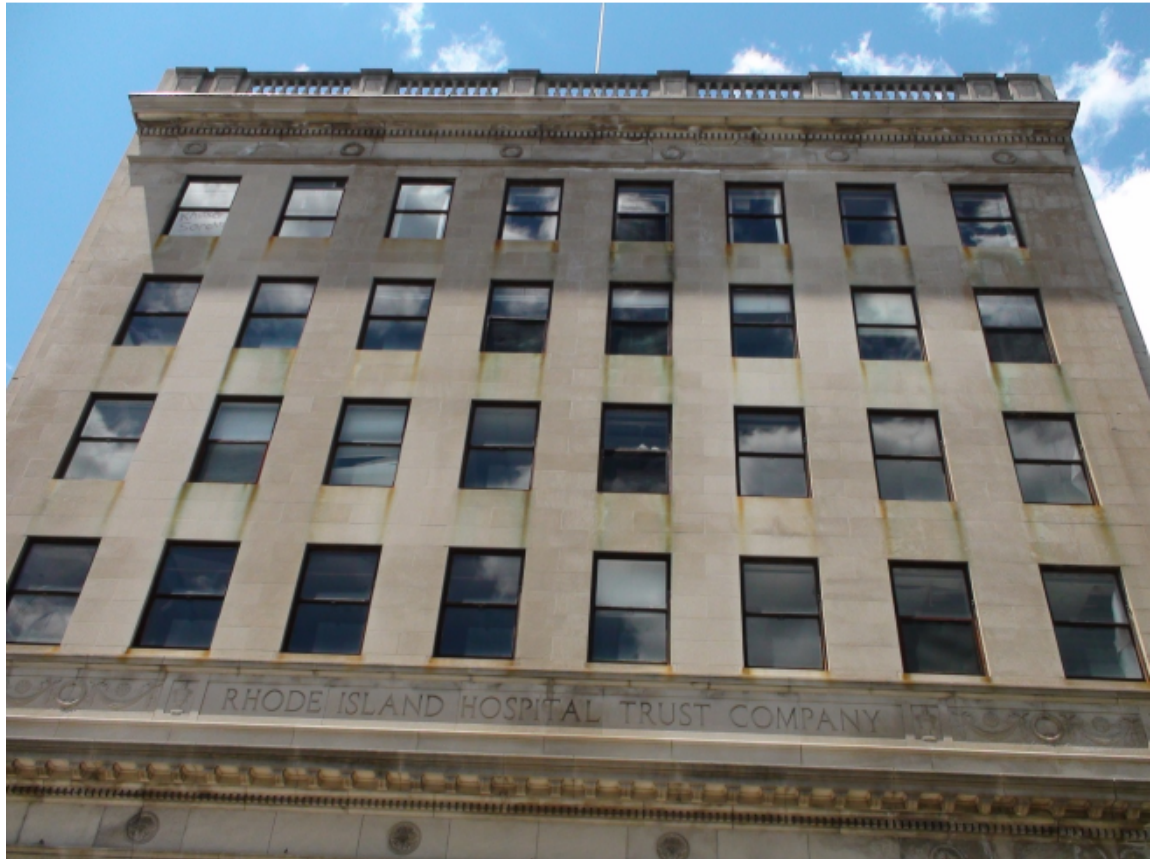
Photo #3

*This photo shows a portion of the ornate limestone veneer façade on the southeast elevation of the former RI Hospital Trust Company building.*

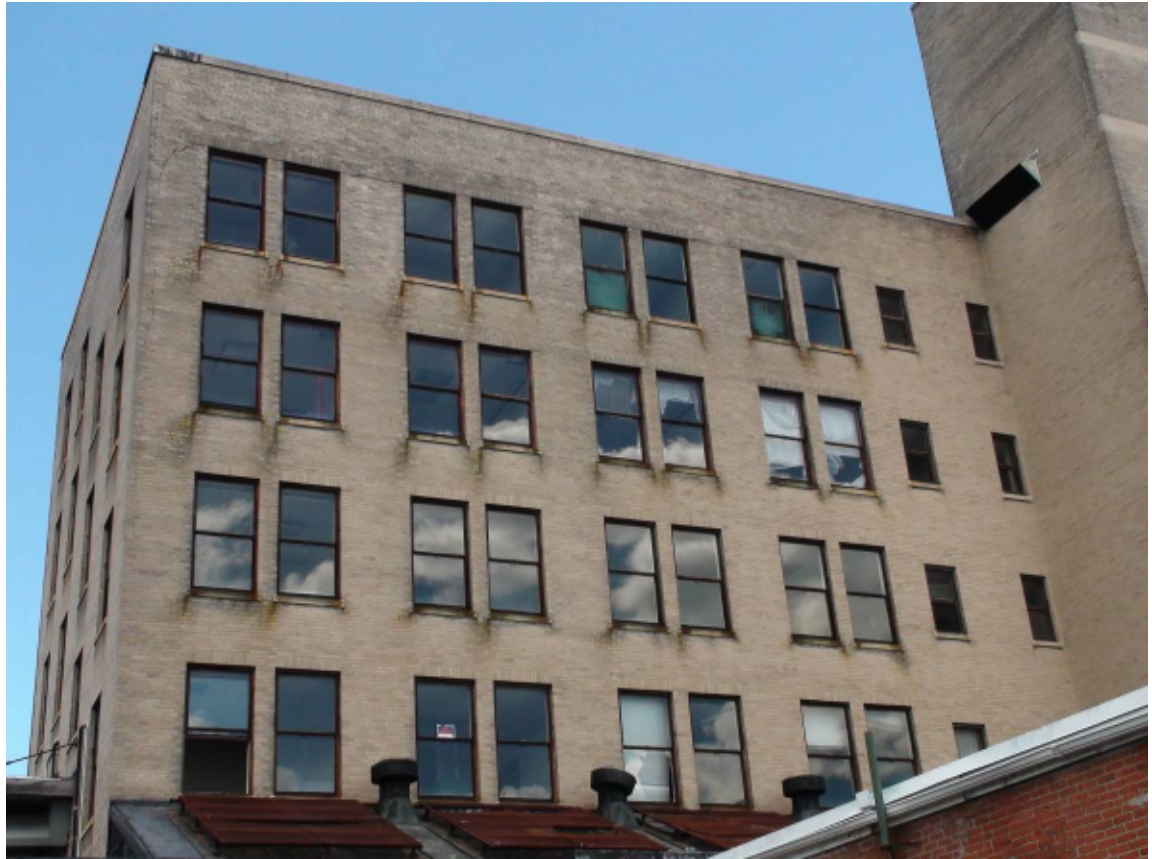
Photo #4

*This photo shows the brick veneer façade typically found along all elevations of the building, with the exception of the southeast elevation.*

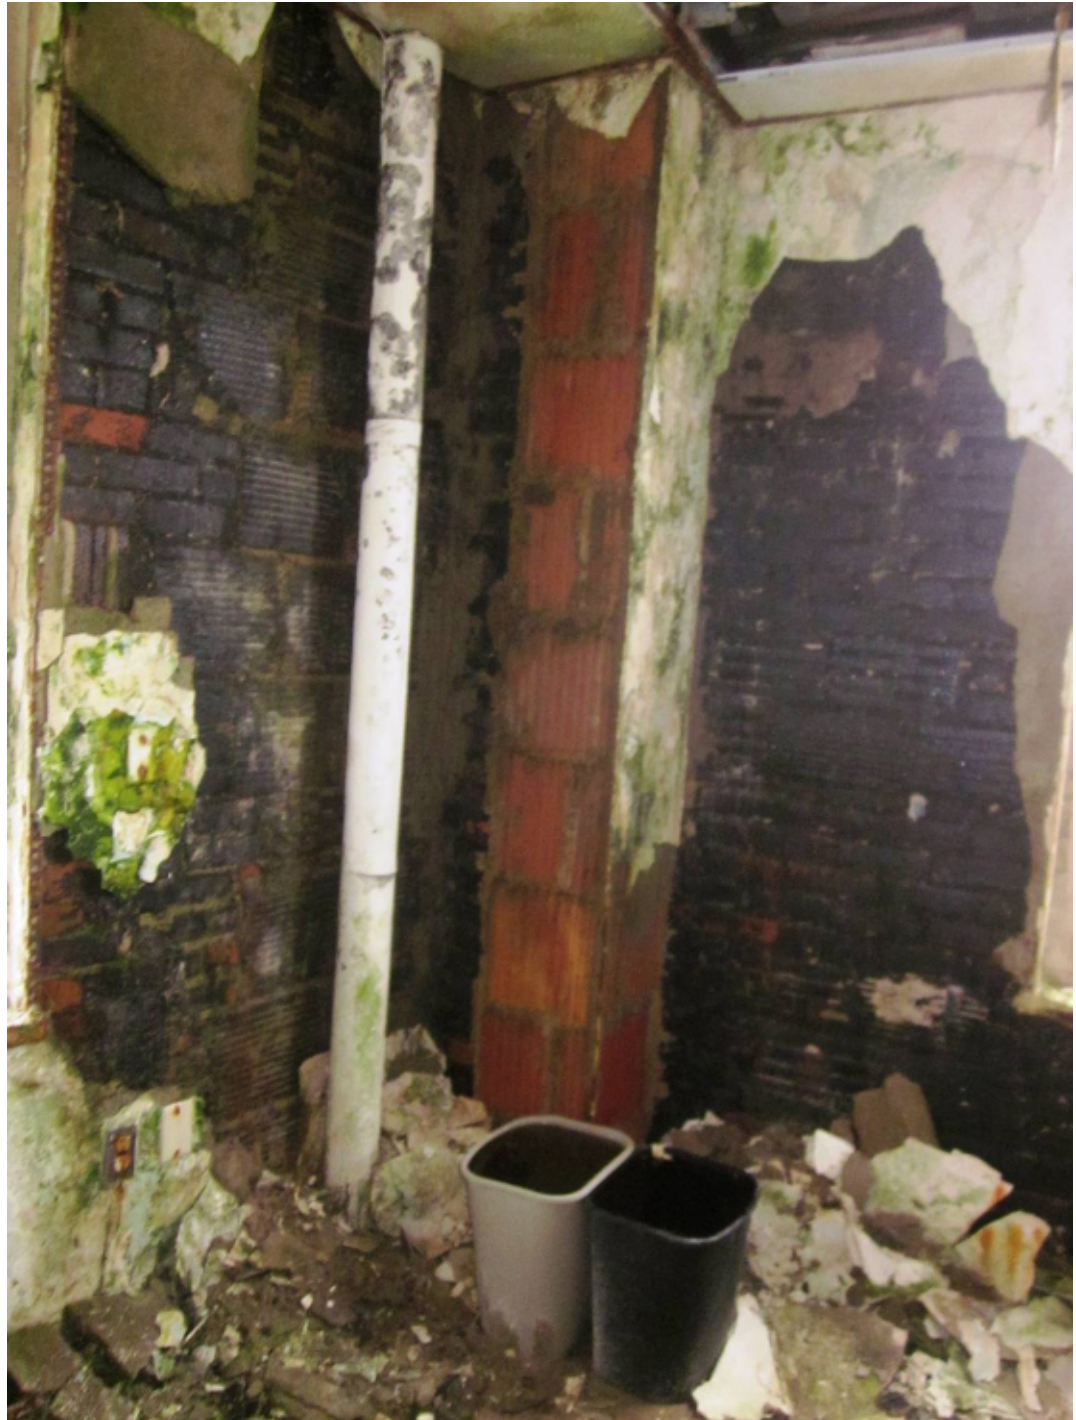
Photo #5

*This photo shows the combination of clay tiles and bricks that were used for the construction of the back-up walls for the exterior façade composite walls. The red terracotta tiles in the middle of the photo enclose the presumed structural steel column at the southeast corner of the six-story tower of the building.*

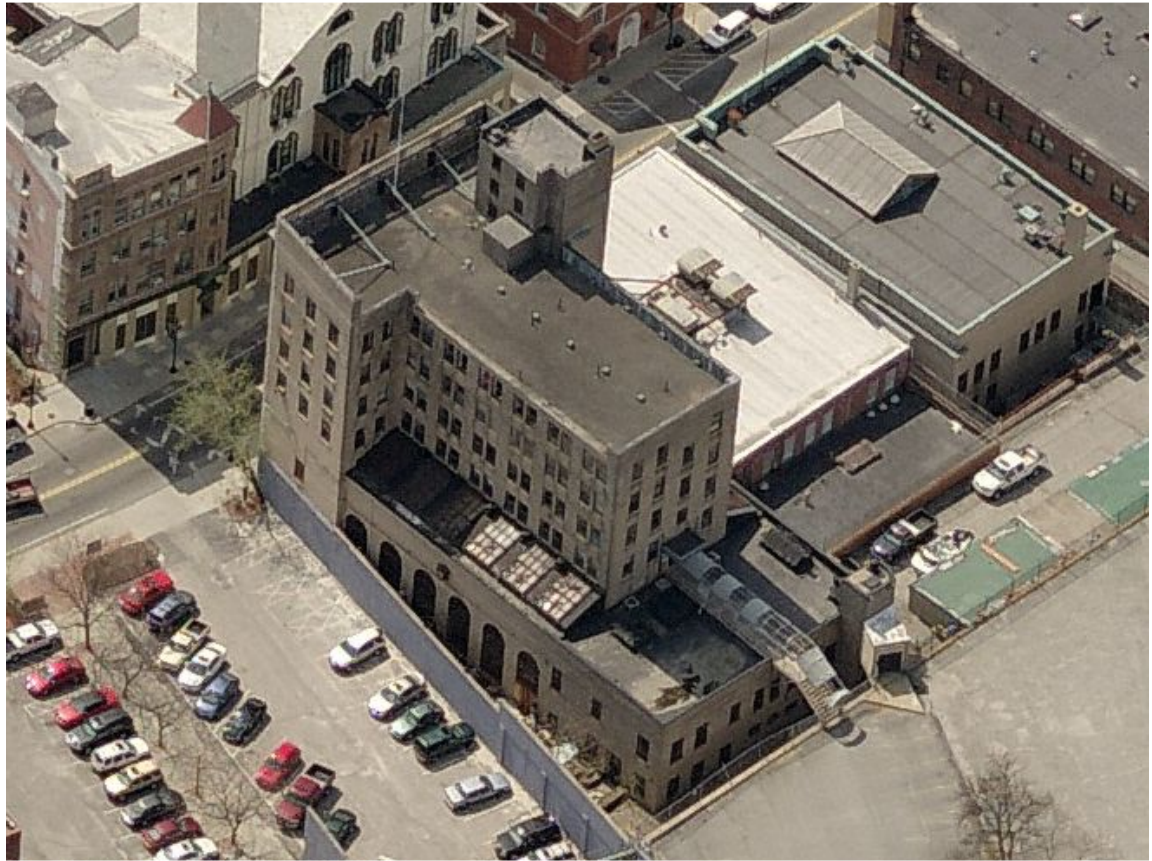
Photo #6

*This aerial photo, looking south, shows the high parapet walls surrounding the southeast side of the six-story tower that extend several feet above the roof.*

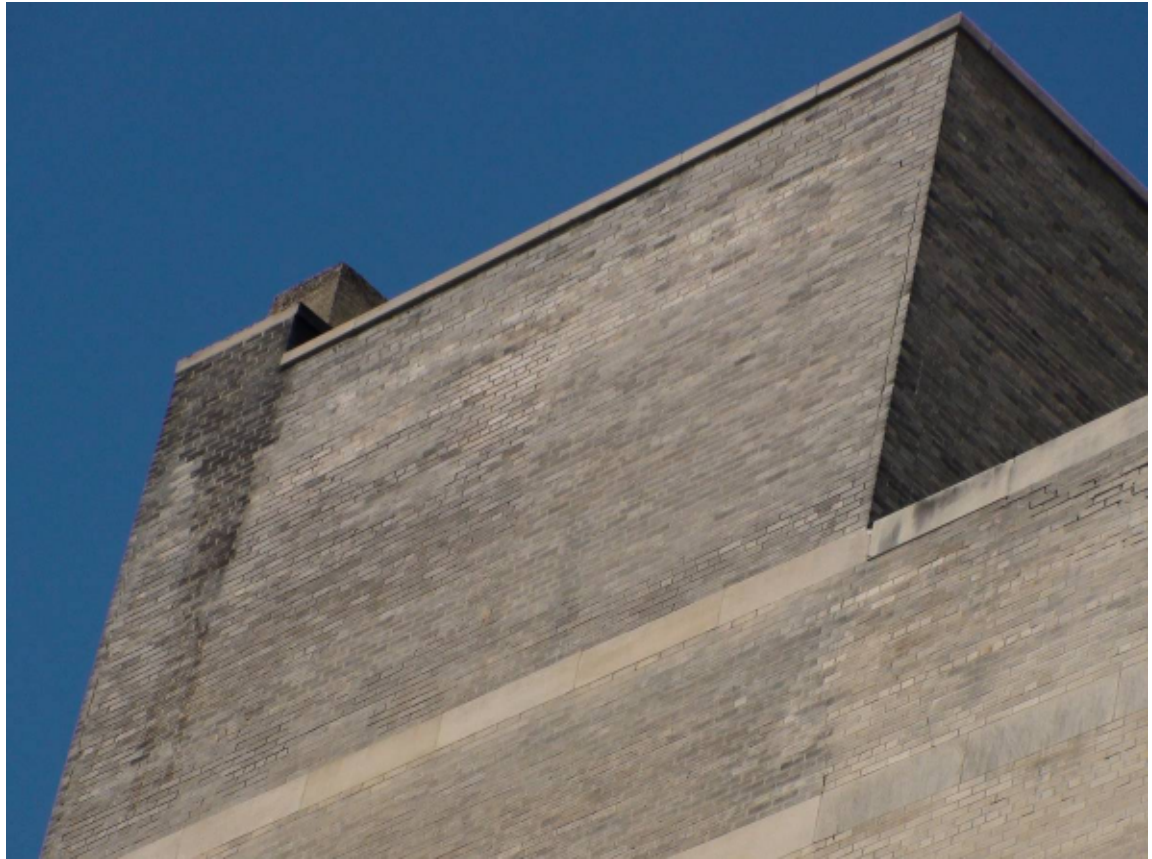
**Photo #7**

- The brick veneer on all elevations of the elevator machine room penthouse tower is severely cracked. Lateral displacements of the brick were observed on the north and south elevations of the tower. **(Please refer to Photos #7 through #10).**

- **Comment:** The vertical cracks in the brick veneer on all elevations of the elevator penthouse machine room tower are likely caused by the lack of control joints that would allow the bricks to freely expand and contract due to changes in temperature and humidity. The lateral displacements of the brick may be caused by this lack of freedom of movement; from the effects of freeze/thaw cycles from water that infiltrates into the wall cavity behind the brick veneer; or, possibly from expansive corrosion of the structural steel members due to long-term moisture infiltration through the walls and into the building envelope.

*This photo, taken from street level, shows the vertical cracking of the brick veneer at each corner of the west elevation of the elevator machine room penthouse/chimney tower.*

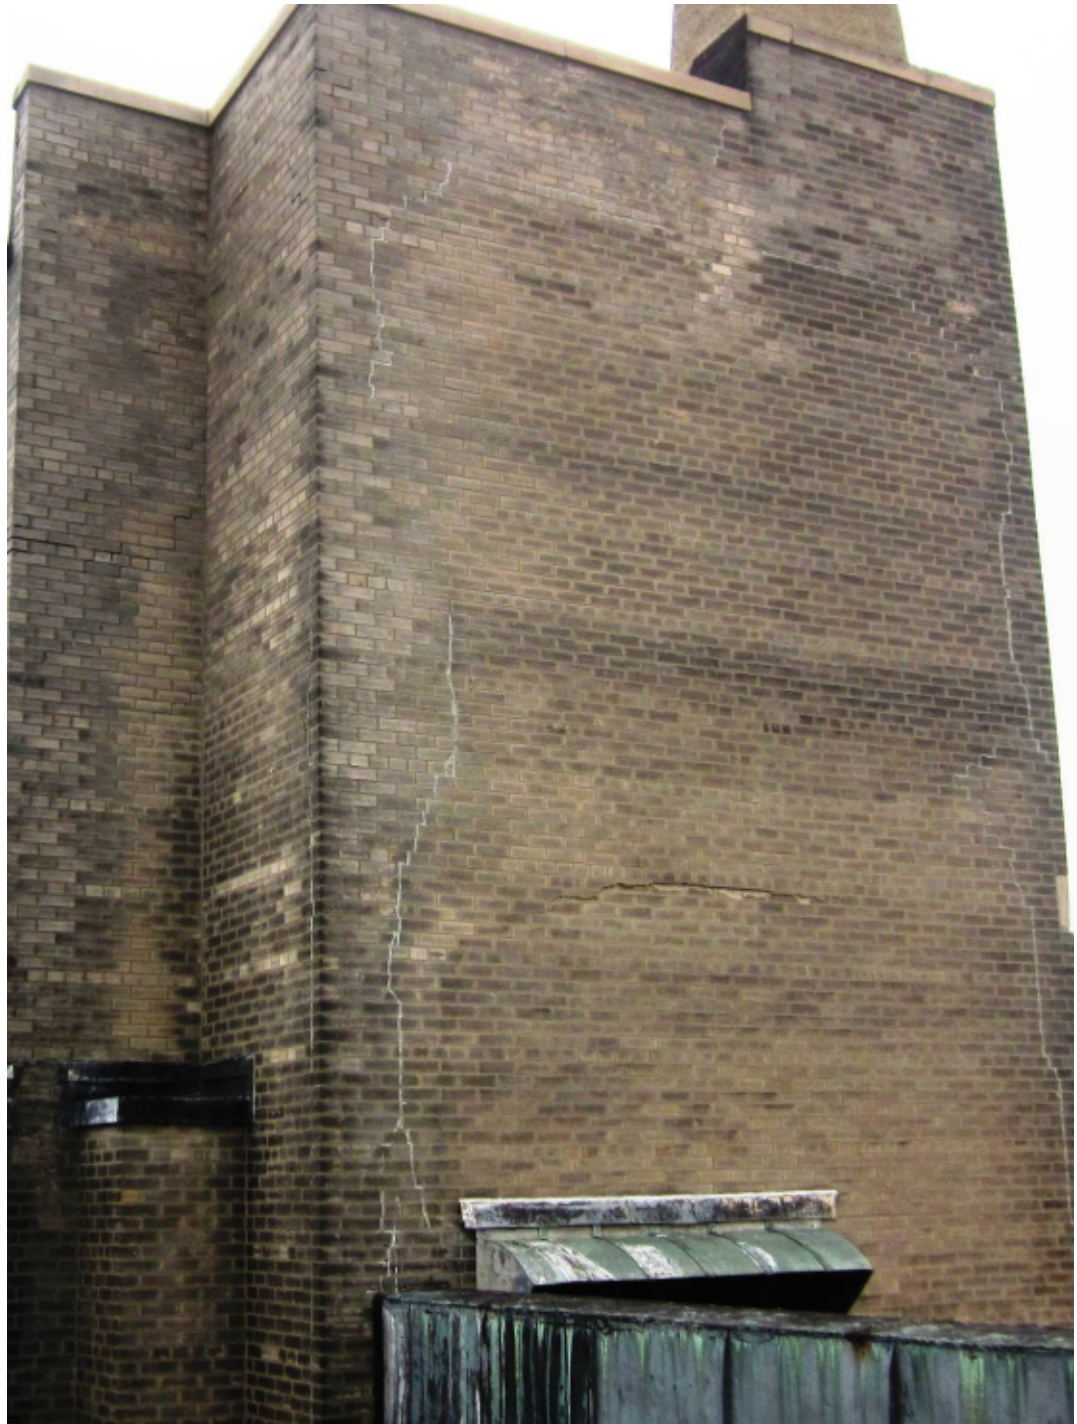
Photo #8

*This photo shows the vertical cracking of the brick veneer and the lateral displacement causing the horizontal crack in the brick on the north face of the elevator machine room penthouse tower.*

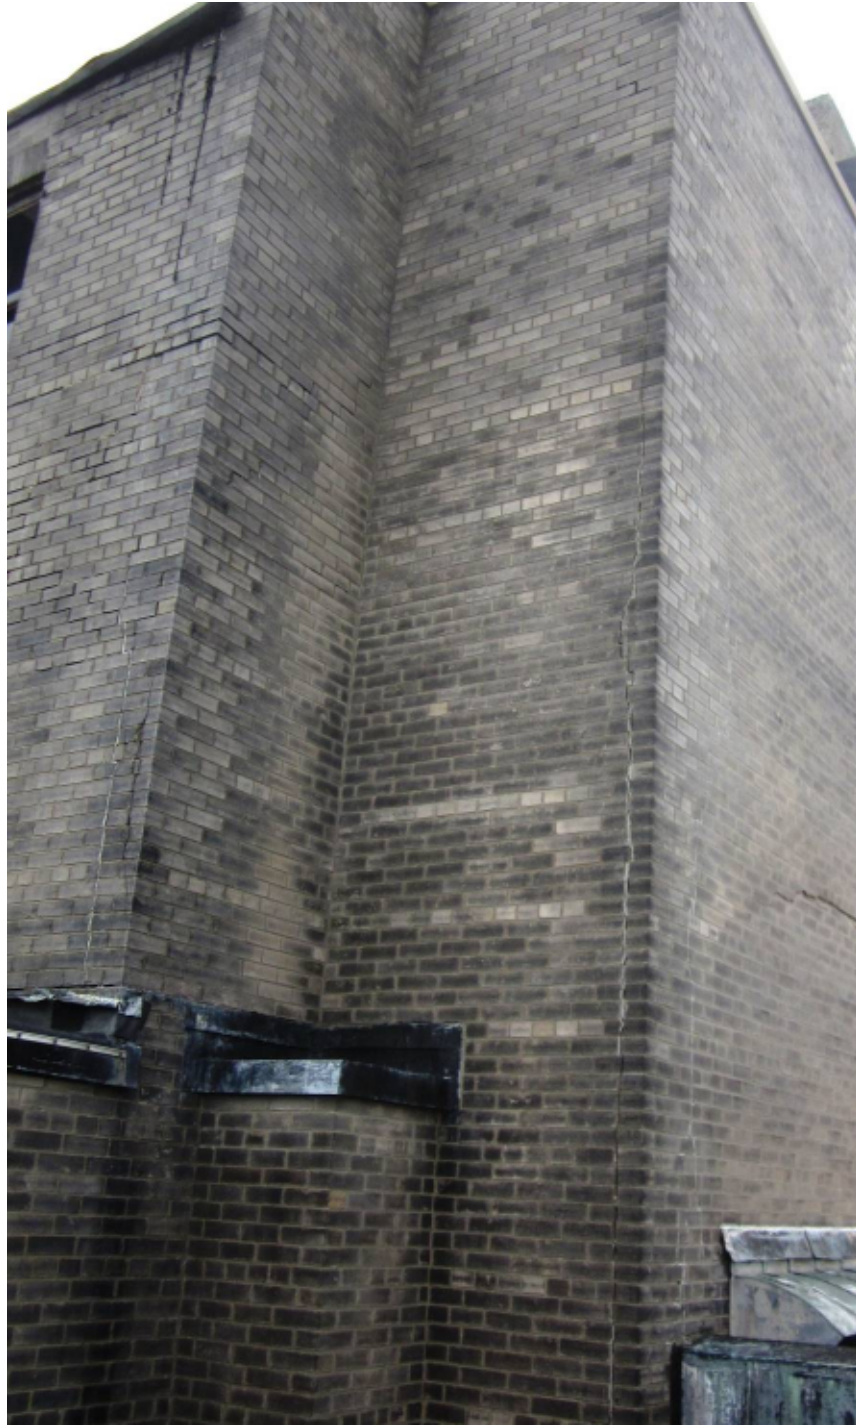
Photo #9

*This photo shows the vertical cracking of the brick veneer on the east face of the elevator machine room penthouse tower.*

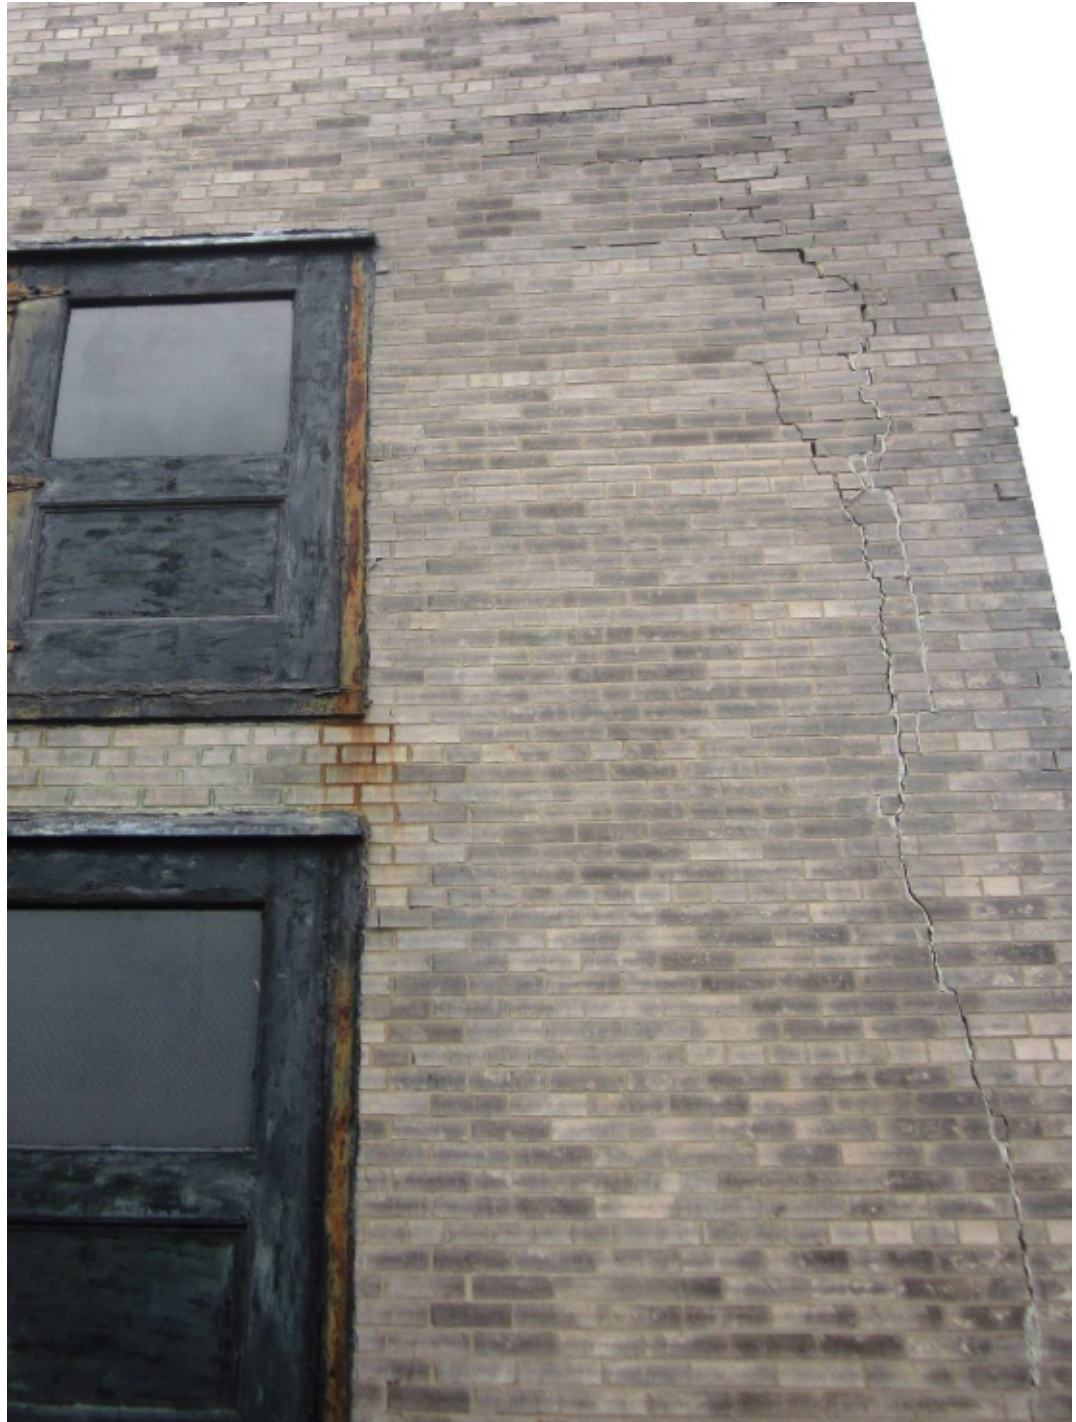
Photo #10

*This photo shows some of the vertical cracks in the brick veneer, and displacement of the bricks, on the south face of the elevator machine room penthouse tower.*

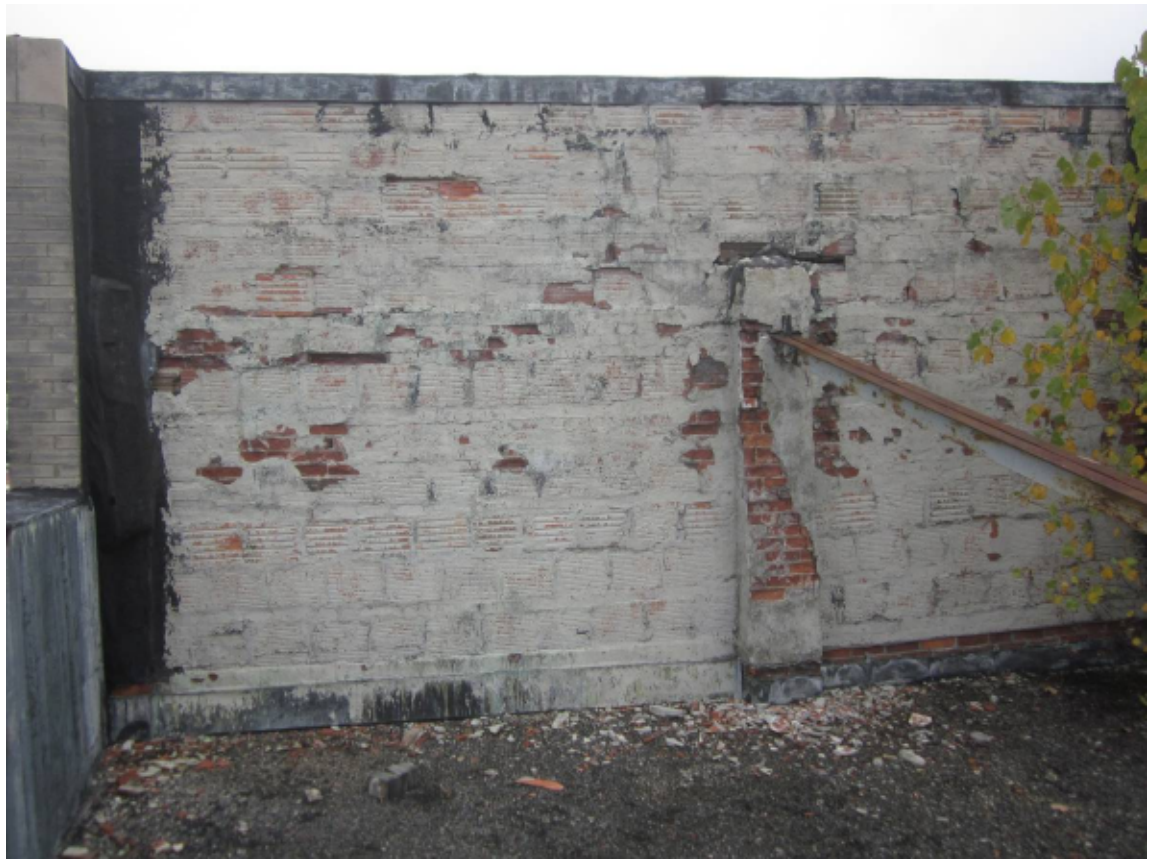
Photo #11

- The parapet walls surrounding the south end of the six-story tower are severely deteriorated. **(Please refer to Photos #11 through #14).**

- **Comment:** Apparently, the wall coverings that protected the inside face (back-up walls of the composite wall system) from the elements has been removed. The loss of the protective inboard wall coverings has exposed the clay tiles, bricks and mortar of the back-up wall to the weather, causing the deterioration of these wall components. In addition, the loss of the wall coverings has allowed water to infiltrate into the building envelope as a result of damage to the flashings and counterflashings at the interface with the roofing system. The parapet walls represent an unsafe condition that could fail, particularly under certain wind or seismic loadings.

*This photo shows the deteriorated condition of the back side of the parapet wall located on the northeast side of the southeast end of the six-story tower.*

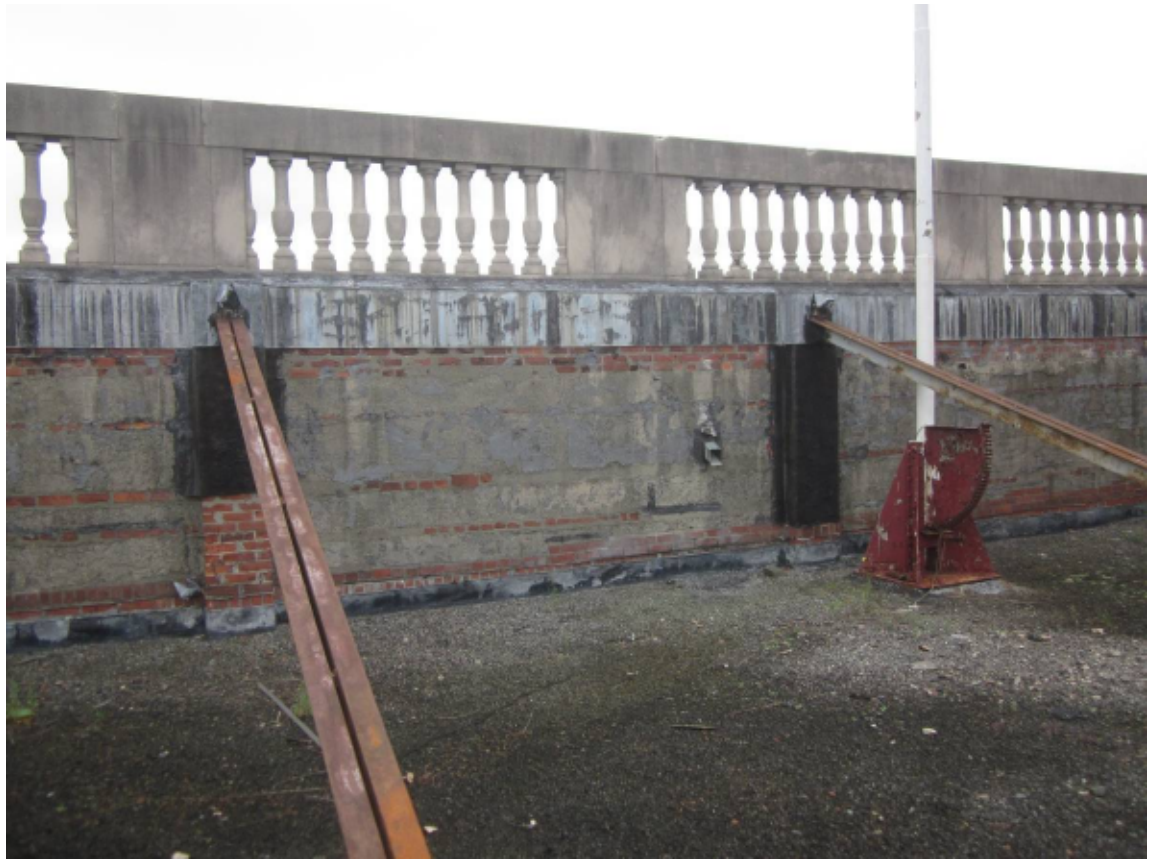
Photo #12

*This photo shows exposed and deteriorated condition of the back-up wall of the parapet wall located along the southeast (Main Street) side of the southeast end of the six-story tower.*

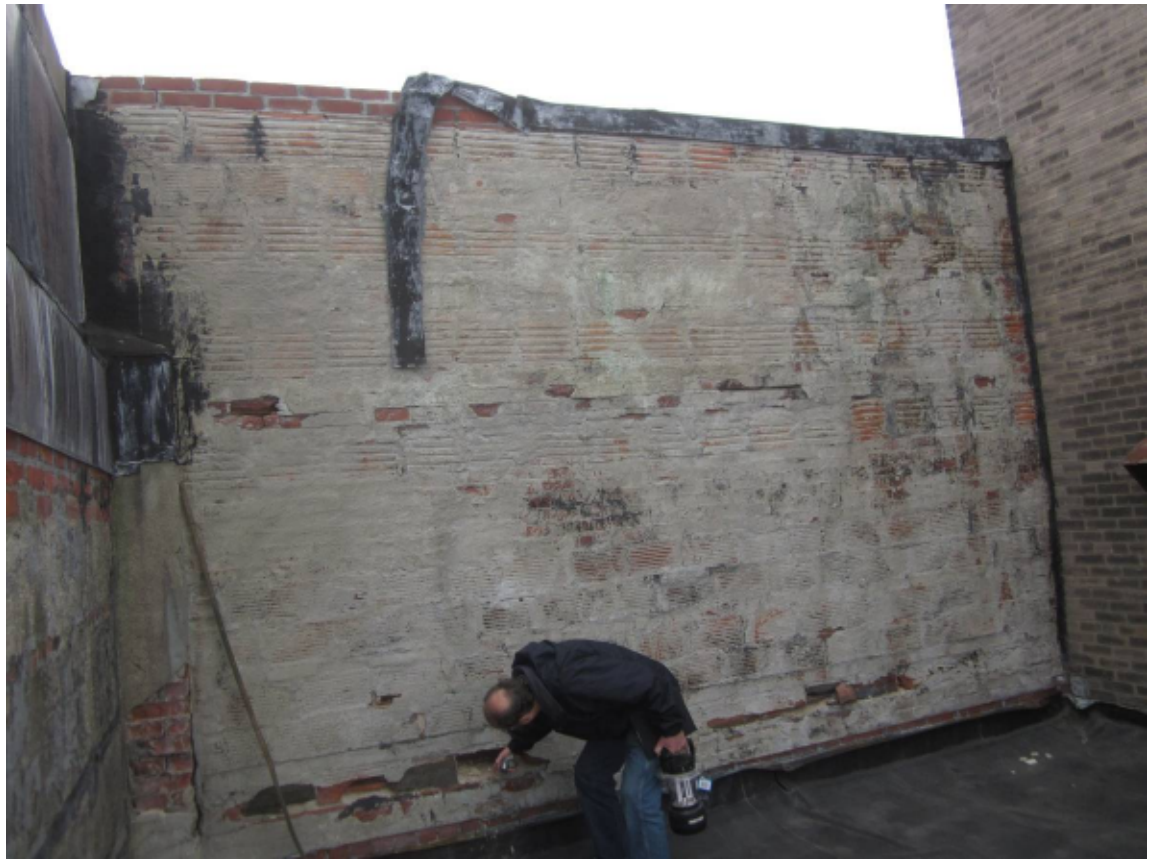
Photo #13

*This photo shows the deteriorated condition of the back-up wall for the parapet wall located along the southwest side of the southeast end of the six-story tower.*

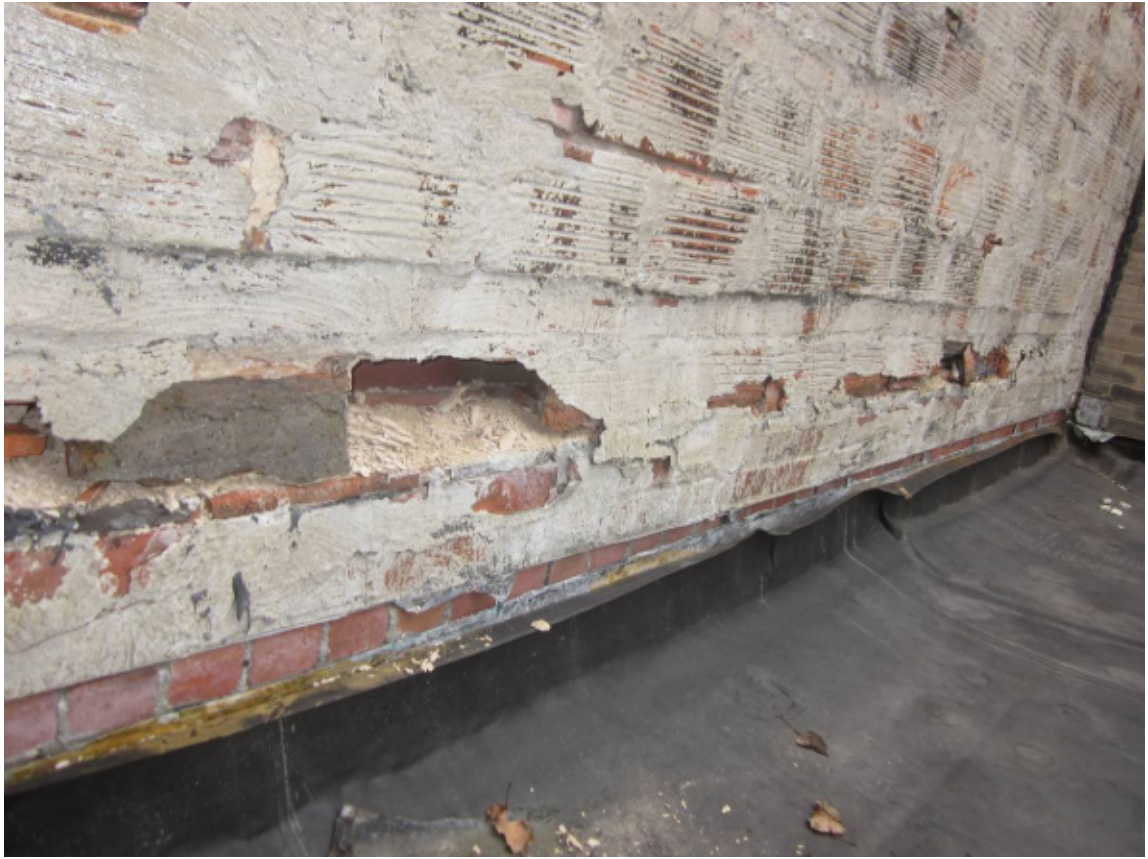
Photo #14

*This photo shows a close-up view of the severity of the deterioration of the back-up wall for the parapet wall located on the southwest side of the southeast end of the six-story tower. Note that there is no positive closure between the inside face of the parapet wall and the installed rubber roofing membrane system.*

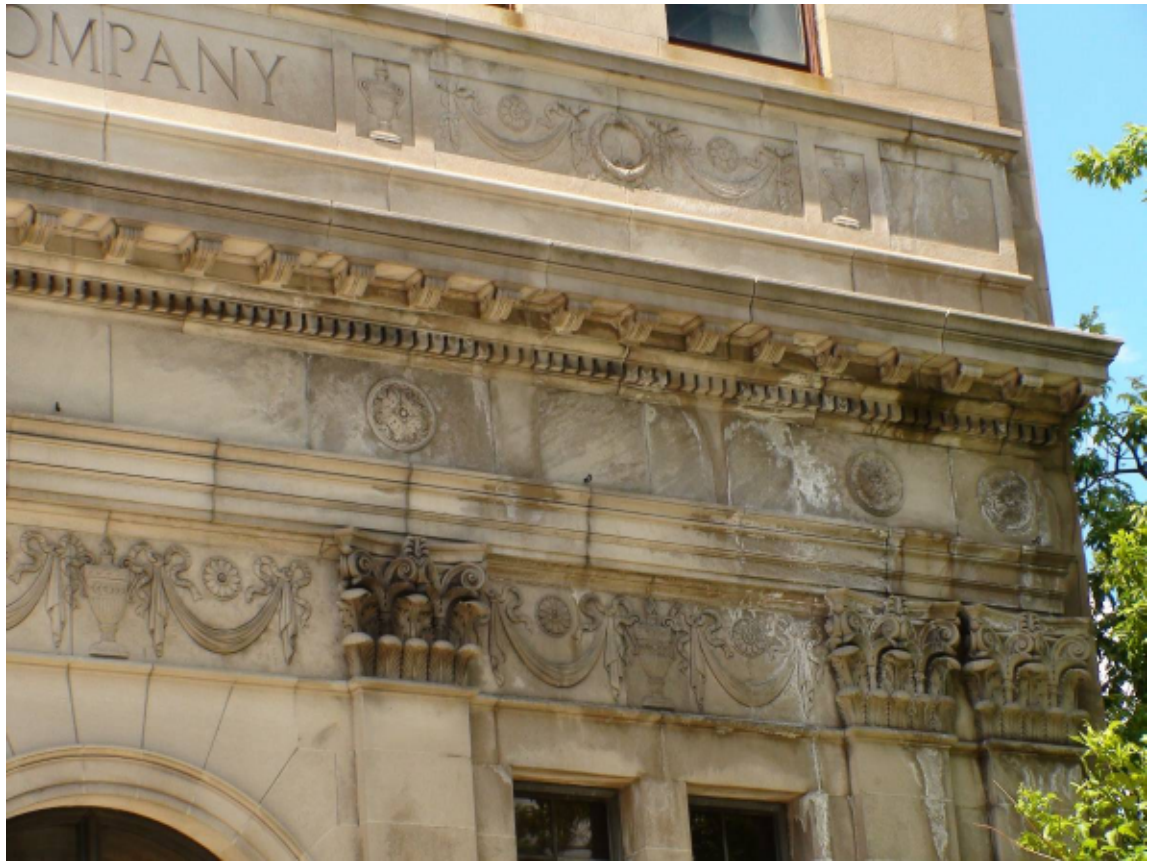
Photo #15

- At numerous and varied locations on all sides of the exterior façade, including both the ornate limestone veneer on the southeast (Main Street) side of the six-story tower, and the brick veneer found elsewhere, the veneer is cracked, spalled, displaced, and exuding efflorescence. **(Please refer to Photos #15 through #27).**

- **Comment:** The initial cause of the cracking, spalling, and displacements of both the limestone and brick veneers is likely caused by the lack of control joints to allow the veneers to freely expand and contract due to changes in ambient air temperature and changes in the moisture content of the veneers. The cracking, spalling and displacements of the veneers provide openings for water to infiltrate into the composite wall system. The infiltrating water can deteriorate the mortar, back-up wall members, and the veneer itself. In addition, water trapped in the cavity between the veneer and the back-up wall can freeze, expanding and displacing the masonry, thereby creating additional space to trap water, and repeat the cycle. Furthermore, the infiltrating water can cause expansive corrosion of the steel angle lintels over the masonry openings and possibly expansive corrosion of the structural steel members.

*This photo shows the evidence of water and efflorescence exuding from the limestone veneer at the southeast corner of the six-story tower.*

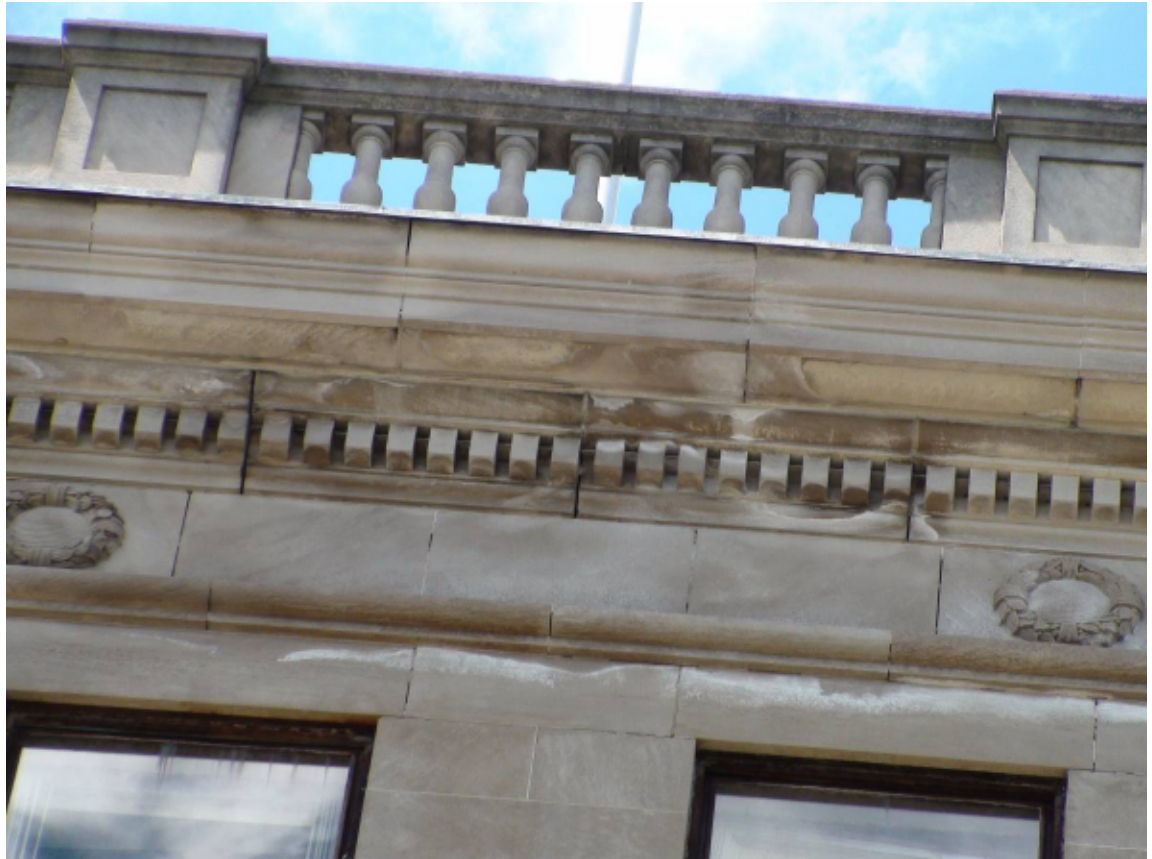
Photo #16

*This photo shows another example of water and efflorescence escaping for the limestone veneer below the parapet on the southeast side of the six-story tower.*

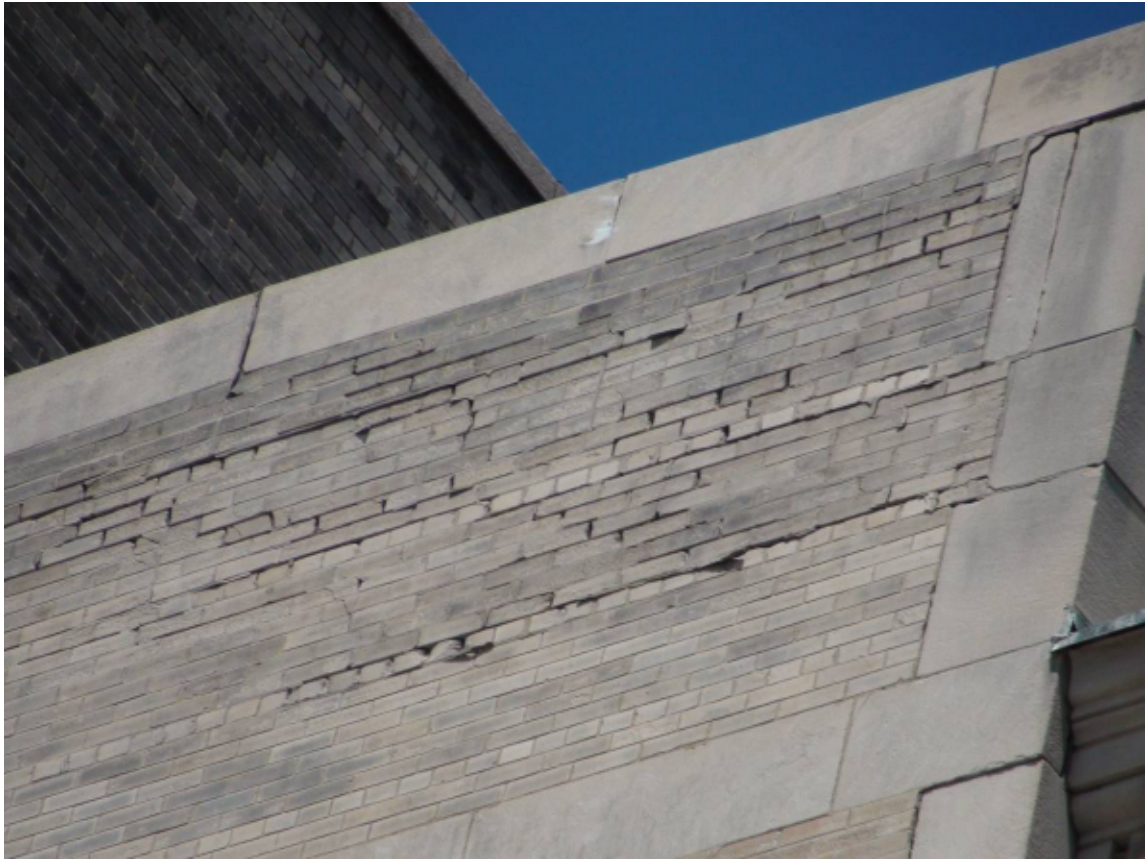
**Photo #17**

*This photo shows the deterioration of the mortar from joints between the veneer bricks on the parapet wall located on the southwest side of the southeast end of the six-story tower.*

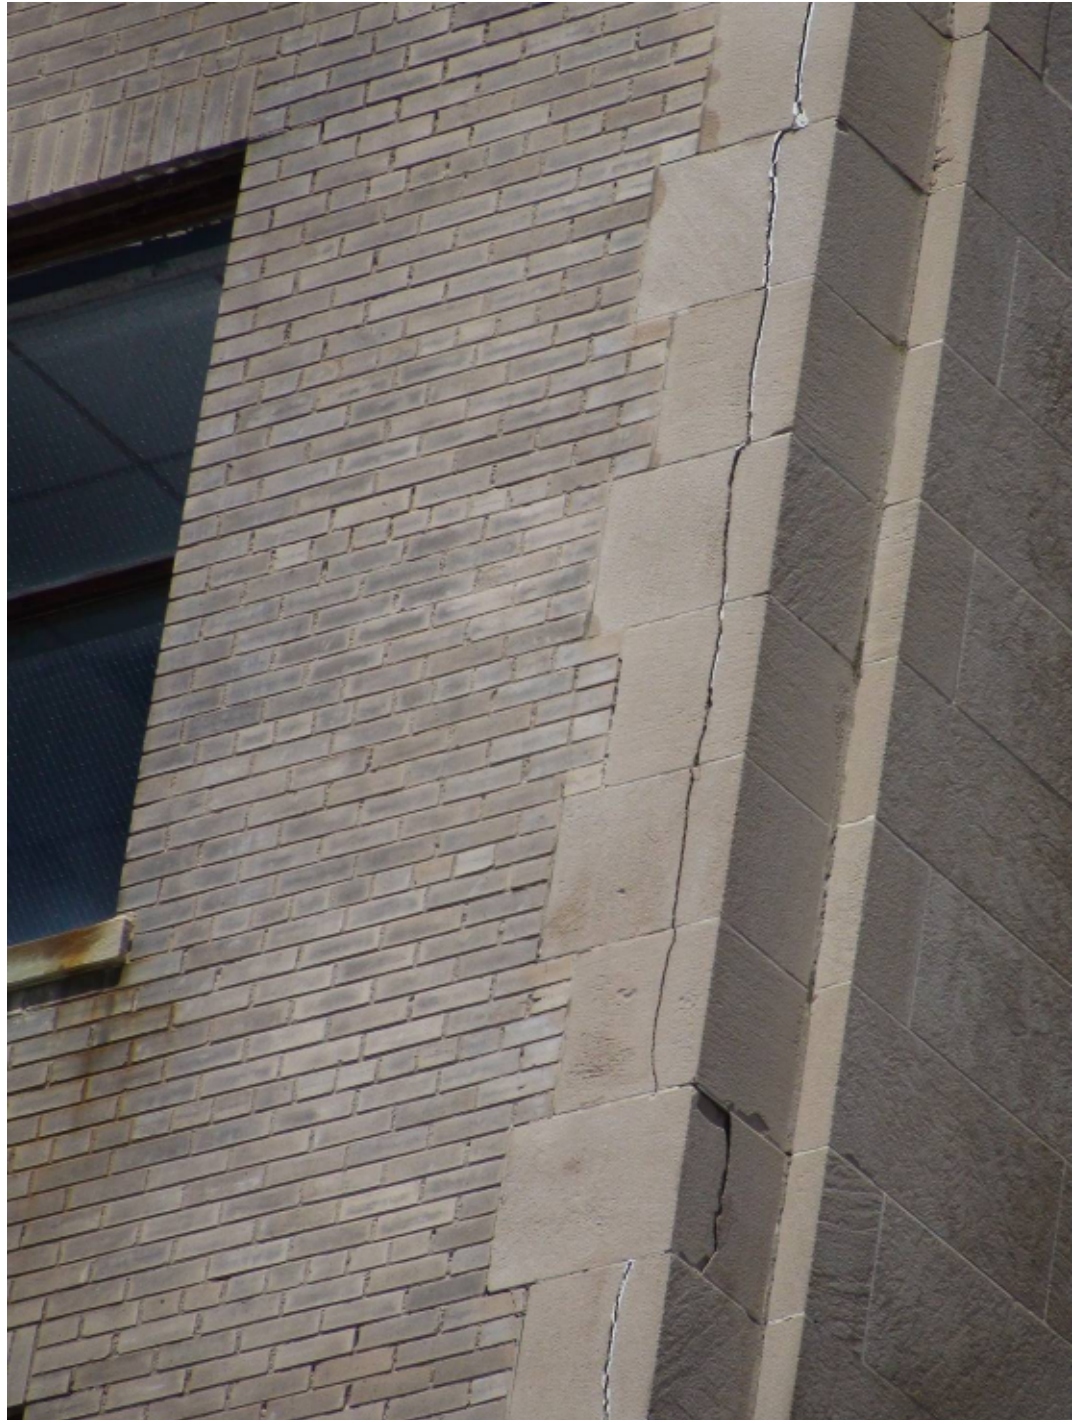
**Photo #18**

*This photo shows the cracking of the limestone quoins located at the southwest corner of the six-story tower.*
