## **LIMITED STRUCTURAL EVALUATION**

### **162 MAIN STREET WOONSOCKET, RHODE ISLAND**

October 18, 2012

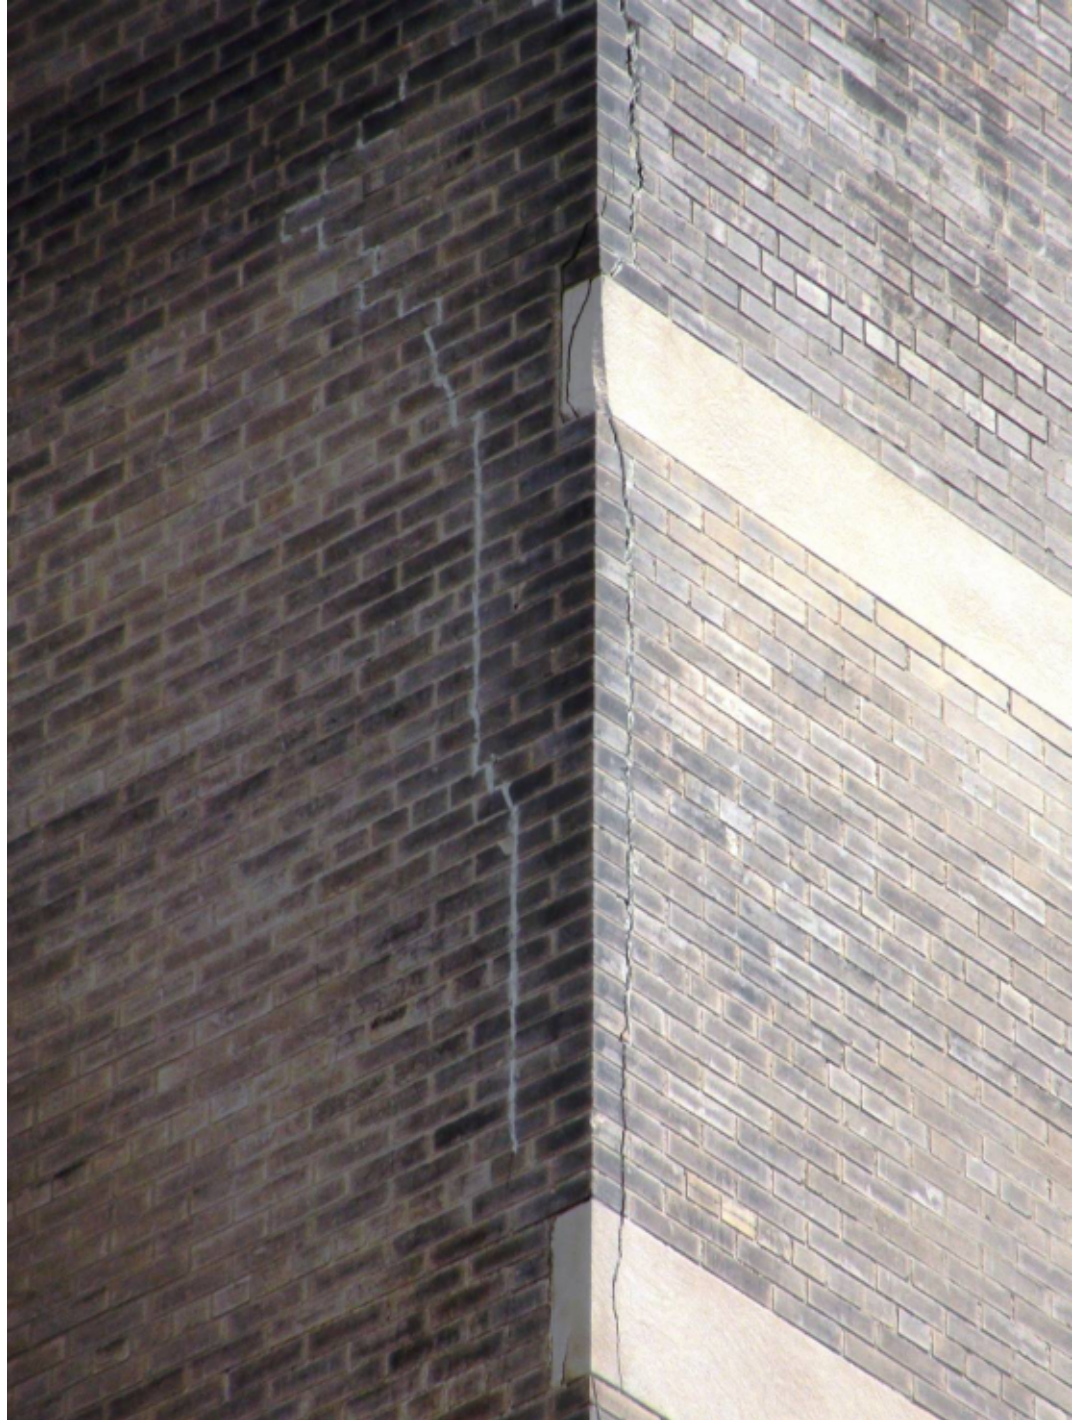
Photo #19

- At numerous and varied locations on all sides of the exterior façade, including both the ornate limestone veneer on the southeast (Main Street) side of the six-story tower, and the brick veneer found elsewhere, the veneer is cracked, spalled, displaced, and exuding efflorescence. **(Please refer to Photos #15 through #27).**

- **Comment:** The initial cause of the cracking, spalling, and displacements of both the limestone and brick veneers is likely caused by the lack of control joints to allow the veneers to freely expand and contract due to changes in ambient air temperature and changes in the moisture content of the veneers. The cracking, spalling and displacements of the veneers provide openings for water to infiltrate into the composite wall system. The infiltrating water can deteriorate the mortar, back-up wall members, and the veneer itself. In addition, water trapped in the cavity between the veneer and the back-up wall can freeze, expanding and displacing the masonry, thereby creating additional space to trap water, and repeat the cycle. Furthermore, the infiltrating water can cause expansive corrosion of the steel angle lintels over the masonry openings and possibly expansive corrosion of the structural steel members.

*This photo shows the vertical cracking of both the brick veneer and limestone bands at the northwest corner of the southeast end of the six-story tower.*

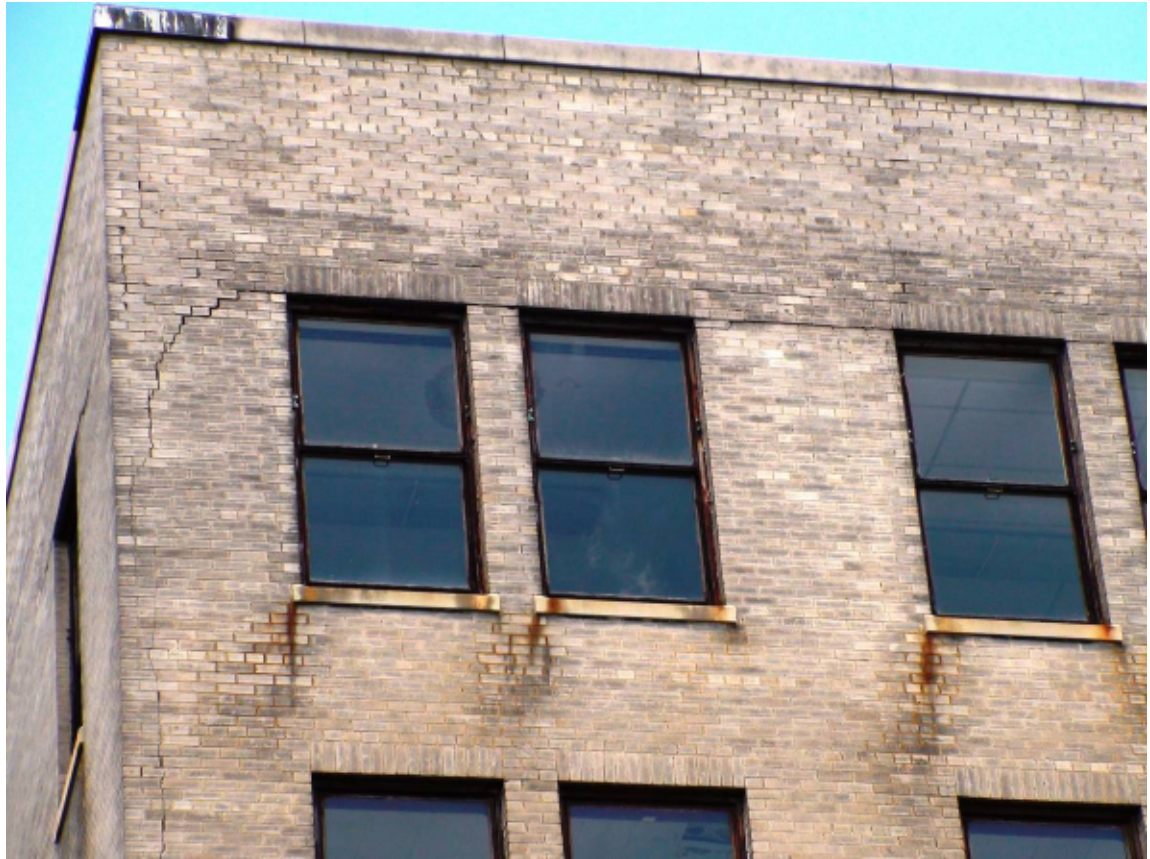
Photo #20

*This photo shows the vertical cracking, diagonal cracking, and lateral displacement of the brick veneer at the northwest corner of the six-story tower.*

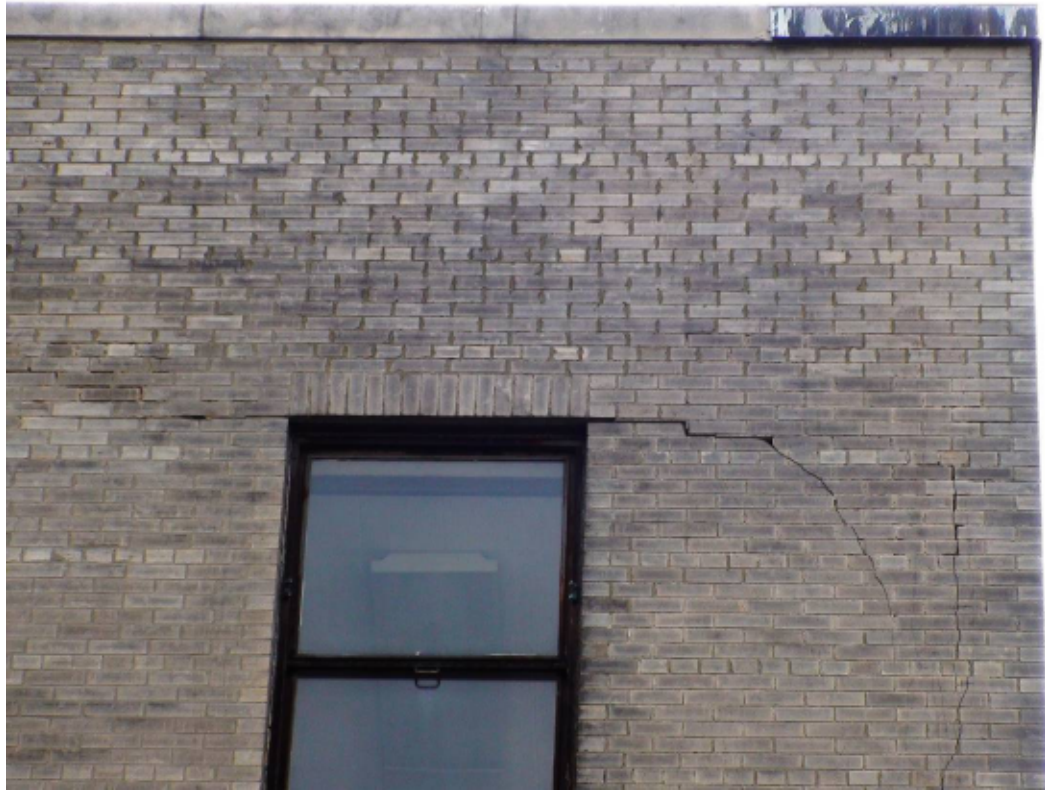
Photo #21

*This photo shows the vertical cracks, diagonal cracks and step cracks in the brick veneer located at the western end of the north wall of the six-story tower.*

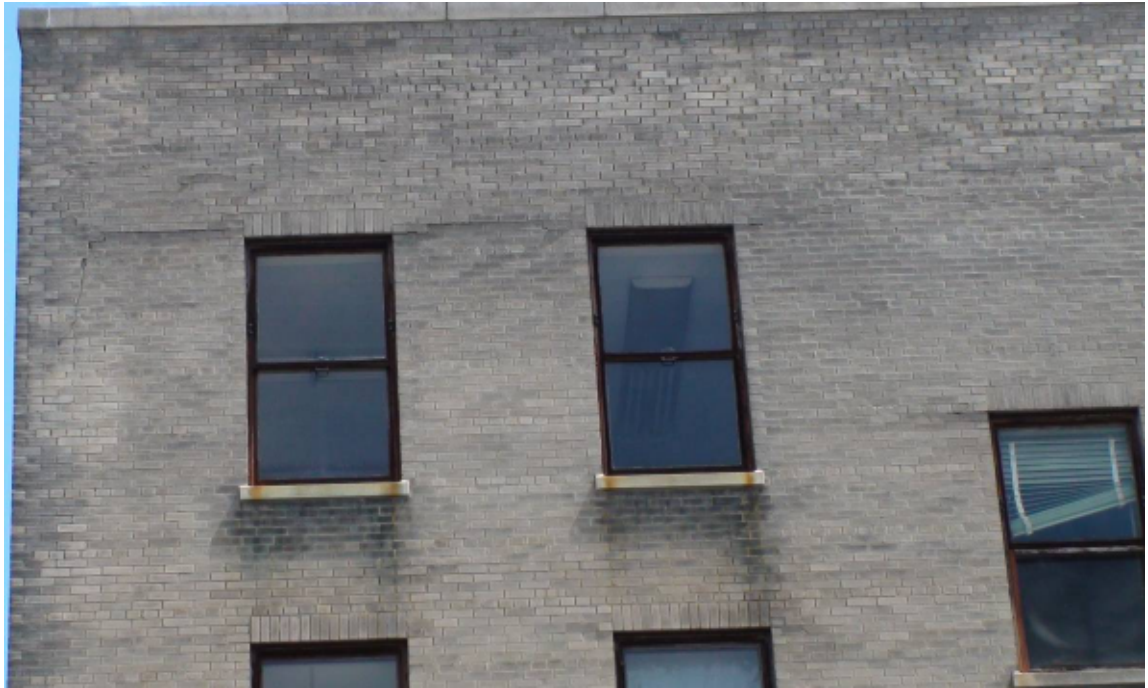
**Photo #22**

*This photo shows the cracking and displacement of the brick veneer at the northeast corner of the six-story tower.*

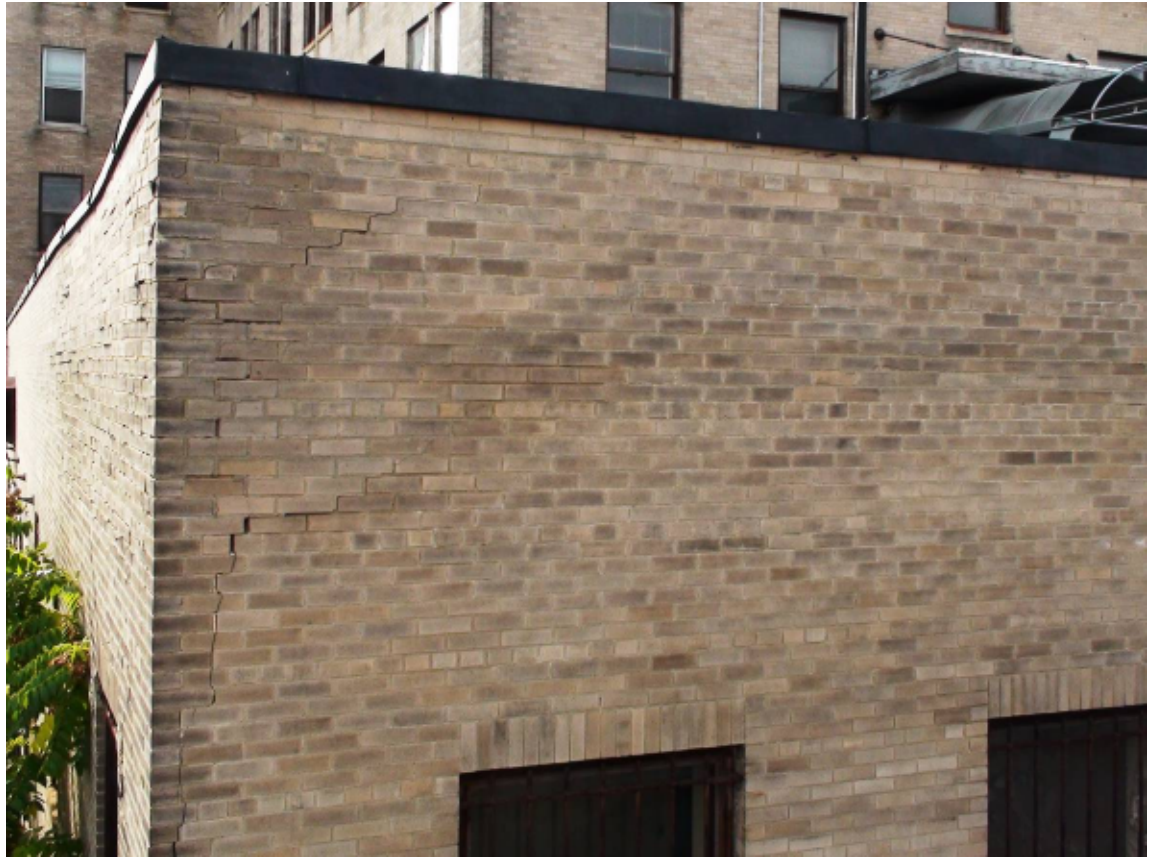
**Photo #23**

*This photo shows the cracking and displacement of the brick veneer at the northeast corner of the two-story portion of the building.*

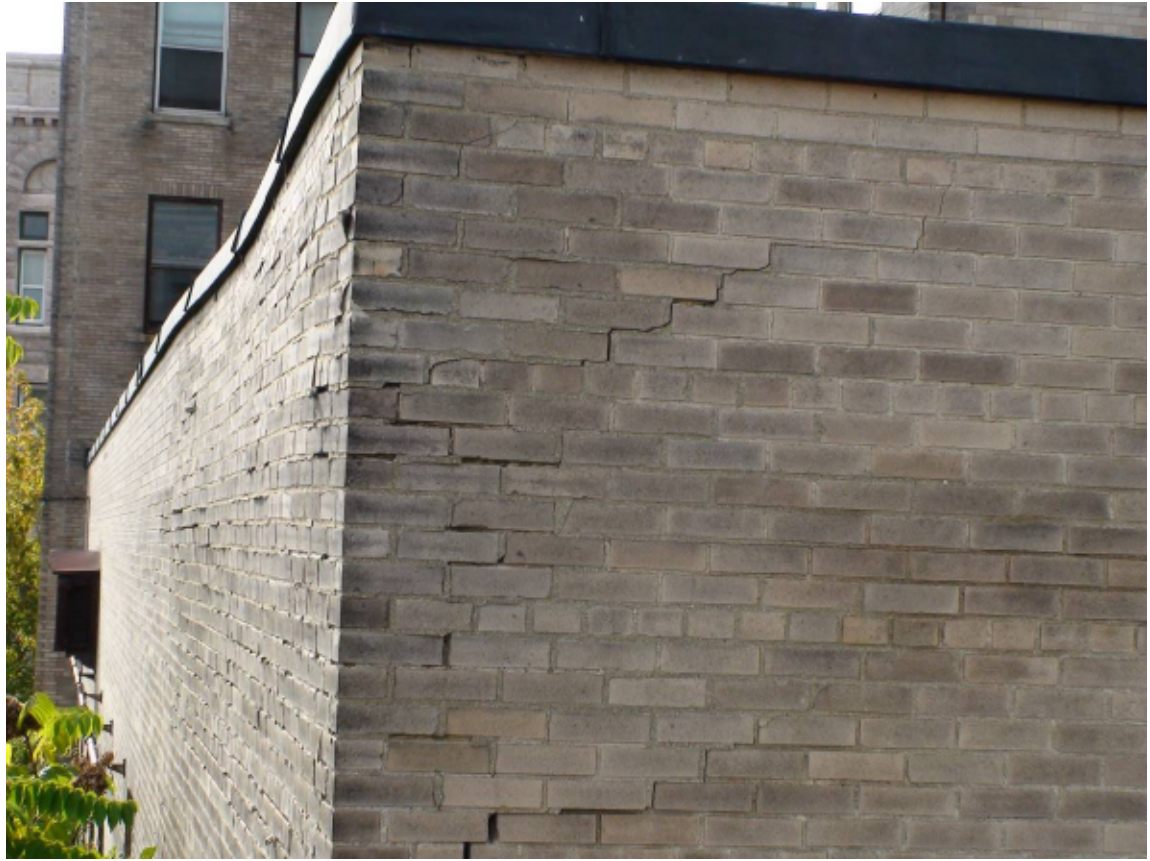
Photo #24

*This photo show closer view of the cracking and displacement of the brick at the northeast corner of the two-story building. Note the outward bowing of the brick at the northern end of the east wall.*

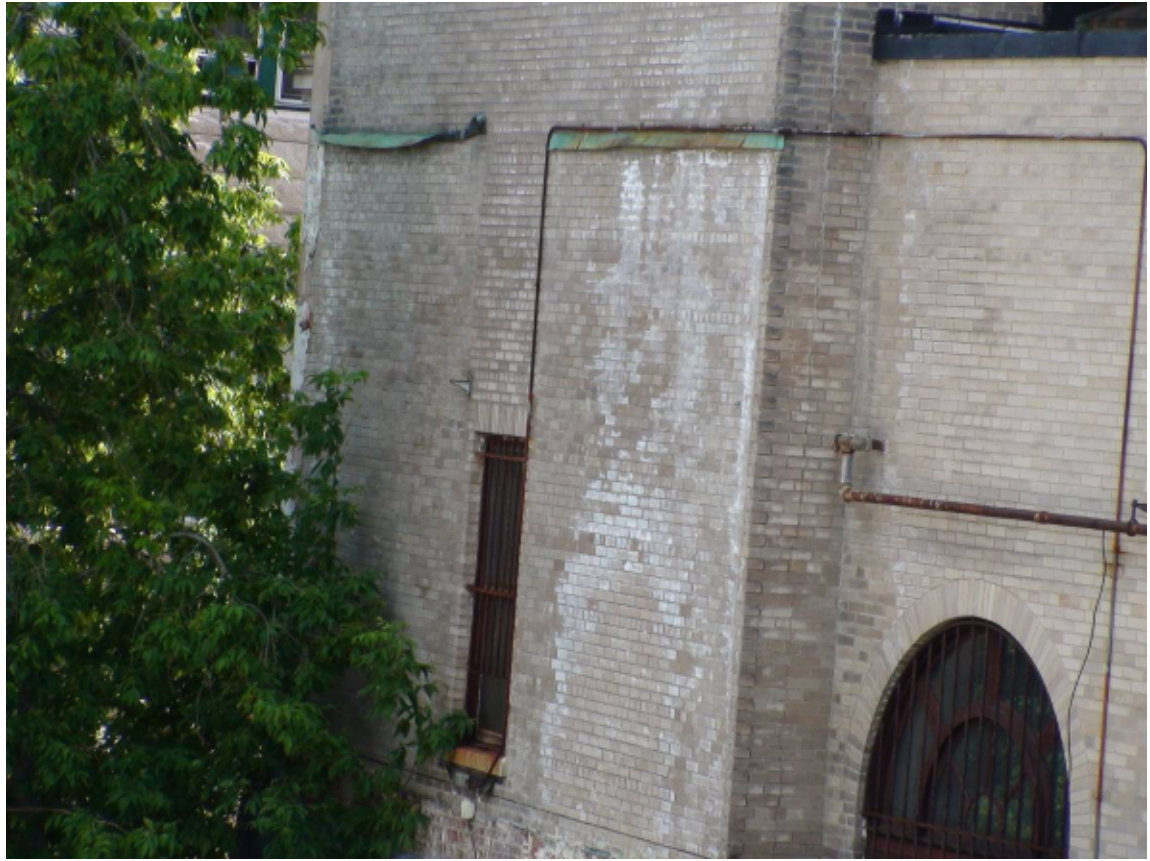
Photo #25

*This photo shows the vertical cracking of the brick veneer and the efflorescence leaching out of the wall at the southern end of the east wall of the building.*

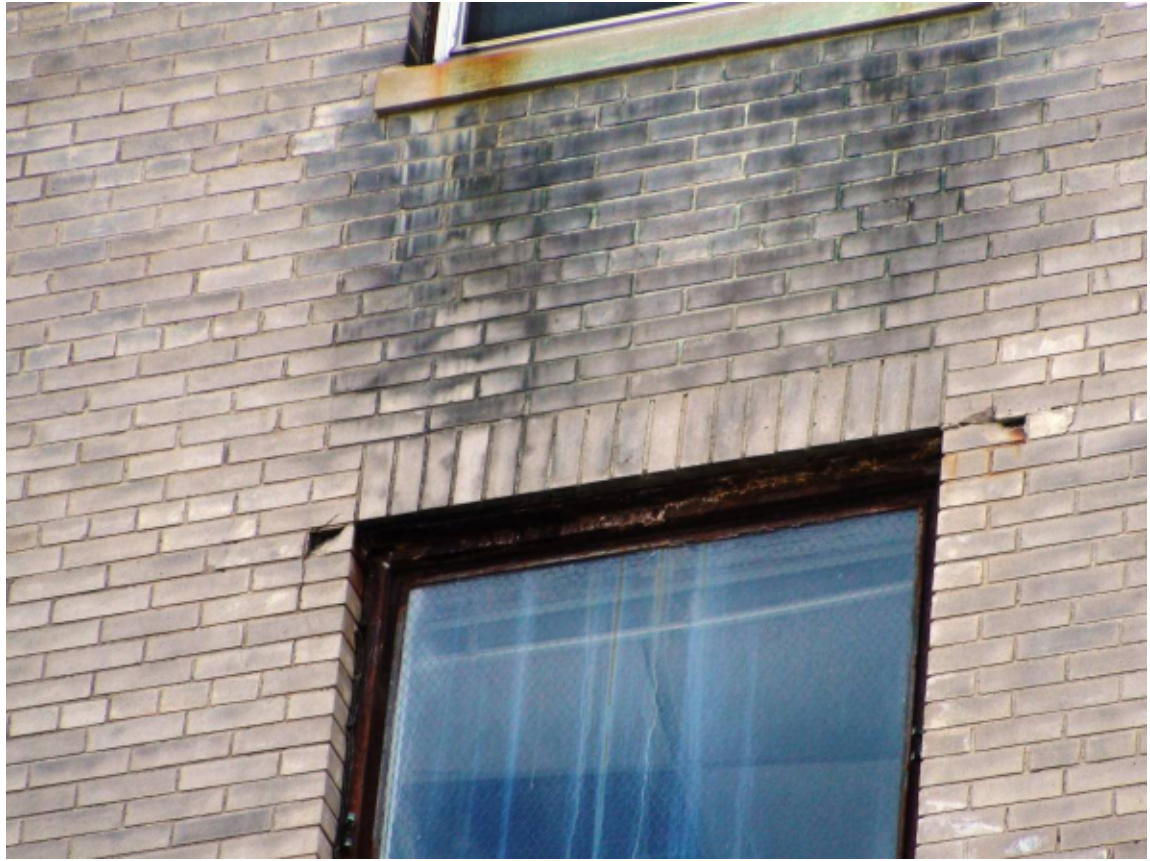
Photo #26

*This photo shows the cracking and spalling of the brick veneer on the east side of the southern end of the six-story tower. The cracking and spalling of the brick appears to be the result of expansive corrosion of the steel angle lintel above the window opening.*

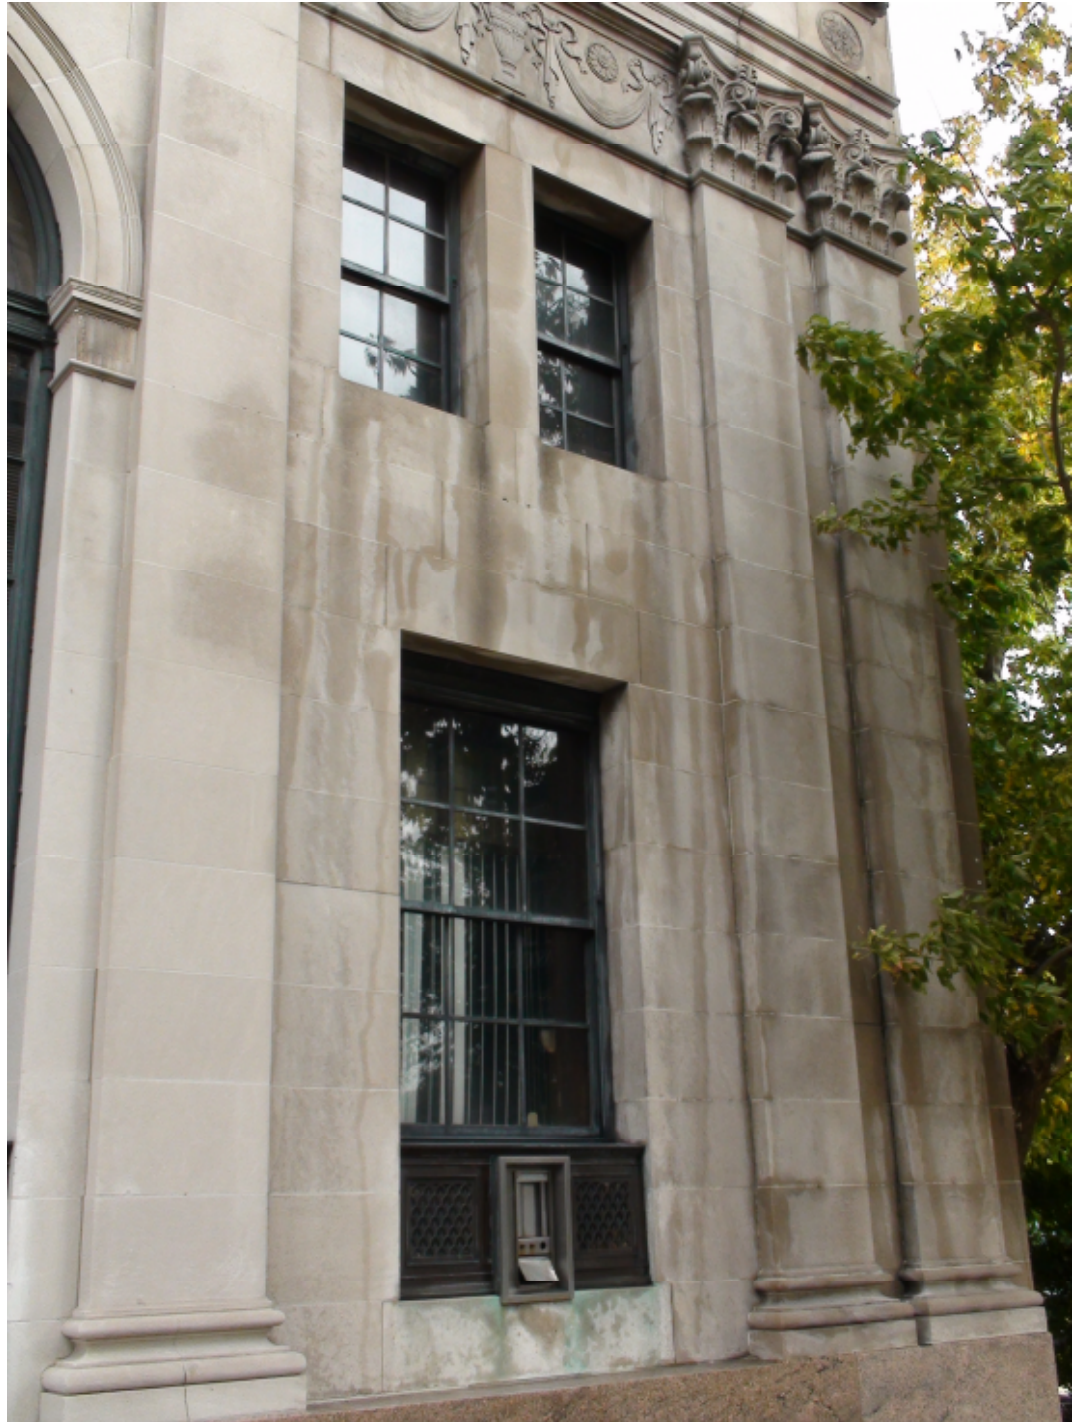
**Photo #27**

*This photo shows water that is trapped behind the limestone veneer on the southeast side of the six-story tower. This water can deteriorated the masonry wall components and may cause displacement of the veneer during winter freeze/thaw cycles.*

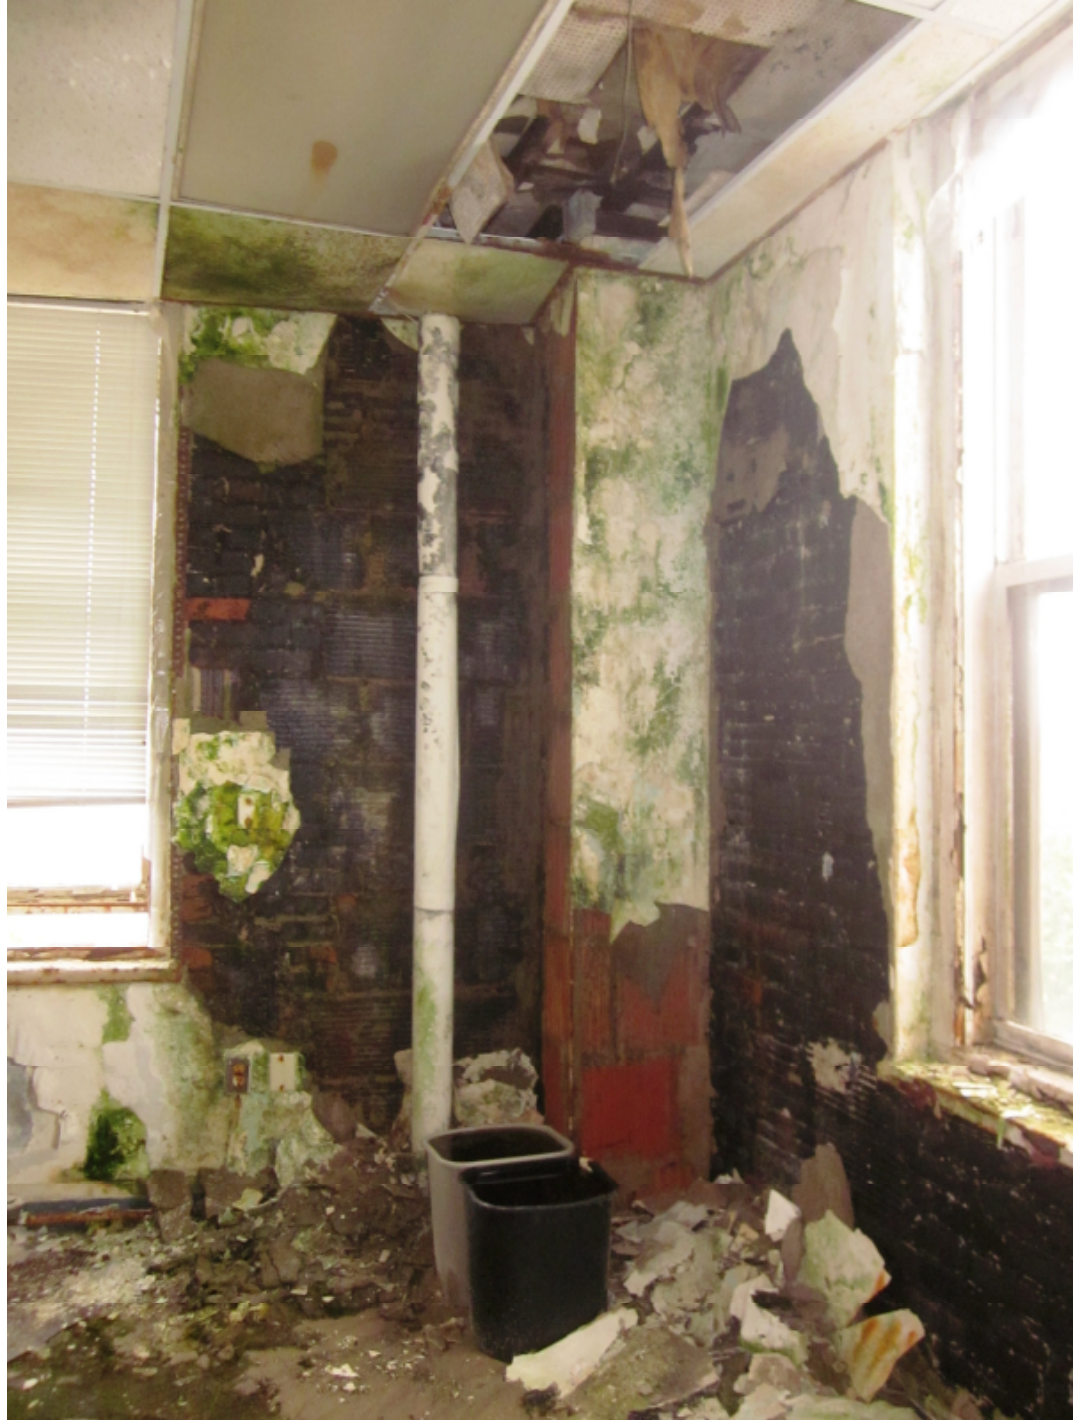
Photo #28

- At several locations there has been long-term infiltration of water into the building envelope. The effects of long-term water infiltration were particularly evident along the east side of the southern end of the six-story tower; at the southwest corner of the southern end of the six-story tower; at the northeast corners of both the six-story tower and the two-story portion of the building; and at isolated locations through the roofs of the building. **(Please refer to Photos #28 through #33).**

- **Comment:** Long-term water infiltration will not only damage the interior architectural finishes, but can cause deterioration of the structural steel framing members and the exterior wall components. Although there was no visible evidence of deterioration of the structural steel framing members caused by the water infiltration, Odeh Engineers would recommend that a careful examination of the steel framing members be conducted at all locations where long-term water infiltration occurred in order to be certain that the steel framing members have not been structurally compromised.

*This photo shows the visible effects of long-term moisture infiltration at the southeast corner at the southeast end of the six-story tower.*

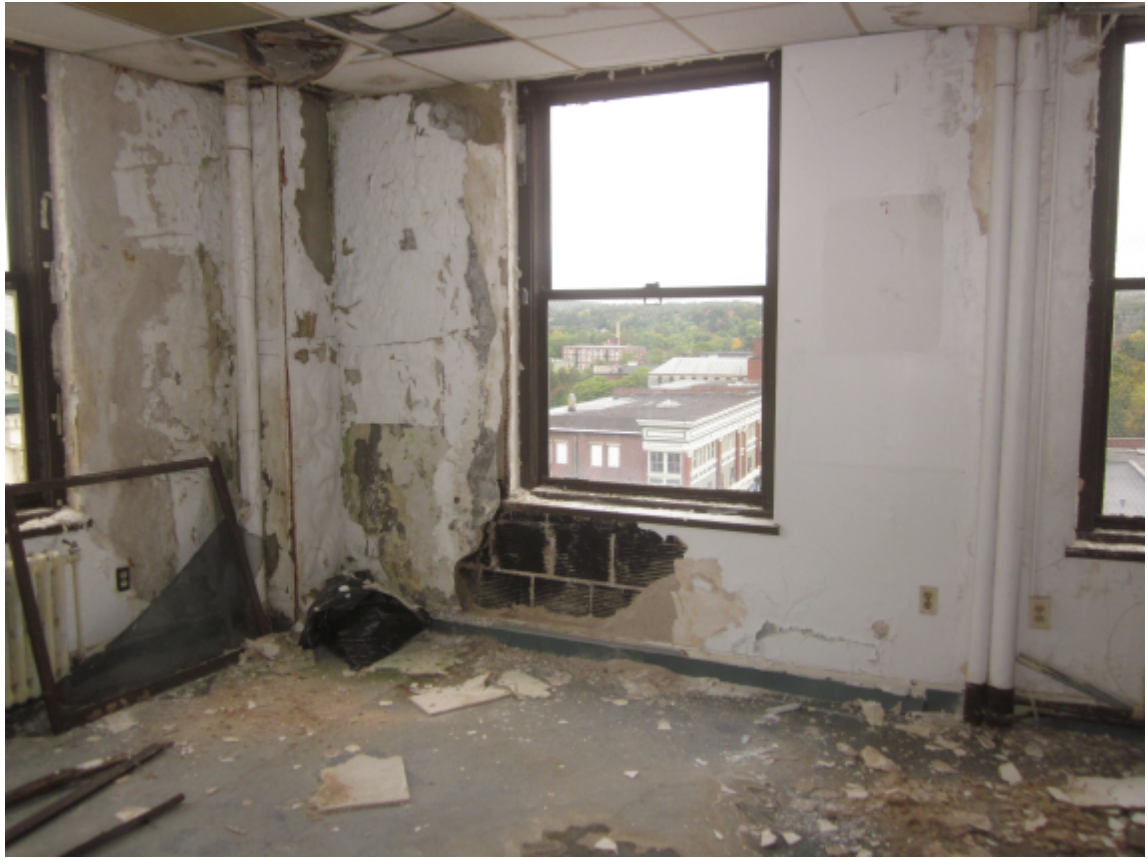
**Photo #29**

*This photo shows the visible effects of long-term water infiltration at the southwest corner at the southeast end of the six-story tower.*

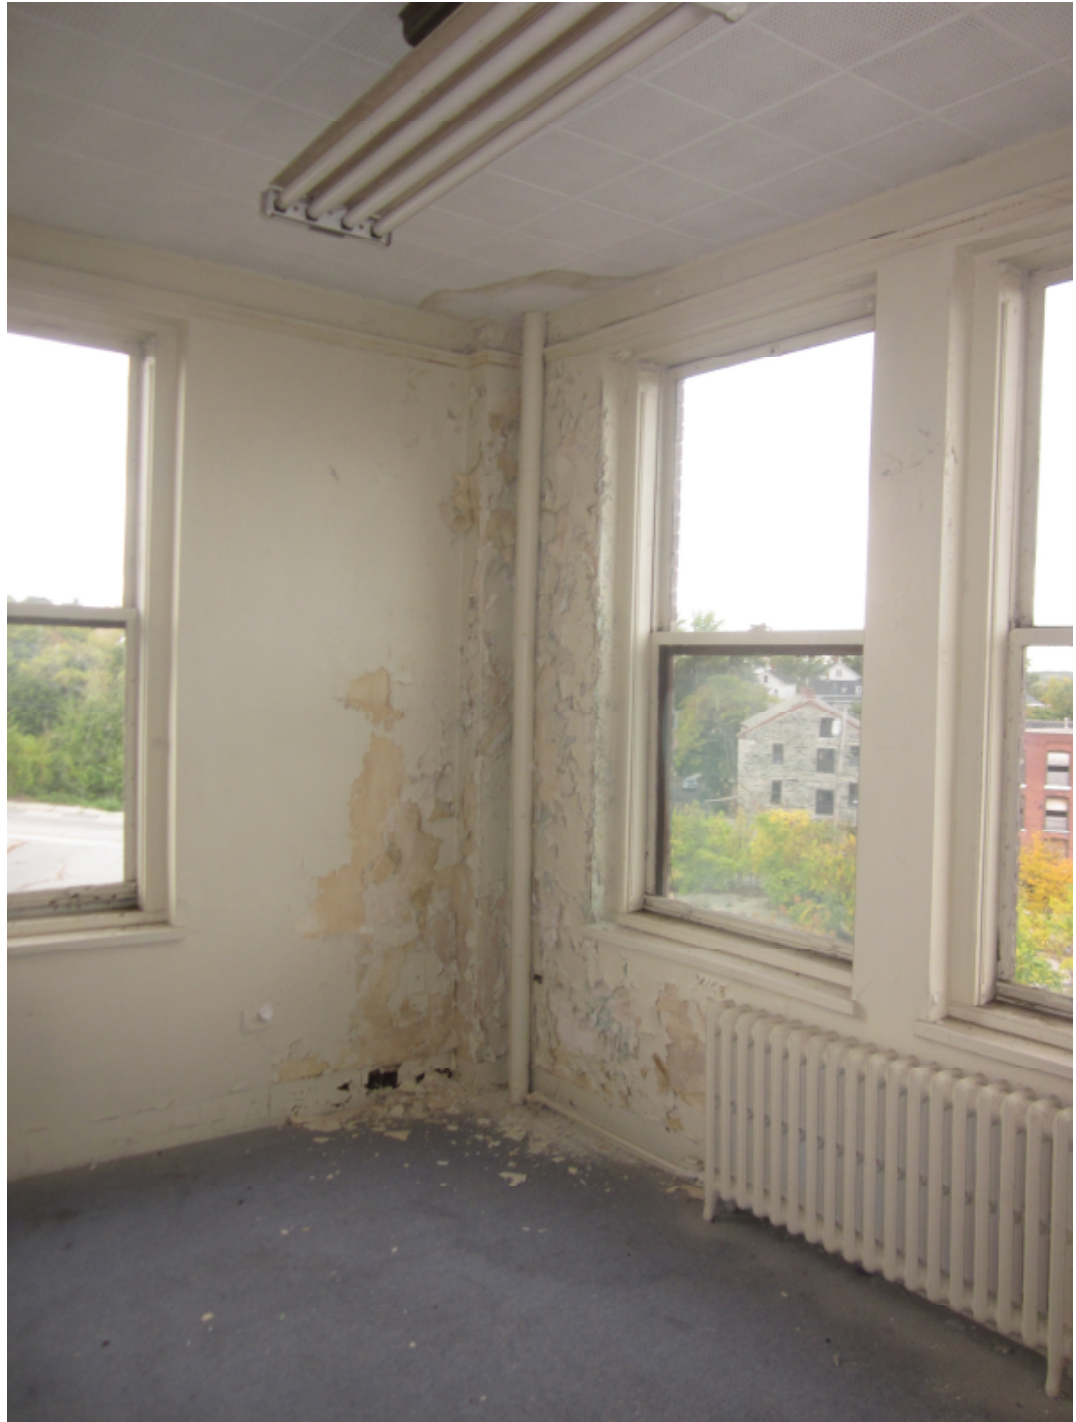
**Photo #30**

*This photo shows the visible effect of water infiltration into the building envelope at the northeast corner of the six-story tower.*

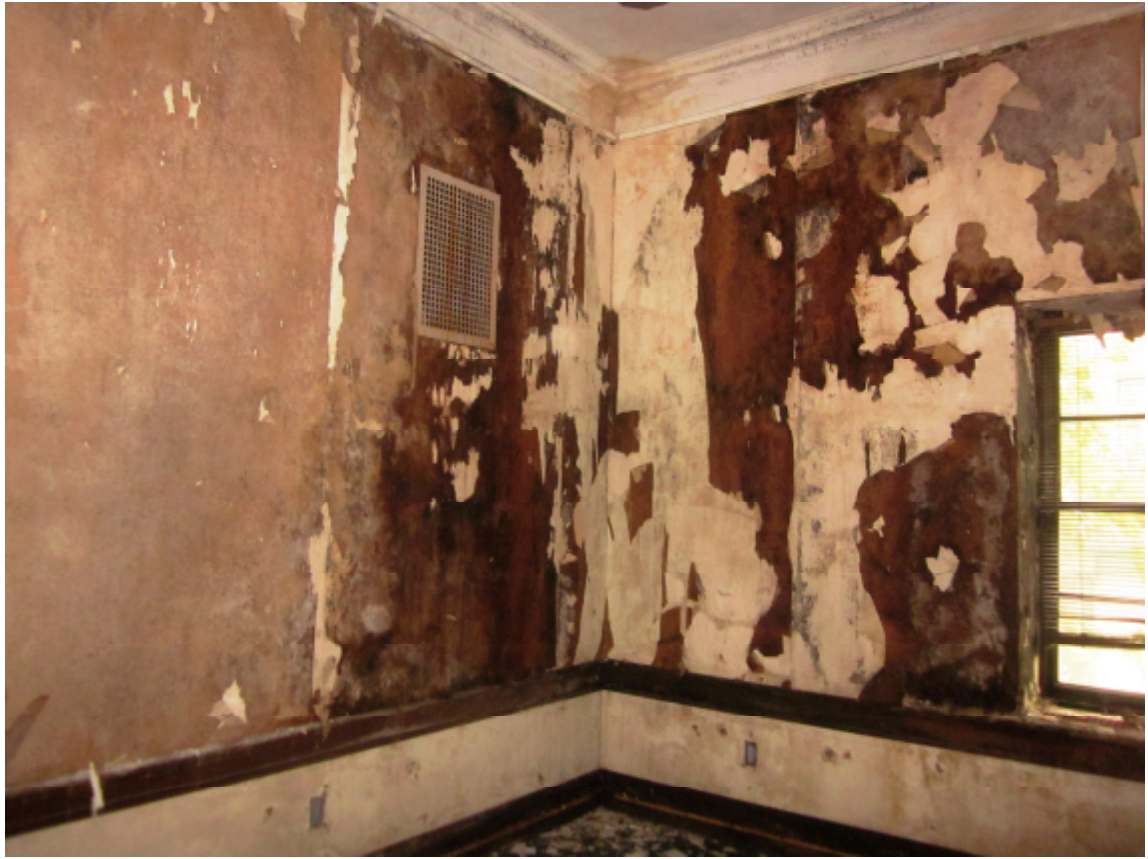
Photo #31

*This photo shows the visible effects of long-term moisture infiltration at the northwest corner of the two-story portion of the building.*

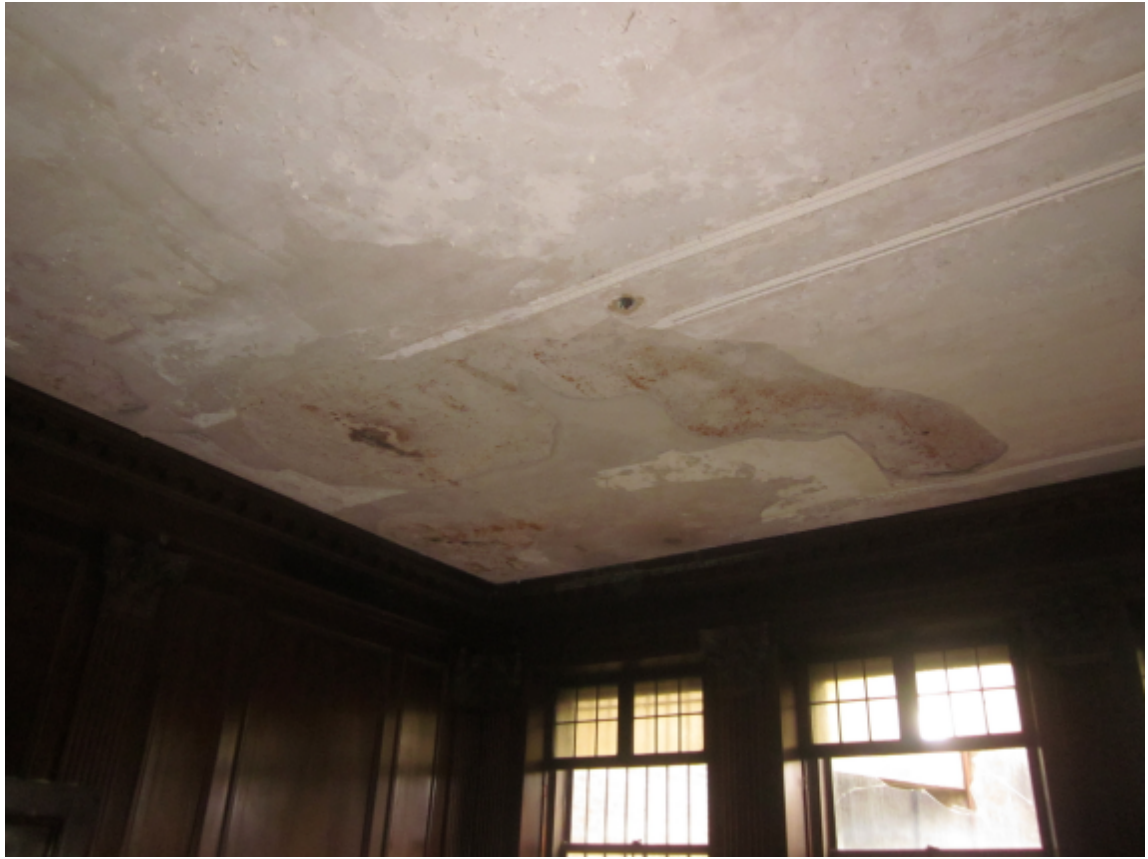
**Photo #32**

*This photo shows the visible effects of moisture infiltration through the roof at the northern end of the two-story portion of the building.*

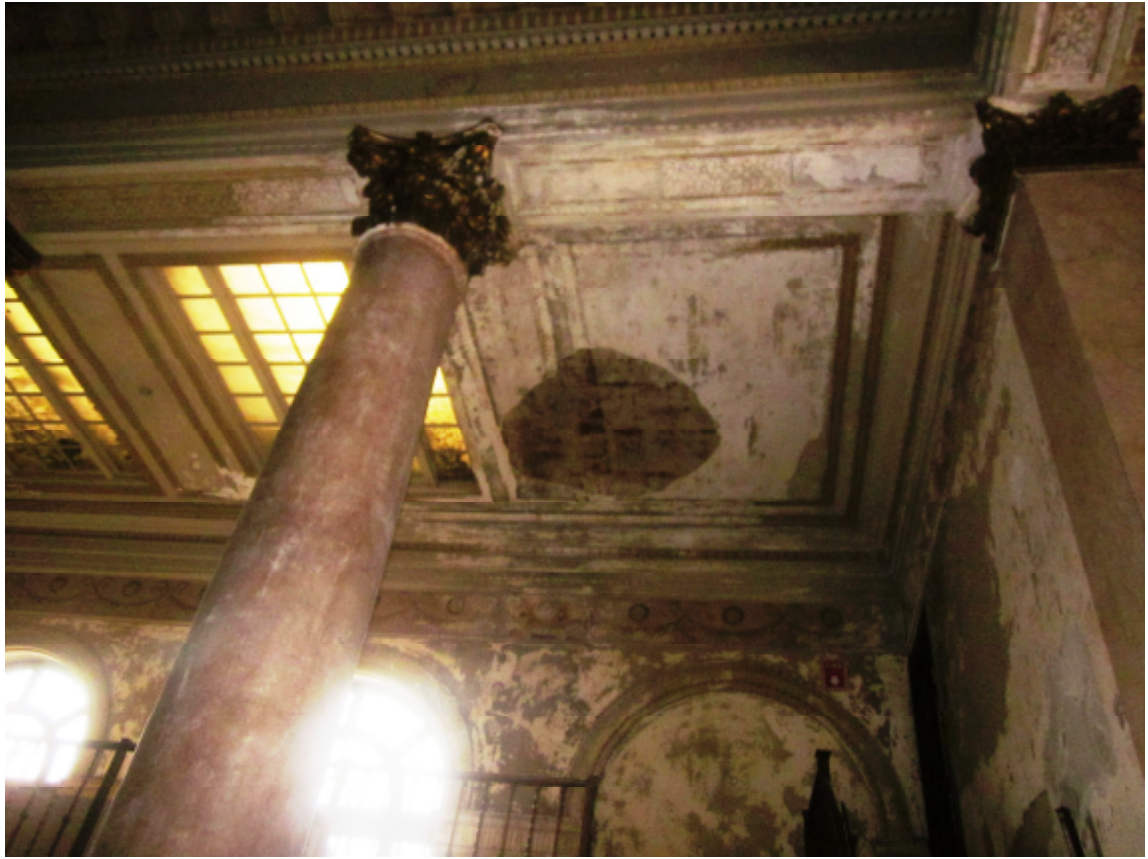
Photo #33

*This photo shows the visible water infiltration through the roof at the southern end of the two-story portion of the building.*
