FUSS & O'NEILL

February 11, 2021

RE: Structural Condition Assessment
162 Main Street, Woonsocket, RI
Fuss & O'Neill Reference No. 20181545.B10

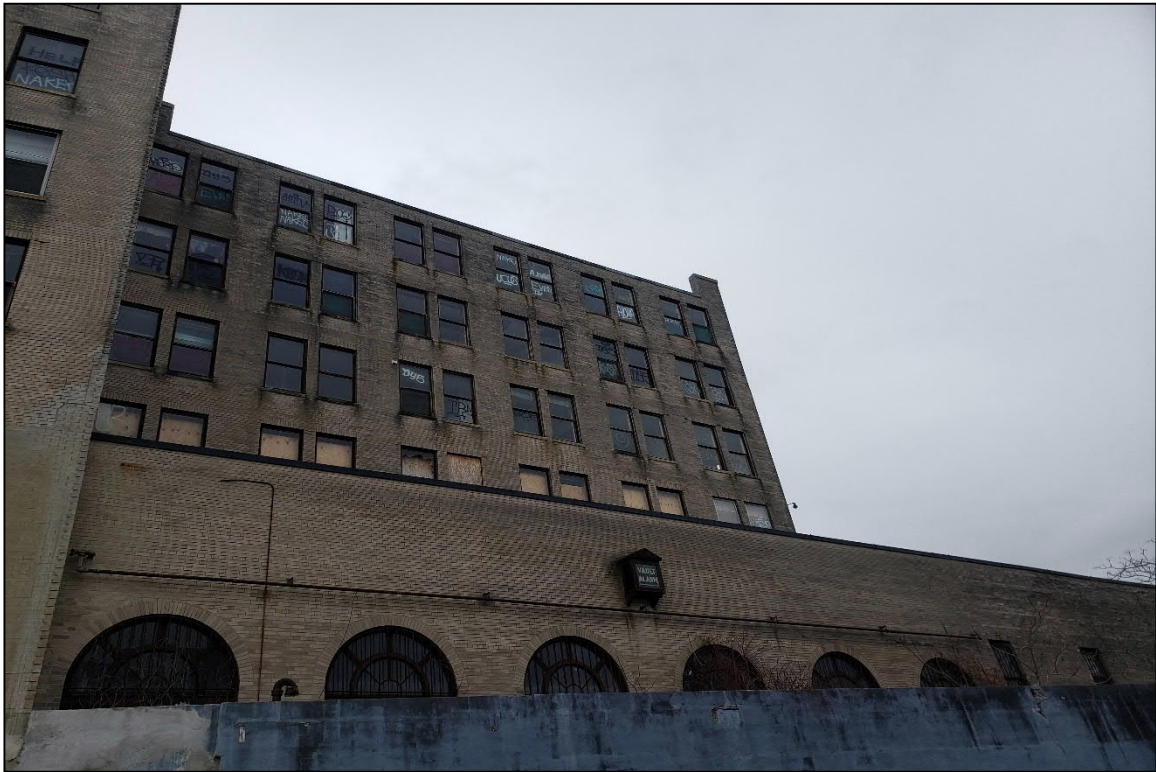
Photo 1: Overview of 162 Main Street

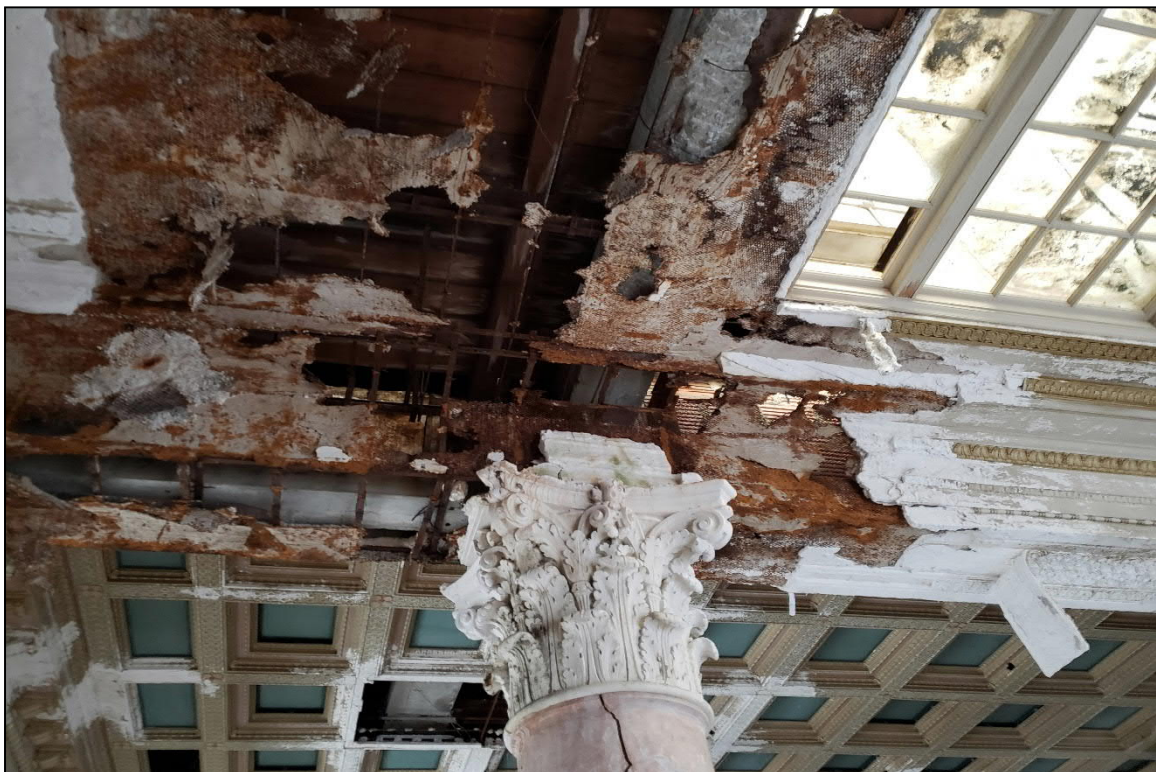
- Much of the framing at the southeastern end of the main level of the building (where there is a low roof) has been severely impacted by continued infiltration of water. This was evident by heavily damaged and missing portions of the ceiling, corroded steel, and significant cracks in the ornamental concrete columns. There appears to be a skylight in this location that has failed and permits water to freely enter the space.

Photo 2: Typical Deterioration to Low Roof Framing Members

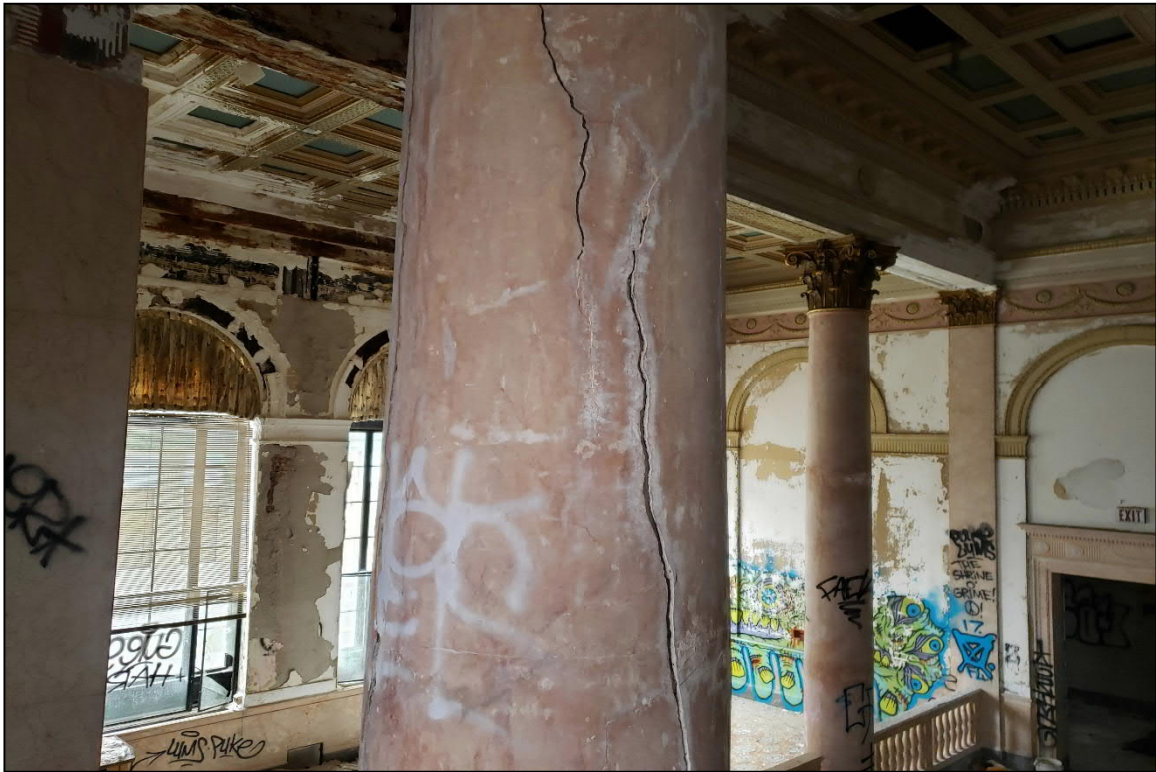
Photo 3: Cracked Column

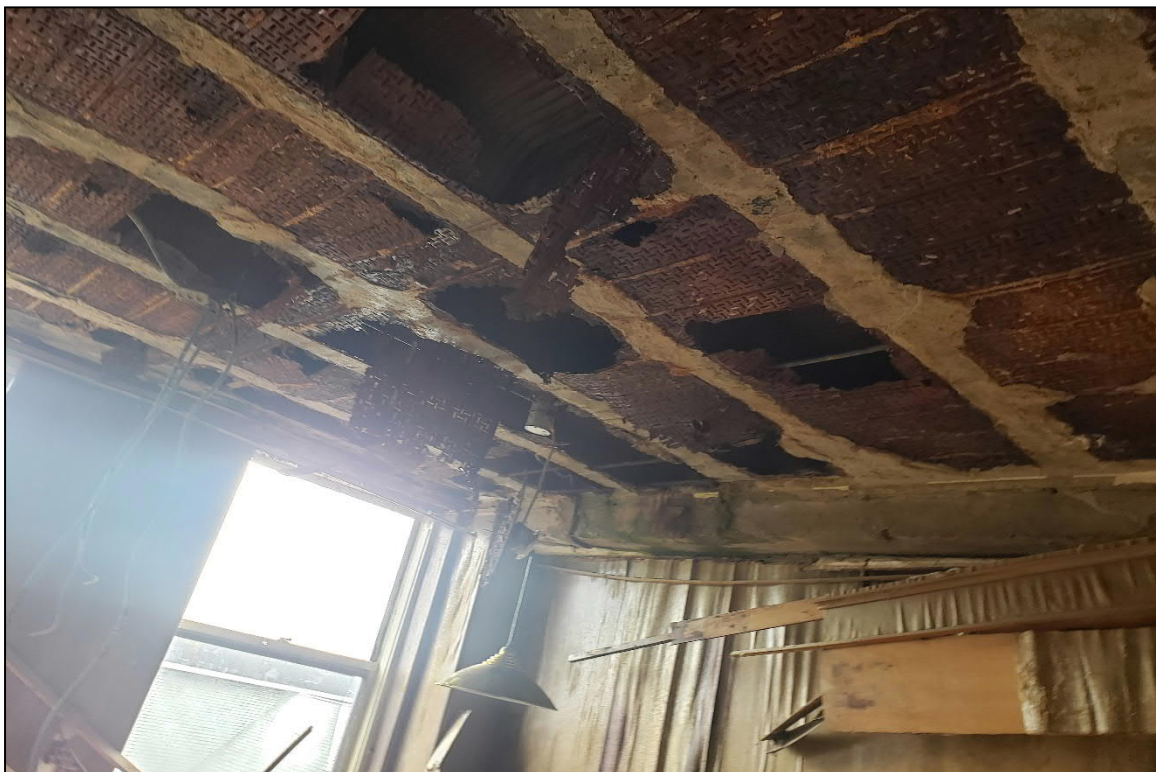
- Much of the steel stay-in-place formwork for the arched floor slabs is corroded and deteriorated due to exposure to water infiltration.
- Many acoustical tile ceilings have failed and partially collapsed in the various office spaces throughout the 4 upper levels of the structure. Specifically, the corner offices, adjacent the exterior portions of the building have been compromised due to continued water infiltration. These corner offices also appear to contain the piping for the roof drains for the structure. Since the building is no longer heated, many of these PVC drain pipes are cracked and no longer functioning as originally designed. Water has compromised the wall construction in these locations and likely provides a path for water to enter other areas of the building.

Photo 4: Typical Deterioration to Office Waffle Slab Floors

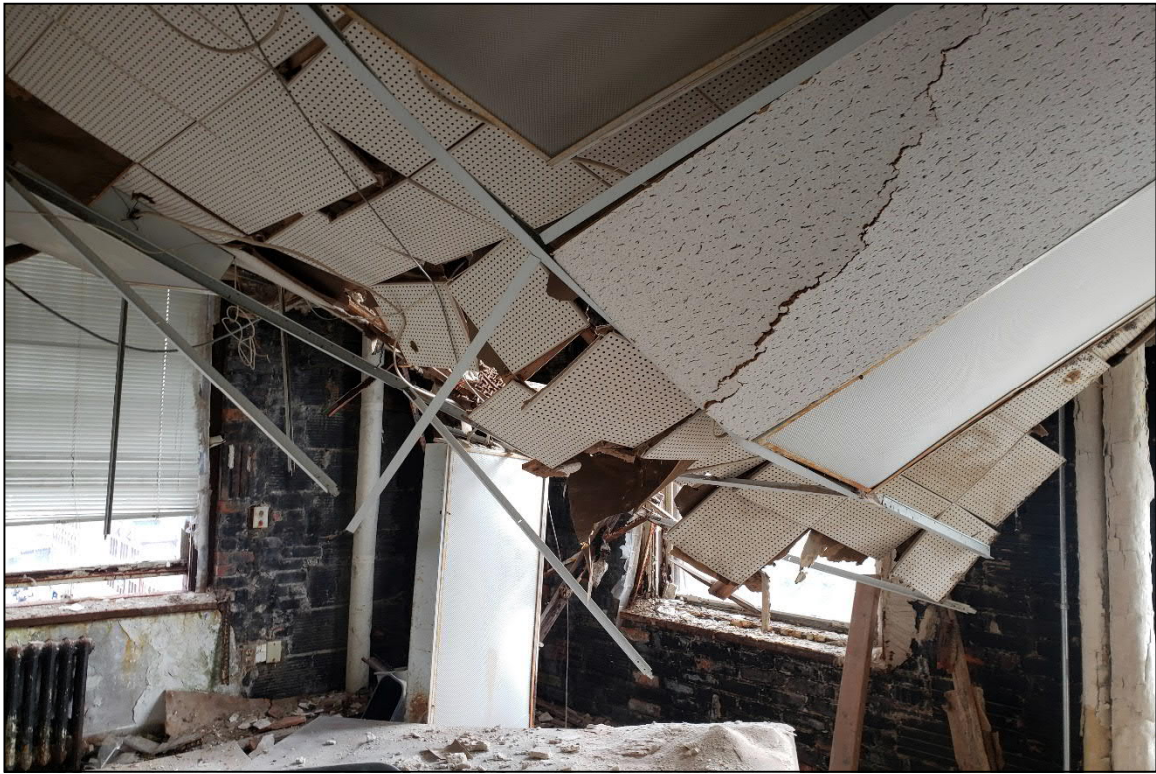
Photo 5: Typical Condition of Corner Office

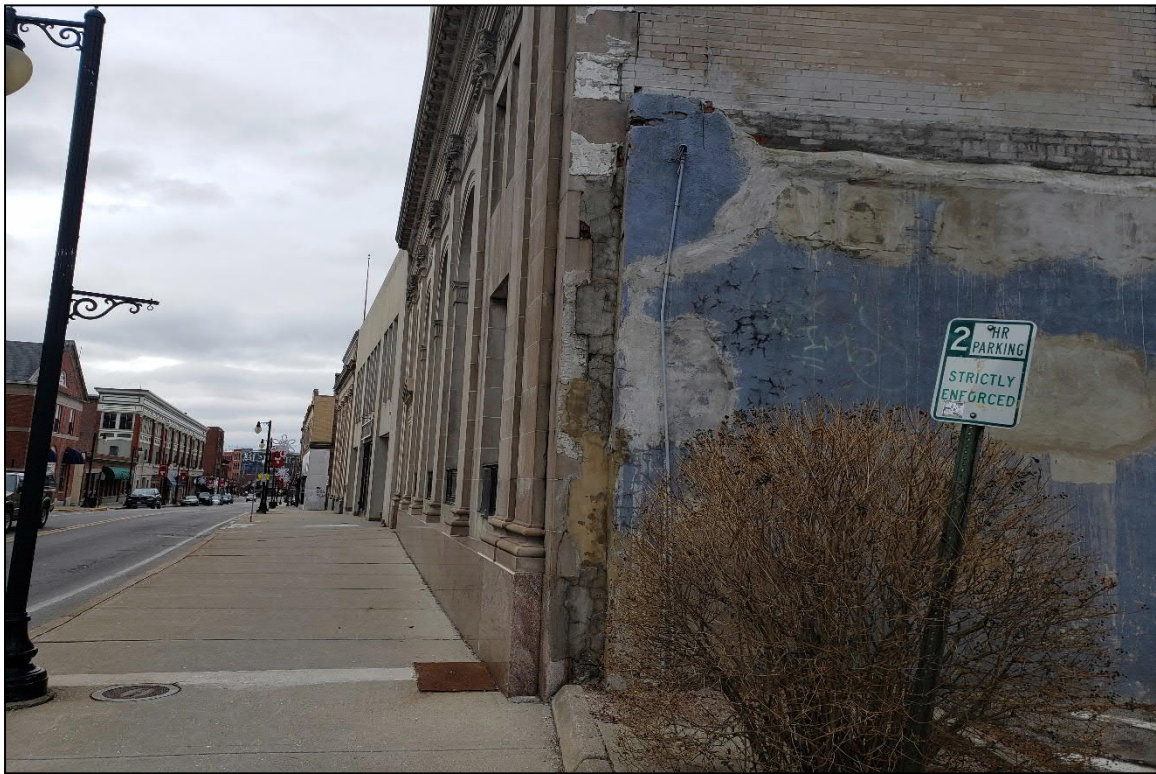
- The southeastern corner of the exterior masonry building walls appears to be moderately cracked and deteriorated on the lower 10 to 12 feet. This area is adjacent to an existing retaining wall that runs almost parallel to the eastern side of the building.

Photo 6: Moderately Deteriorated Masonry Wall at Intersection with Retaining Wall
