WOONSOCKET REGIONAL WASTEWATER COMMISSION
11 Cumberland Hill Road (Rear)
Woonsocket, Rhode Island 02895-4819

**City of Woonsocket
Sewer Collection System**

Annual Report

2012

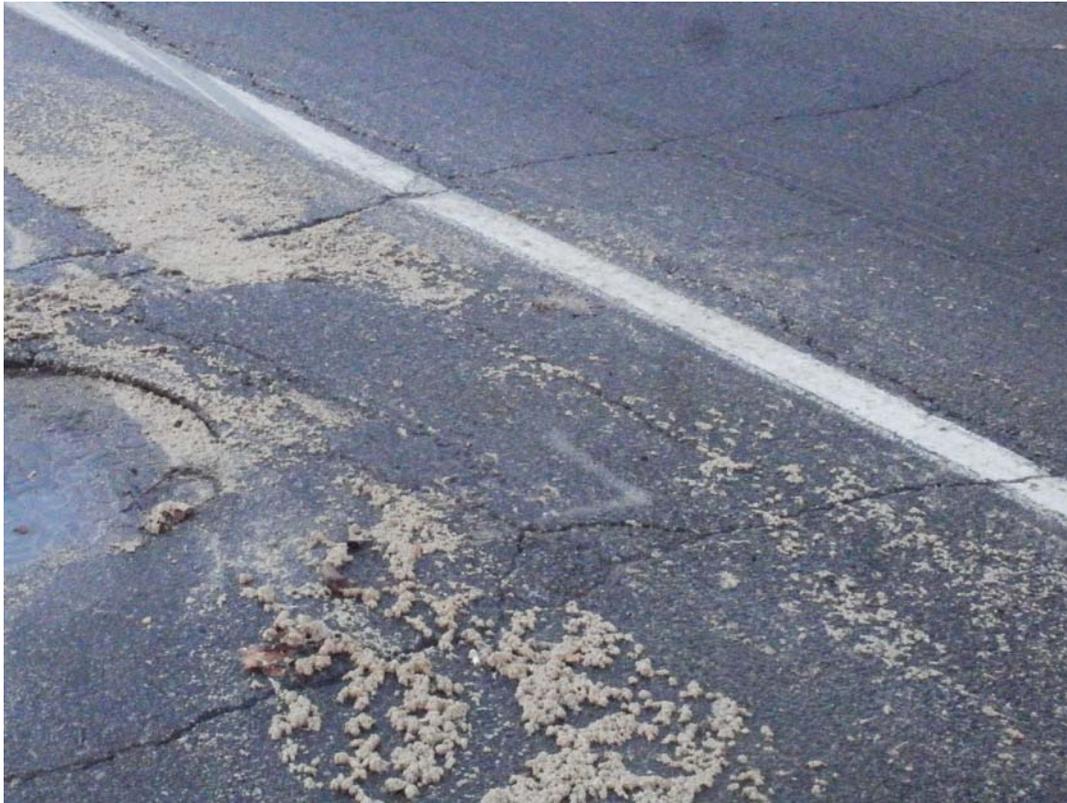
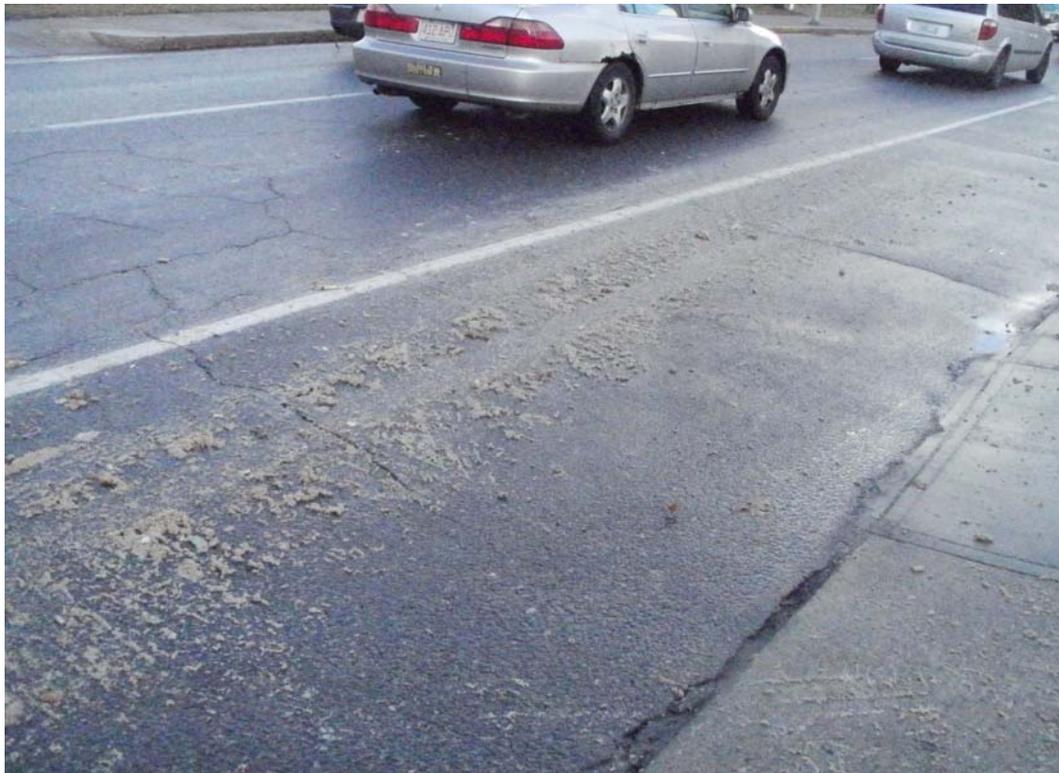
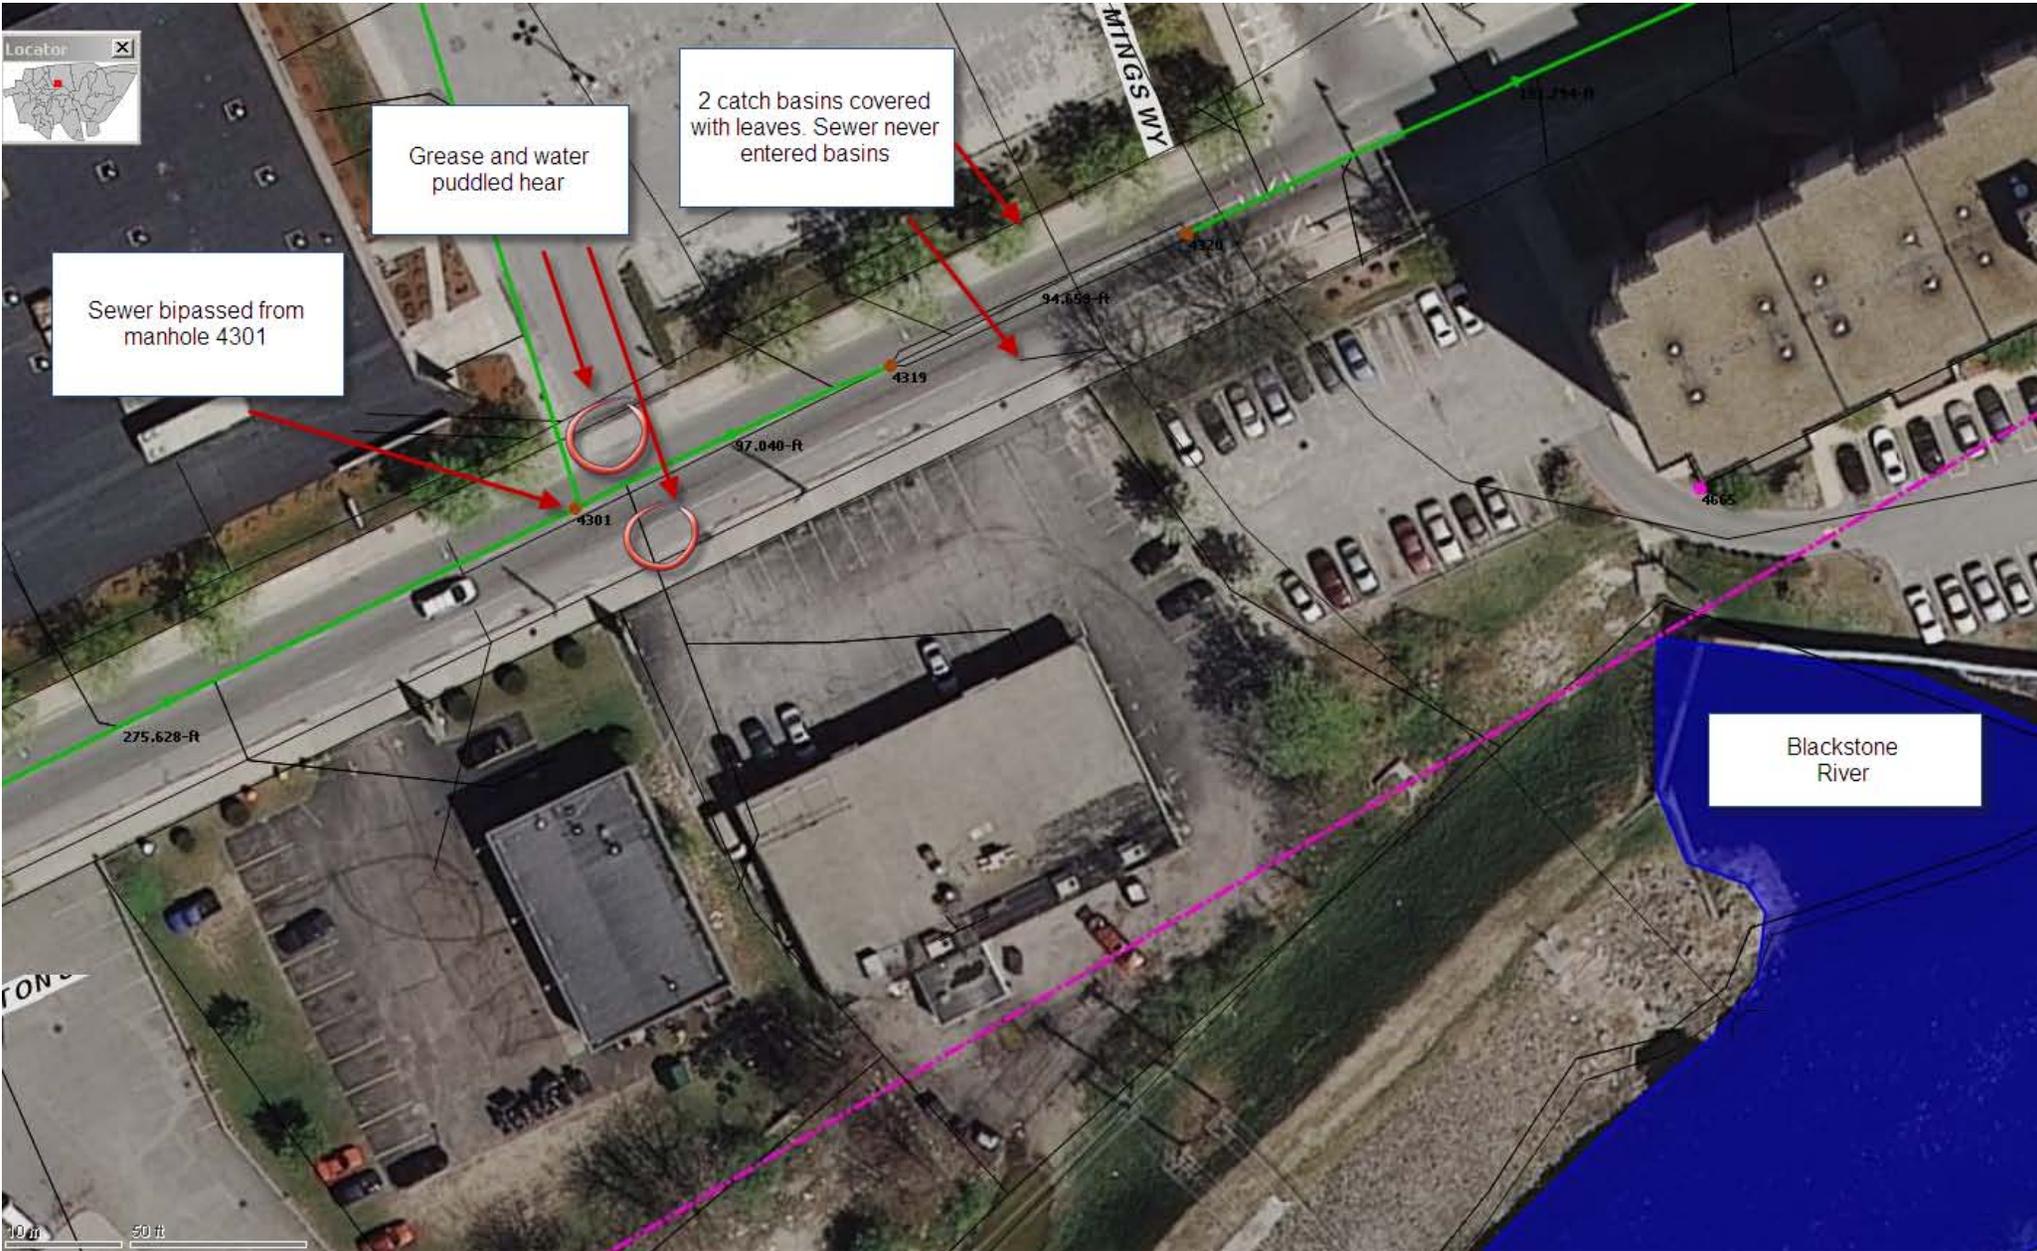
What Occurred: At 1:45 p.m. the City Pre-Treatment Department called the Woonsocket Collections Department to report a sanitary sewer overflow on Clinton Street. Upon arrival at 2:00 p.m. the street had a layer of grease coming from the sewer manhole extending to both sides of the street where it had formed puddles. At 2:20 p.m. Jim Galipeau was notified of the incident. The sewer was not overflowing at the time of arrival, but the sewer was surcharged. As the crew worked their way downstream opening manholes to find one that was not surcharged they noticed the flow was going down. The crew opened the last manhole before the siphon and saw the flow return to normal below the bench. With the flows back to normal the crew returned to the vacator truck and began cleaning the grease and standing water from the street. There was a half gallon of hypo used with water to clean the street and then sucked up by the vacator truck. The clean up was completed at 5:30 p.m. Upstream pipe cleaning is being completed to make sure any remaining debris in the main is removed to prevent further backups.

2 catch basins covered with leaves. Sewer never entered basins

Grease and water puddled hear

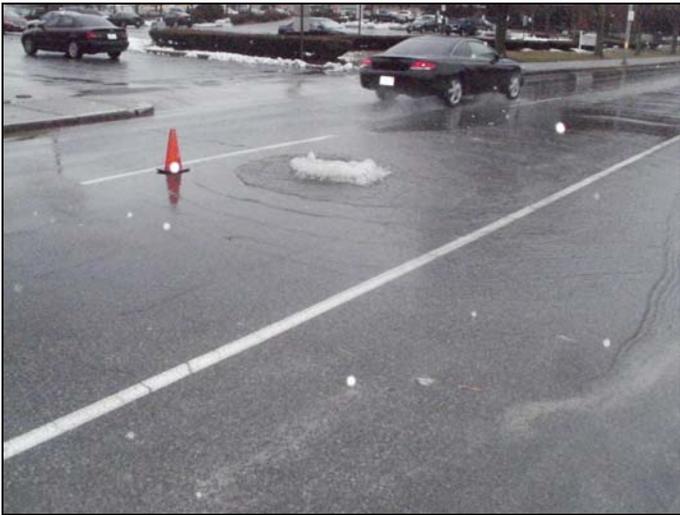
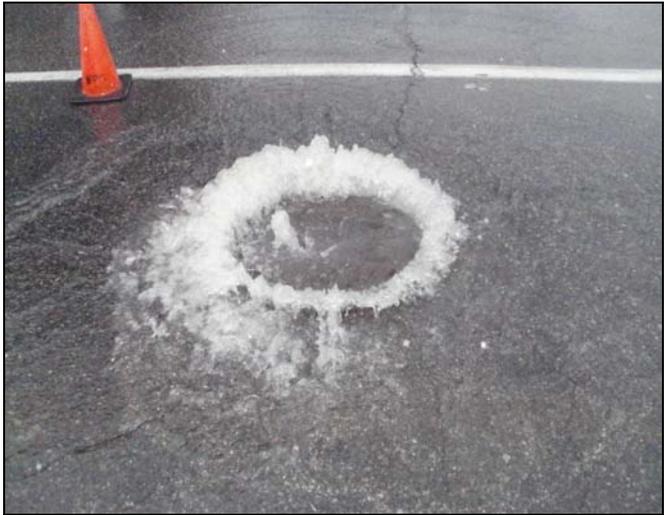
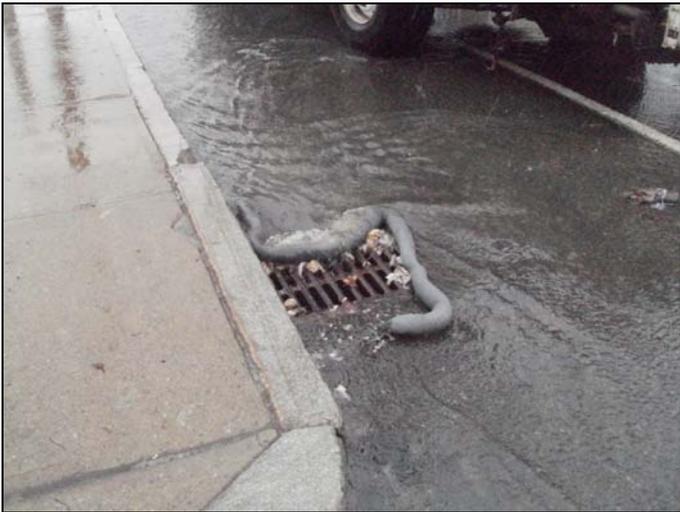
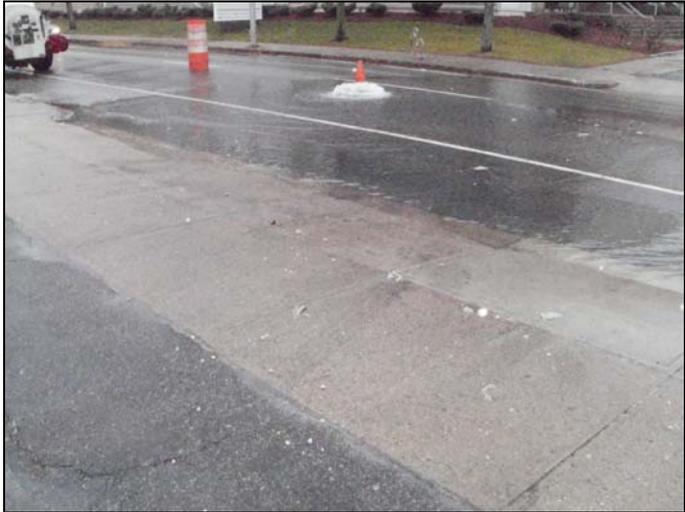
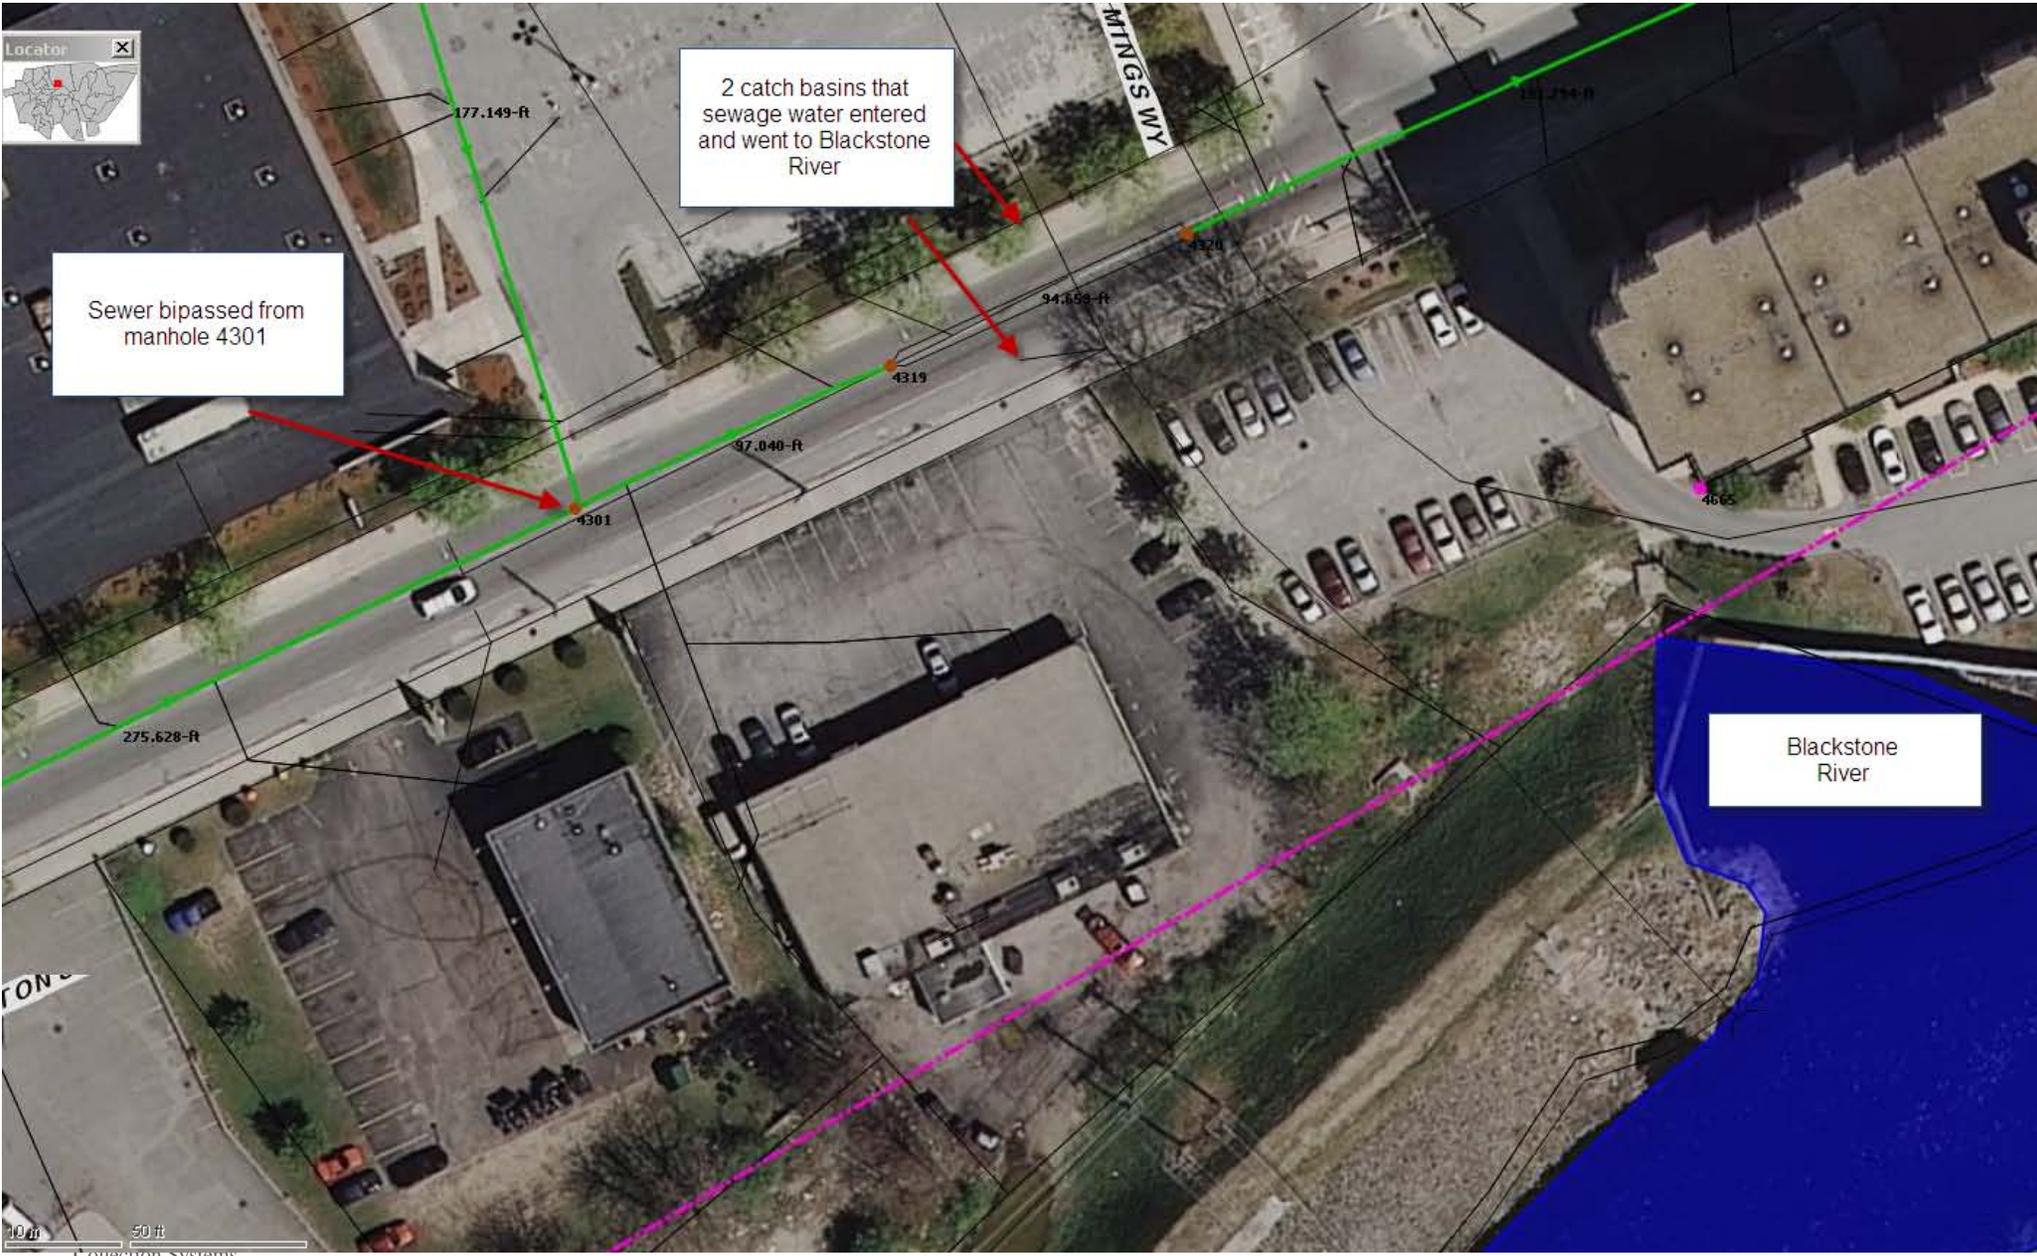
What Occurred: At 8:00 a.m. the collections staff was driving down Clinton Street to begin cleaning the sewer main when they noticed a sewer manhole overflowing in the street. The crew set up the vactor truck and began sucking the water coming out of the manhole. At 8:07 a.m. Jonathan Mongie was notified of the current SSO. There were two catch basins observed that the sewage was flowing into. The crew used the spill containment kit from the truck to dam the catch basins and have the sewage pool around the basins. Sewage was stopped from flowing into the catch basin at 8:30 a.m., at which time the second vactor arrived on site and began sucking the pooled water from the break down lanes. The two vactors cycled bypass pumping while other staff members looked for manholes up to the siphon that were not surcharged. Upon investigating the siphon tower it was observed that the tower was surcharged and there was a large amount of grease built up. The crew found that the siphon outlet manhole was flowing but slowly. One of the vactors was brought through the easement and began jet rodding the siphon piping. After two water tank cycles the crew broke through the grease blockage in the siphon tower. At 2:00 p.m. the sewage stopped overflowing and cleanup of the street began. Two staff members used a half gallon of hypo to clean the area that the sewage pooled on the street and washed the area with water then sucked it up with the vactor. While the street cleaning was happening two other staff members continued jet rodding the siphon as more grease would come out each time the jet rod would go through. At roughly 3:00 p.m. the siphon tower was entered and it was observed that flows had returned to normal, but there was still a large amount of grease on the walls. The crew utilized the vactors hydro excavation gun to power wash majority of the grease off of the walls while the second vactor continued to jet rod the siphon. At 4:30 p.m. the crew finished jet rodding and power washing the siphon and siphon tower. Two crew members cleaned downstream pipe segments to make sure there was no debris left in the 60" interceptor that could cause a backup while the other staff members checked the main siphon that goes to the wastewater treatment plant for debris buildup. The siphon appeared clear. At roughly 5:00 p.m. the crew finished and returned to the garage.

2 catch basins that sewage water entered and went to Blackstone River

Sewer bypassed from manhole 4301

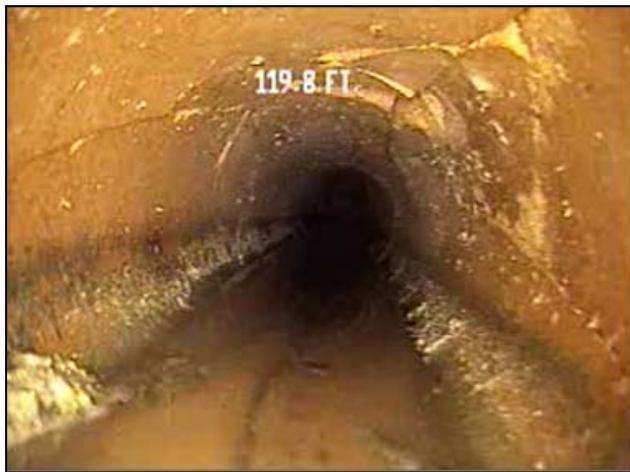
Pre Repair

Repair ID: 1333536464_rodman		Job Number: 2020900.3501	
Status: COMP (Completed)	Defect Type: MAIN (Break In Main)	Repair Type: CIP_LINER (Cured In-Place Liner)	Cause of Failure: GROUND (Ground Movement)
Start Length (ft): 119.000	Repair Length (ft): 4.000	CCTV Required: Y	Shape: CIRC (Circular)
Material: VCP (Vitrified Clay Pipe)	Lining Material: EP (Epoxy)	Lining Type: CIP (Cured in Place)	I/I Removed: 0 GPD
Width (in): -	Height (in): 8.0	Location: Rustic Dr. 4475-4476 (119')

Pipe ID:		Pipe Type: Gravity
Location: Rustic Drive		Site Condition:
US Material: VCP	US Lining Type: N/A	
US Shape: CIR	US Height (in): 8"	
DS Material: VCP	DS Lining Type: N/A	
DS Shape: CIR	DS Height (in): 8"

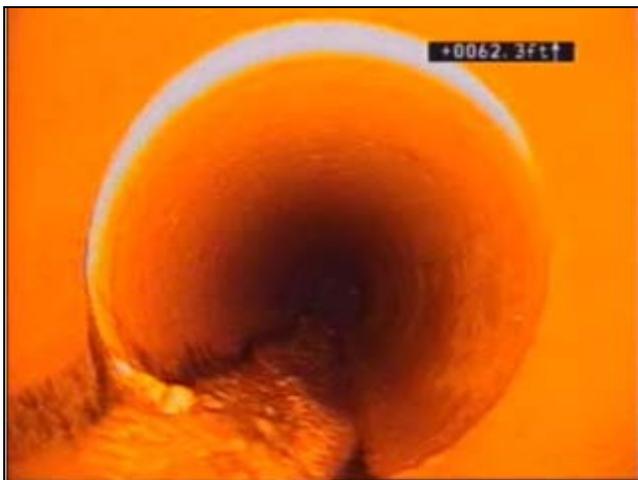
Pre Repair

Repair ID: 1333536235_rodman		Job Number: 2020900.3501	
Status: COMP (Completed)	Defect Type: INFILT (Infiltration)	Repair Type: CIP_LINER (Cured In-Place Liner)	Cause of Failure: GROUND (Ground Movement)
Start Length (ft): 62.000	Repair Length (ft): 2.000	CCTV Required: Y	Shape: CIRC (Circular)
Material: VCP (Vitrified Clay Pipe)	Lining Material: EP (Epoxy)	Lining Type: CIP (Cured in Place)	I/I Removed: 5760 GPD
Width (in): -	Height (in): 8.0	Location: Langevin St. 3297-3296 (62')

Pipe ID:		Pipe Type: Gravity
Location: Langevin Street		Site Condition:
US Material: VCP	US Lining Type: N/A	
US Shape: CIR	US Height (in): 8"	
DS Material: VCP	DS Lining Type: N/A	
DS Shape: CIR	DS Height (in): 8"

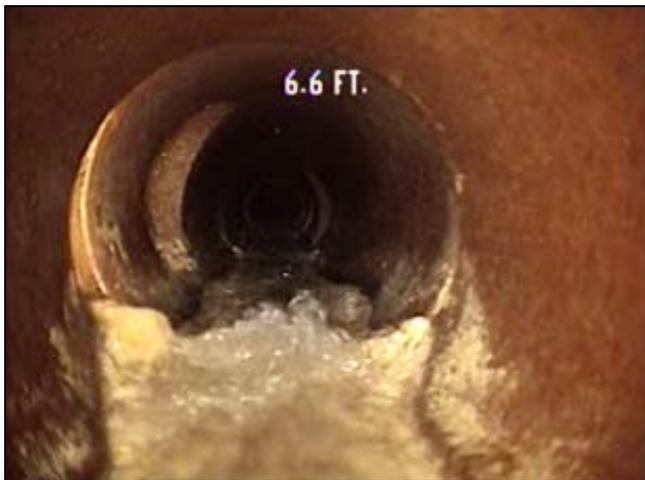
Pre Repair

Repair ID: 1333970937_rodman		Job Number: 2020900.3501	
Status: COMP (Completed)	Defect Type: INFILT (Infiltration)	Repair Type: CIP_LINER (Cured In-Place Liner)	Cause of Failure: GROUND (Ground Movement)
Start Length (ft): 6.000	Repair Length (ft): 4.000	CCTV Required: Y	Shape: CIRC (Circular)
Material: VCP (Vitrified Clay Pipe)	Lining Material: EP (Epoxy)	Lining Type: CIP (Cured in Place)	I/I Removed: 7200 GPD
Width (in): -	Height (in): 8.0	Location: Congress St. 3644-3643 (188.5')

Pipe ID:		Pipe Type: Gravity
Location: Congress Street		Site Condition:
US Material: VCP	US Lining Type: N/A	
US Shape: CIR	US Height (in): 8"	
DS Material: VCP	DS Lining Type: N/A	
DS Shape: CIR	DS Height (in): 8"

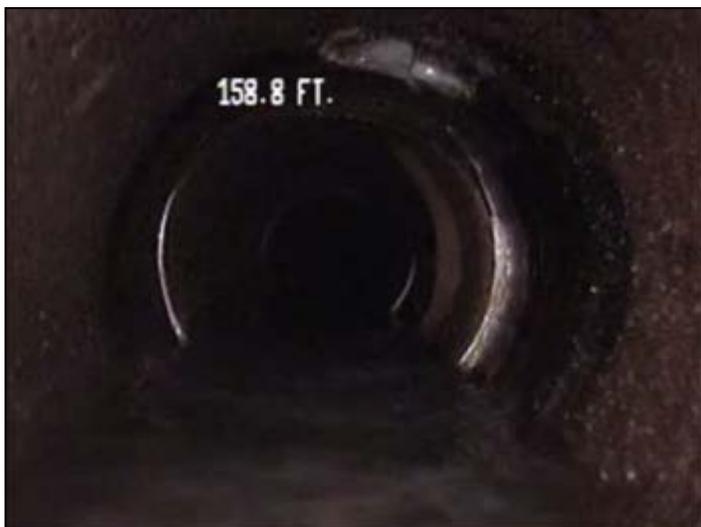
Pre Repair

Repair ID: 1333971117_rodman		Job Number: 2020900.3501	
Status: COMP (Completed)	Defect Type: MAIN (Break In Main)	Repair Type: CIP_LINER (Cured In-Place Liner)	Cause of Failure: IMPACT (Impact Damage)
Start Length (ft): 160.000	Repair Length (ft): 2.000	CCTV Required: Y	Shape: CIRC (Circular)
Material: VCP (Vitrified Clay Pipe)	Lining Material: EP (Epoxy)	Lining Type: CIP (Cured in Place)	I/I Removed: 2880 GPD
Width (in): -	Height (in): 8.0	Location: Prospect St. 3843-3844 (160')

Pipe ID:		Pipe Type: Gravity
Location: Prospect Street		Site Condition:
US Material: VCP	US Lining Type: N/A	
US Shape: CIR	US Height (in): 8"	
DS Material: VCP	DS Lining Type: N/A	
DS Shape: CIR	DS Height (in): 8"

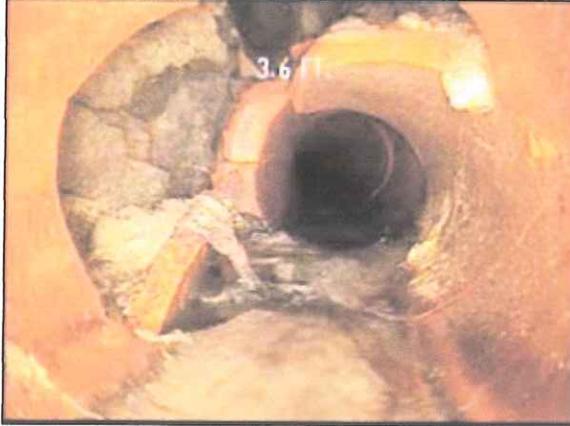
On October 2, 2012 during a routine CCTV assessment it was identified that a fifty (50) foot section of sewer main was near failure due to significant structural damage. Also the downstream manhole on this section of pipe is severely damaged and needs replacement. Attached please find the CCTV pipe section report that identifies each individual defect as well as pictures of the pipe and manhole defects.

Broken Void Visible

Due to the amount of damage throughout the entire section of sewer main and manhole I have classified this as an emergency repair and recommend that the entire fifty (50) section of sewer main and downstream manhole be excavated and replaced. With your authorization I would like to conduct an emergency repair to fix the sewer main on Tuesday, October 16, 2012 and Wednesday, October 17, 2012.

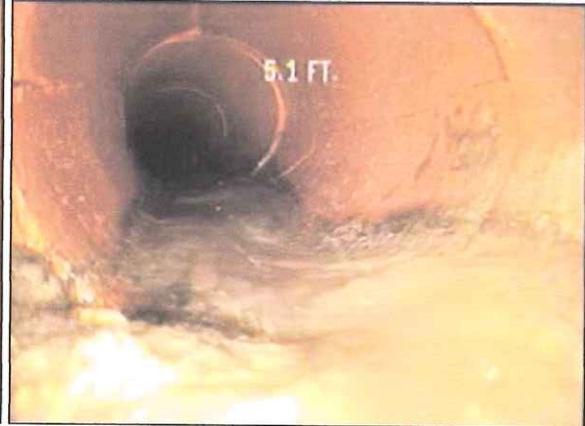
Fractures Hinged (4)

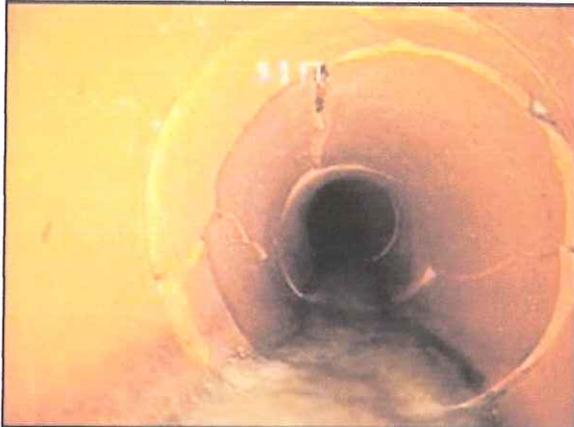
Broken Soil Visible

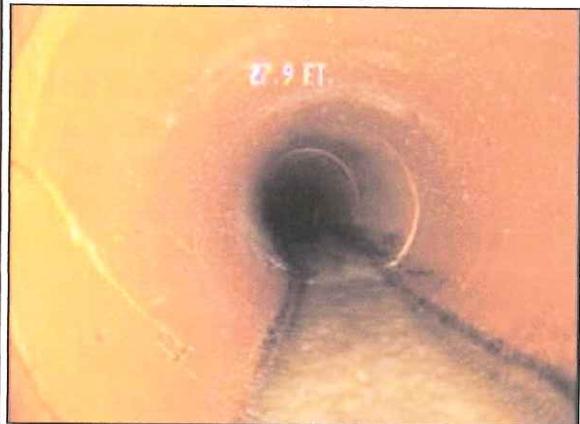
Multiple Fractures

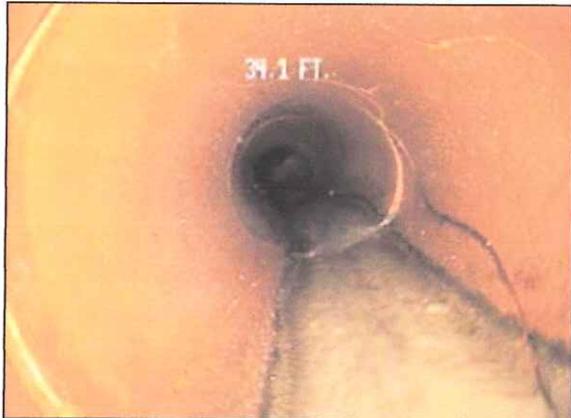
Multiple Fractures

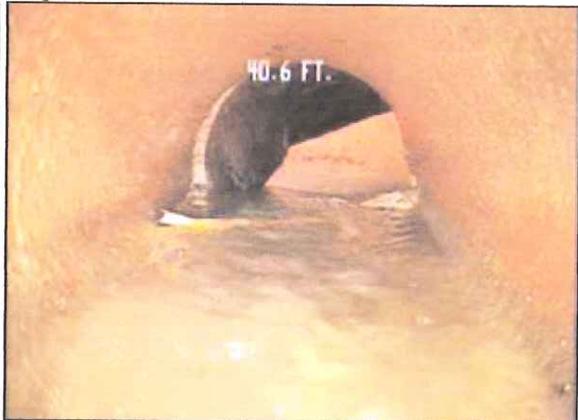
Pipe Broken

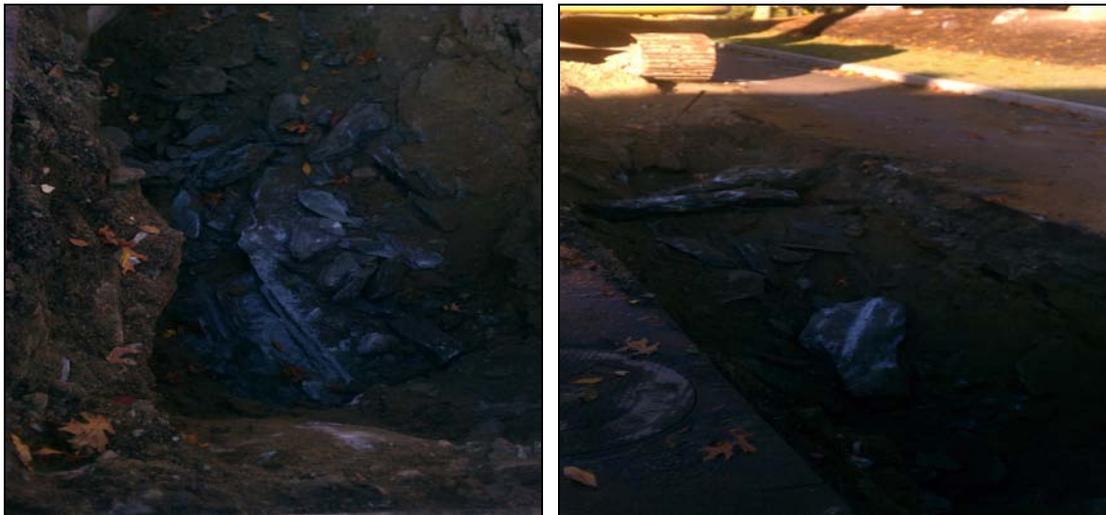
At 7:00 a.m. the police detours where set in place and the road cutting began. By 8:00 a.m. the excavator had begun removing asphalt and digging down to the sewer main. The excavation process was prolonged due to the amount of ledge that the crew encountered. See the photos below.

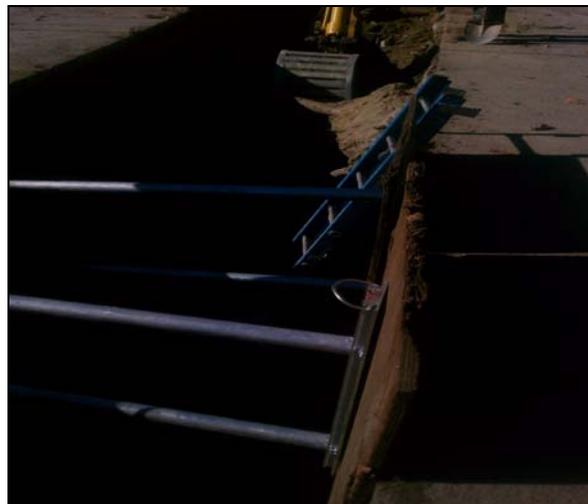
When the sections of the trench were excavated enough to begin pipe installation prep, sections of hydraulic shoring were installed for safety measures. See photos below.

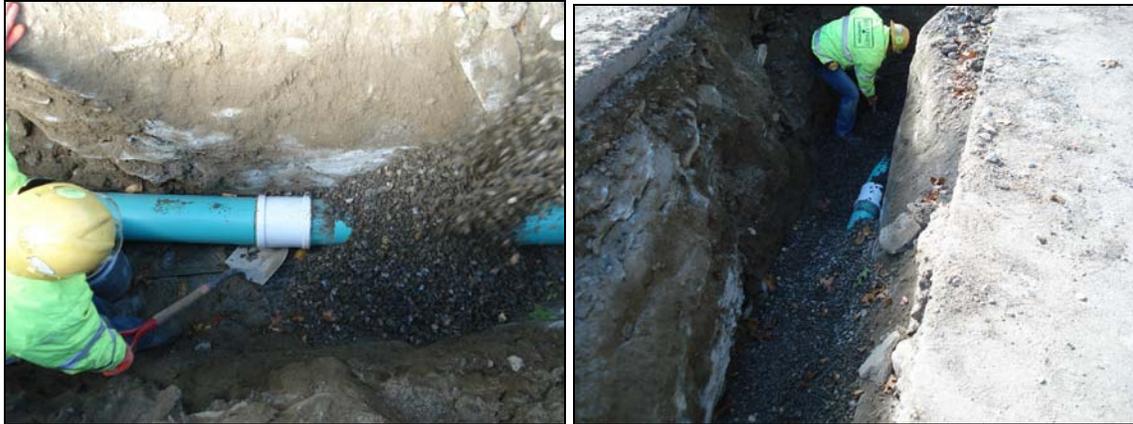
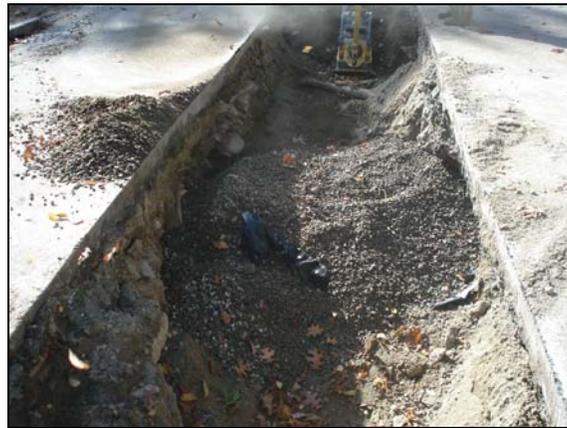
After the new 8 inch sewer main was placed and approved by the City Engineering staff the construction crew began to back fill first using a bed of crushed stone and the then processed gravel. See photos below.

The repair trench was backfilled, compacted, and temporary patch was put on the trench by 4:00 p.m. when the construction crew left the job site and the road was opened again.

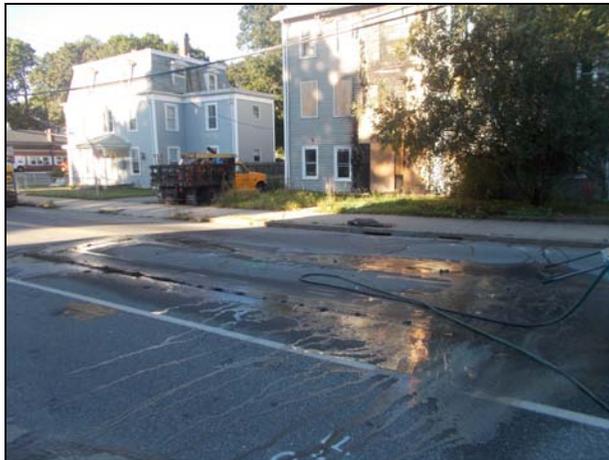
At 7:00 a.m. Boyle and Fogarty Construction arrived on site and began saw cutting the street and setting the detour route.

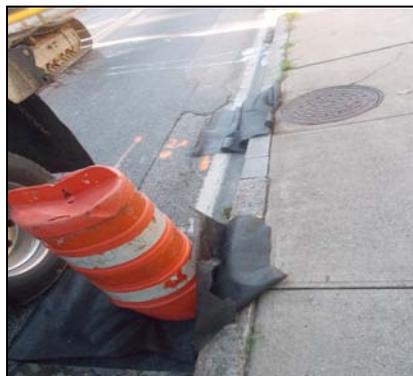
7:30 a.m. the storm drain grates were covered to prevent excavation debris from entering and causing a potential blockage.

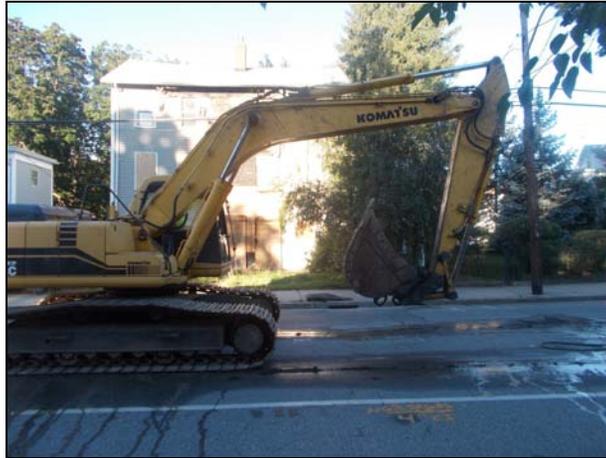
8:00 a.m. excavation begins.

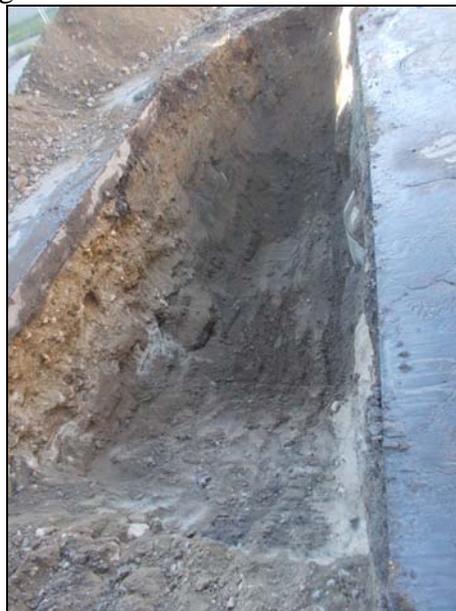
9:00 a.m. Excavation comes to a stop due to uncovering an unmarked 6" cast iron pipe. The Woonsocket Water Department is contacted to remark the area because the unmarked pipe is believed to be a live water main. The Water Department confirmed that the pipe was a live 6" water main.

9:45 a.m. Excavation begins again.

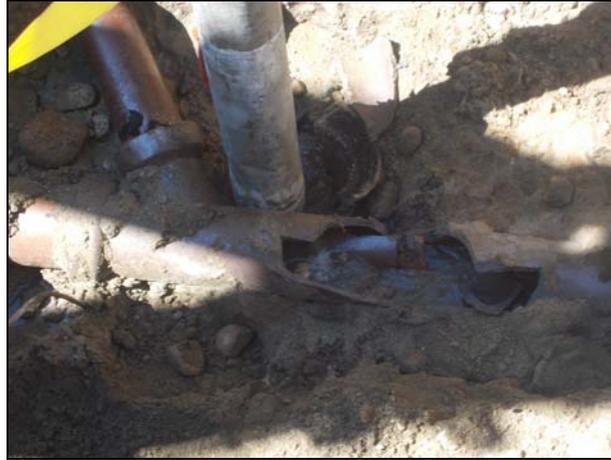
11: 30 a.m. the sewer main and lateral are located. Through hydro excavation all of the piping is uncovered and damage assessed.

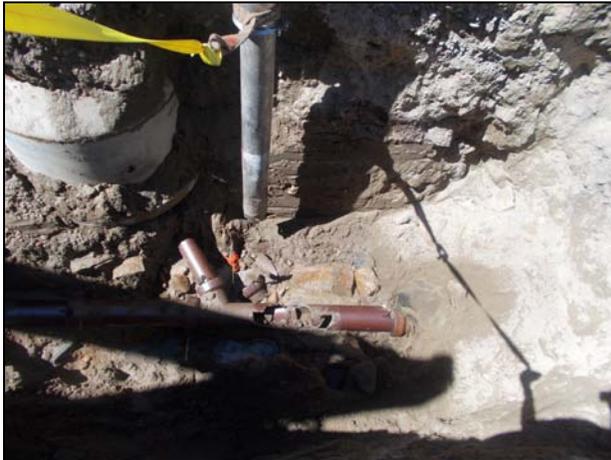
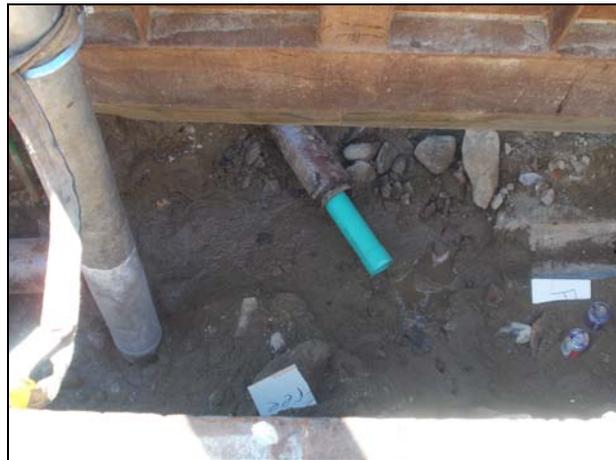
While cleaning around the service lateral it was discovered that the storm drain manhole structure is placed directly on top of the service lateral. The lateral is found to be separated 6 feet up from the connection to the main which places the break in the center of the storm drain structure. At this time the only repair was to sleeve 3 foot sections of 4 inch PVC pipe into the existing lateral and if the house ever gets repaired then connect to the 4 inch.

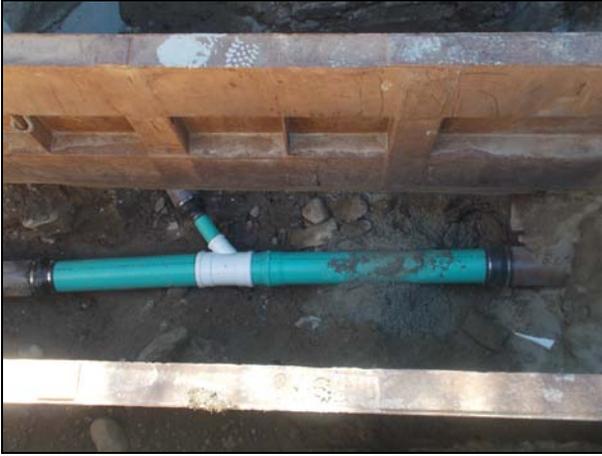
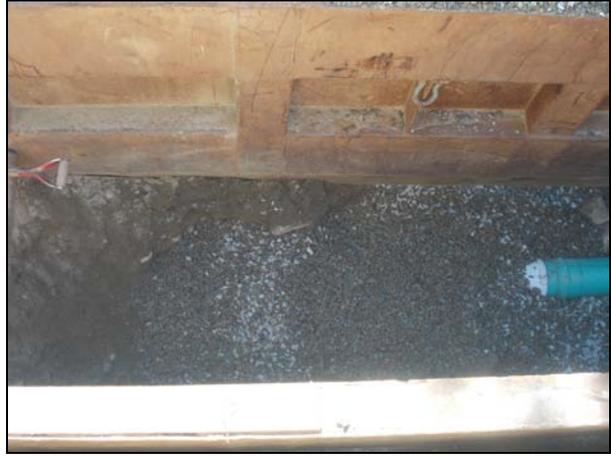
At roughly 4:00 p.m. the repair of the sewer main and lateral are complete and back filling begins.

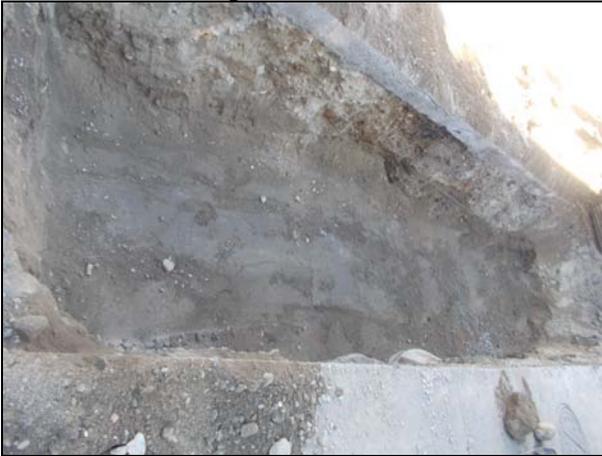
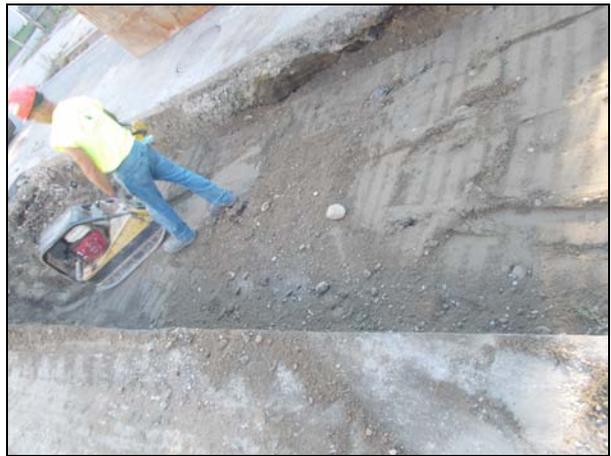
The trench is compacted in 3 foot increments.

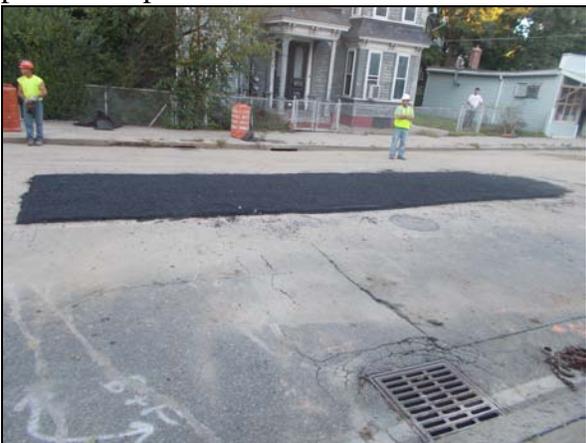
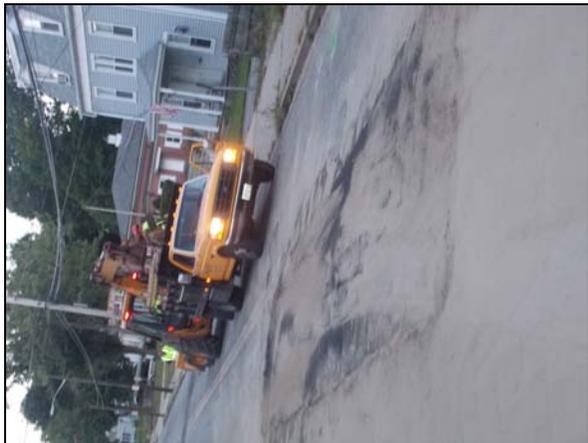
A temporary hot asphalt patch is placed over the trench until Picolli Paving can put down the permanent patch.
