Asbestos Abatement Plan
Demolition – Multi-use Building

Site Address: 40-56 Arnold Street, Woonsocket, RI 02895

RI Analytical Project #2023022

DATE: March 1, 2023

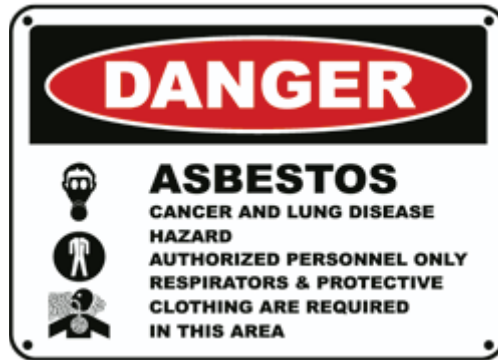
DANGER
ASBESTOS
MAY CAUSE CANCER
CAUSES DAMAGE TO LUNGS
AUTHORIZED PERSONNEL ONLY
WEAR RESPIRATORY PROTECTION AND PROTECTIVE CLOTHING IN THIS AREA

Example below (not necessarily OSHA compliant).

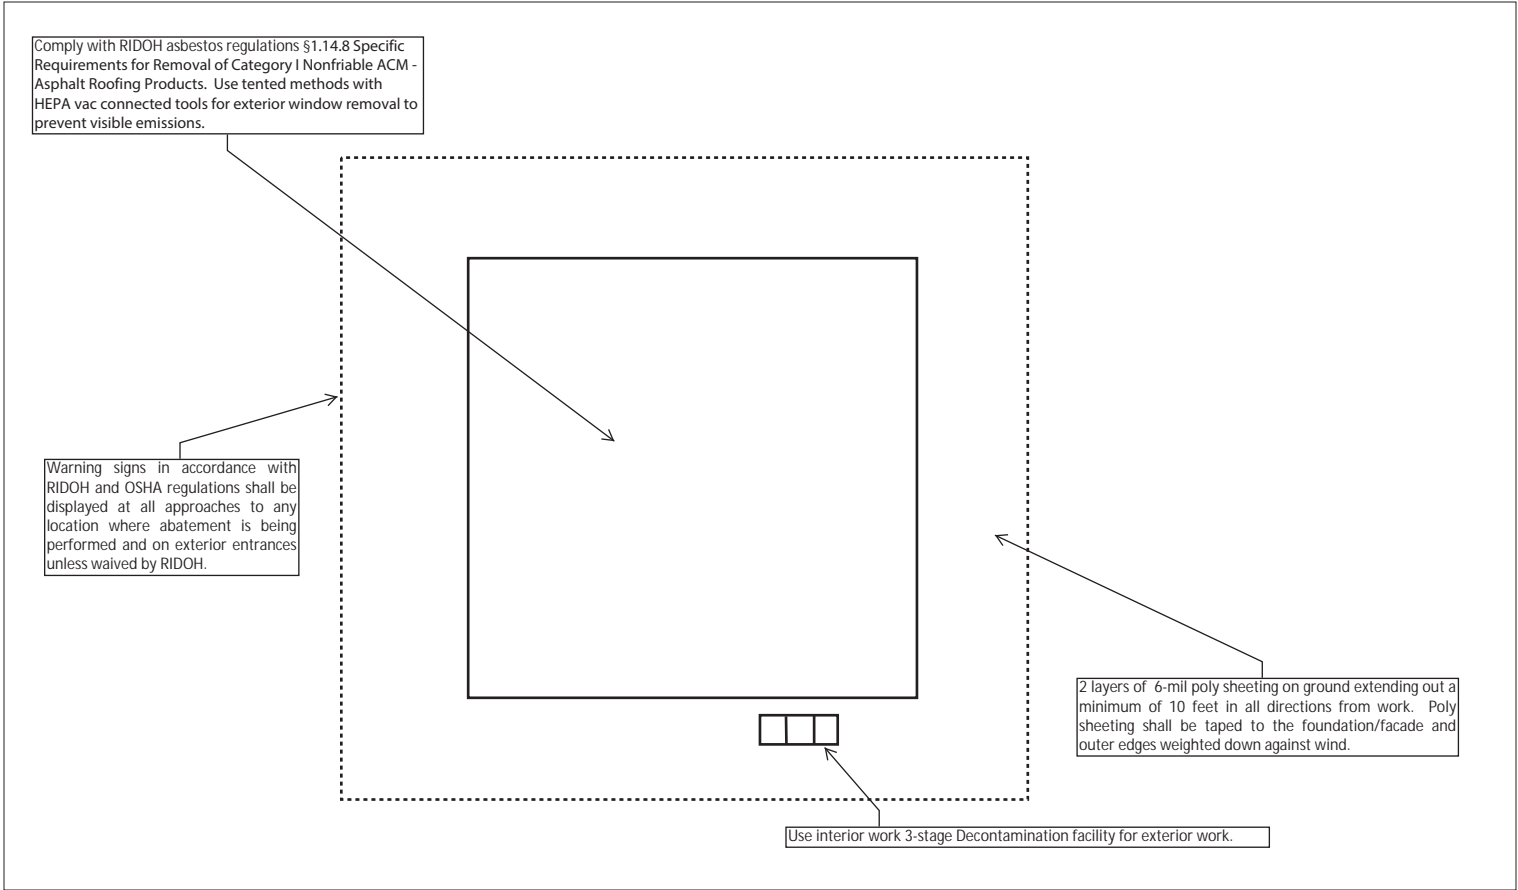
Typical Exterior
Abatement Set-Up **AA.07**

Not to scale. Typical ACM setups - setups are not shown at all locations. Actual setup configuration will be determined by the Contractor based on site conditions, access restrictions and Owner's requirements. Refer to contract documents including drawings for renovation/demolition areas as well as details and dimensions.

There is potential for hidden ACM.

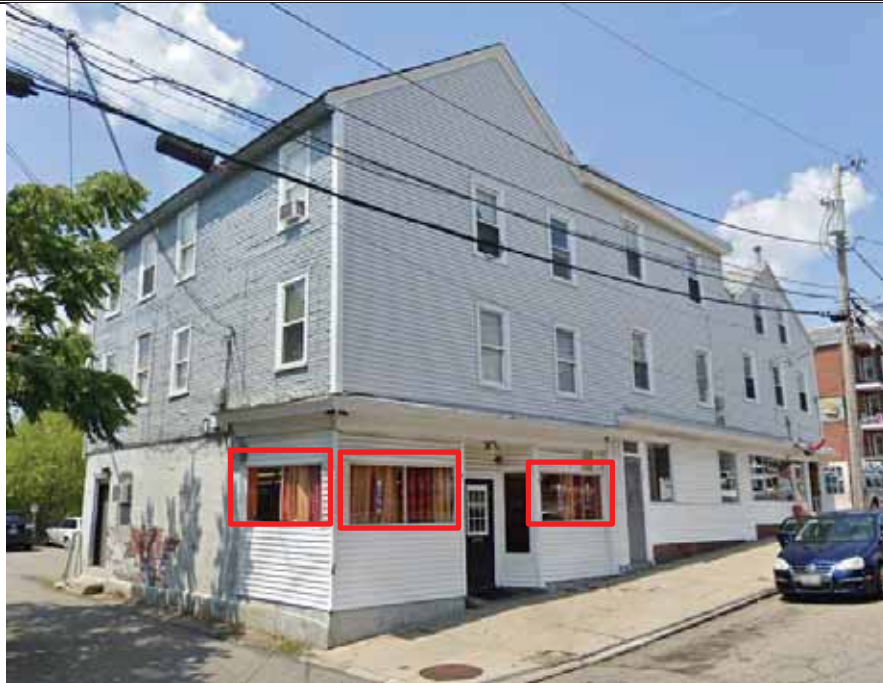
ACM Window glazing (gray)

3	56	Window glazing (gray) on interior side of windows	Store space 2 front windows and 1 side window	56A 1-5% Chrysotile	(F)(ND)	30 SF	Remove and dispose of whole windows as ACM.

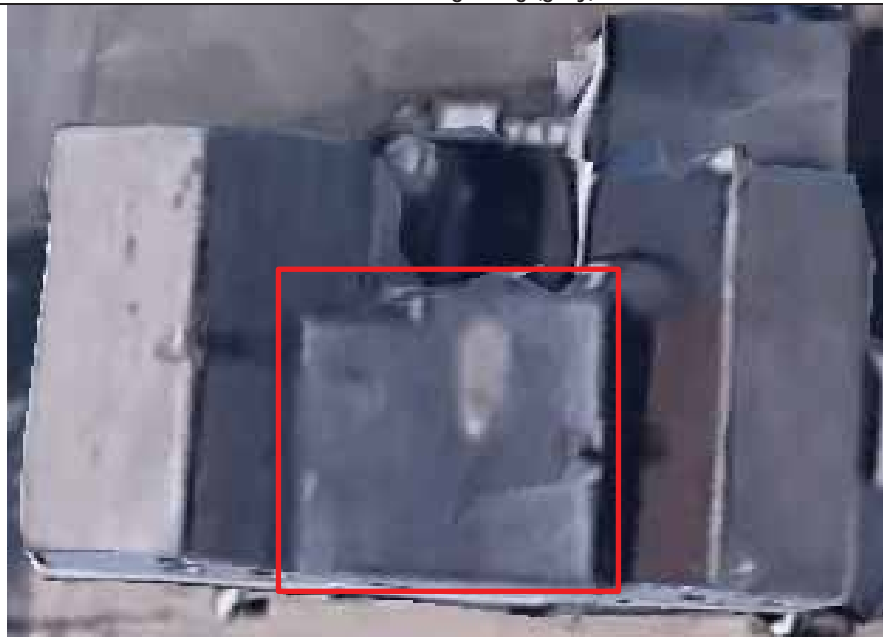
ACM Tar and gravel (black) Flat Roof

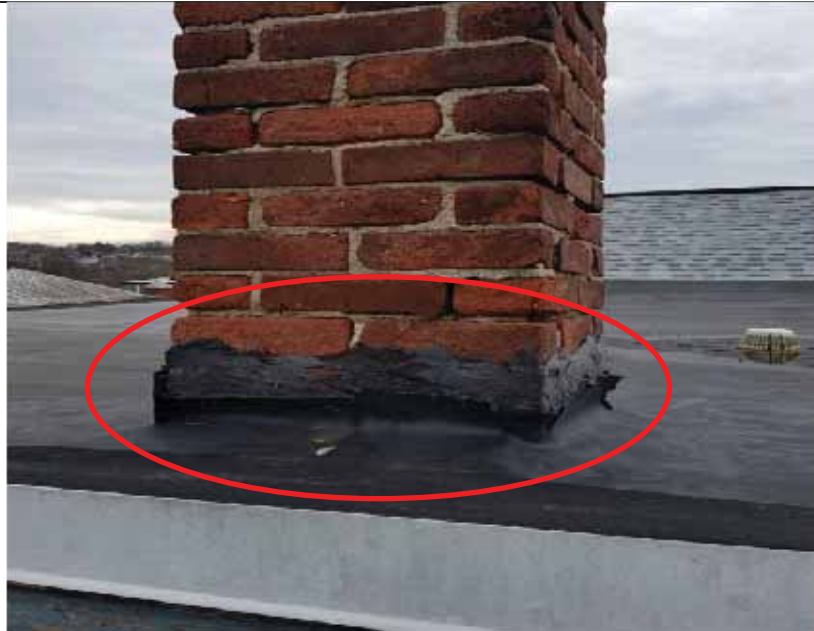
ACM sealer (gray) on brick chimney and roof ACM materials under visible new rubber and iso-board materials. Roof drain visible. Remove all perimeter metal flashing to access ACM roof materials beneath – scrape any sealers off flashing or dispose of flashing as ACM.

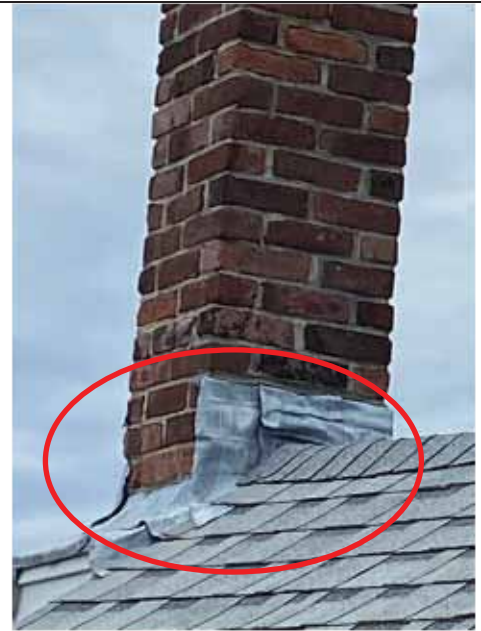
2nd chimney with ACM sealers and flashing. Remove flashing and sealers beneath on chimney as ACM – scrape any sealers off flashing or dispose of flashing as ACM.

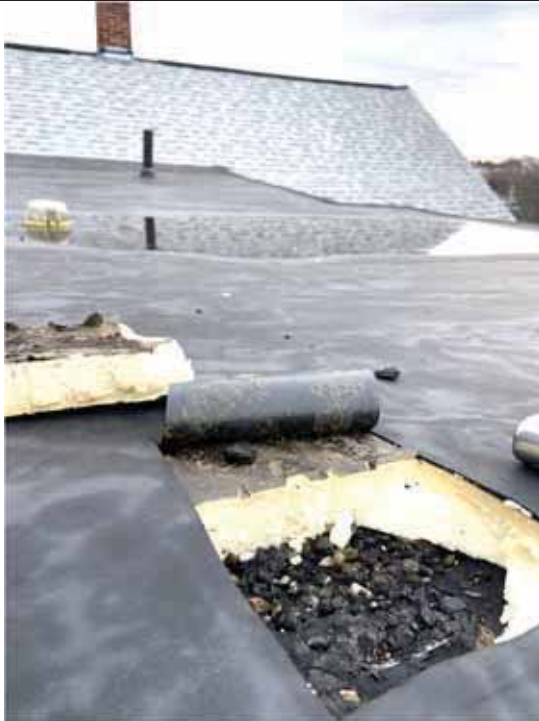
Roof ACM materials under visible new rubber and iso-board materials. Roof drain and 1 pipe penetration visible.

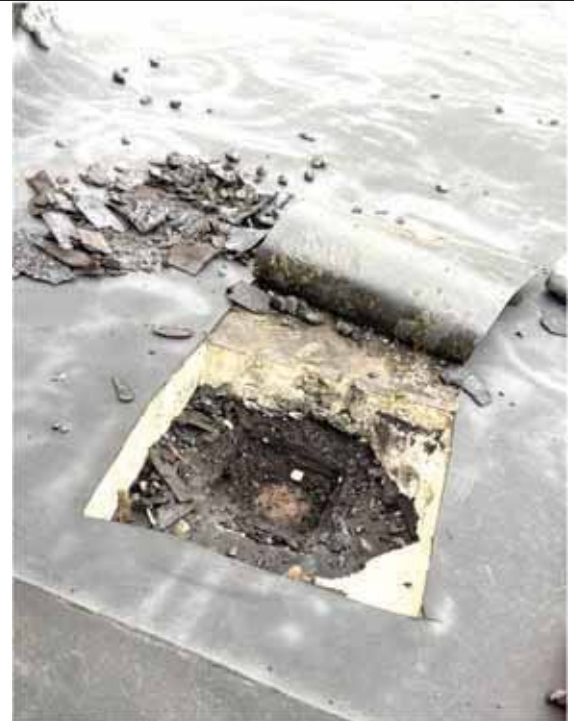
Roof ACM materials under visible new rubber and iso-board materials, on wood deck.
