**RE: Revised Report – Pre-Demolition Inspection for Materials Suspected of Containing Asbestos**  
**Site: Former Animal Shelter, 9 Cumberland Hill Rd, Woonsocket, RI 02895**  
**RI Analytical Laboratories, Inc. Project #2022221**

RI Analytical conducted a pre-demolition inspection with sampling materials suspected of containing asbestos (“**Suspect Materials**”) on December 15, 2022, in the animal shelter building located at the above-referenced Site.

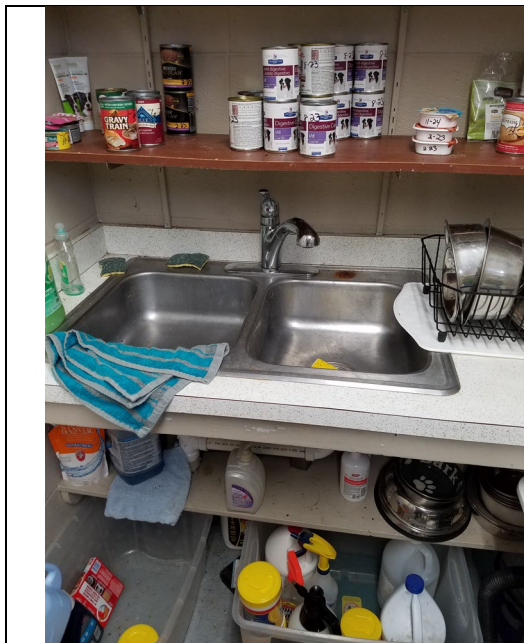
Kitchen – showing kitchen sink that has ACM undercoat material

| Table 3 - ACM and ACWM Inventory Summary | | | | | | |
|---|---|---|---|---|---|---|
| 3 | Anti-condensate coating (black) on stainless steel sink | Kitchen | 3A, 3B<br>5-15% Chrysotile | I, NF | 3 SF<br>(One double bowl stainless steel sink) | Remove sink intact, double-wrap in 6-mil poly for disposal as ACM |

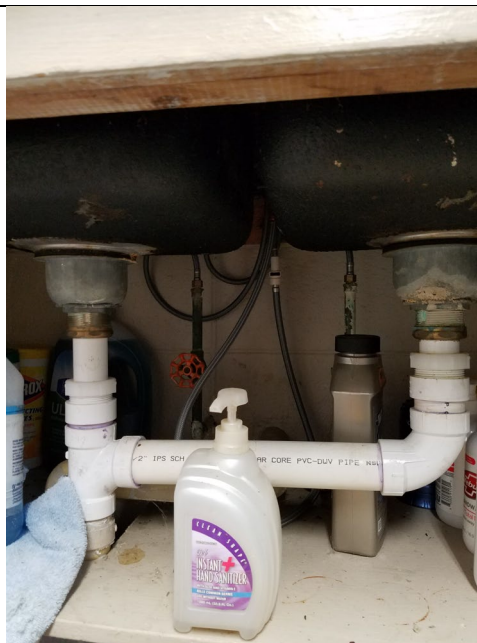
Kitchen – showing underside of sink showing ACM black anti-condensate coating

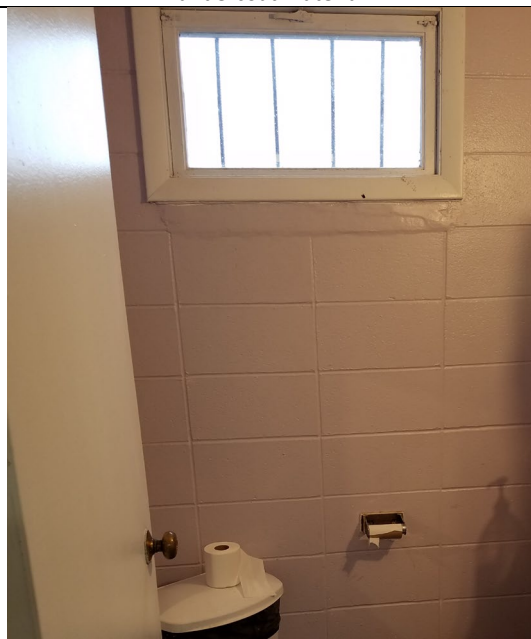
Bathroom – showing window with ACM caulk (gray) on outside perimeter of wood window frame at CMU

| Table 3 - ACM and ACWM Inventory Summary | | | | | | |
|---|---|---|---|---|---|---|
| 7 | Window caulk (gray) between wood window frame and CMU block wall | Bathroom, Kitchen, and Reception | 7A, 7B<br>5-15% Chrysotile | I, NF | 2.8 SF<br>(½" bead of caulk around each wood window frame at CMU block. <b>Seven (7) windows</b> , each 22" x 36" | Scrape ACM caulk off substrates or scrape off CMU block and dispose of wood with adhered caulk as ACM. |

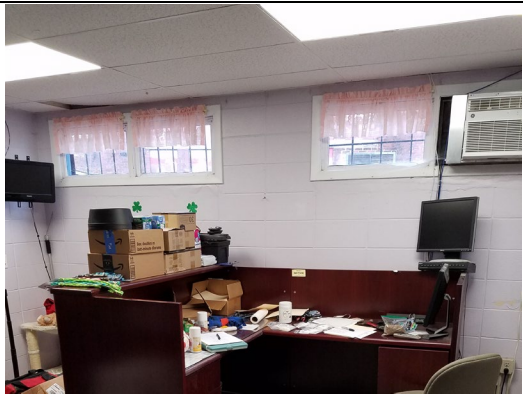
| Reception – showing window with caulk (gray) on wood and CMU | Reception – showing hole made in CMU block revealing Vermiculite material |

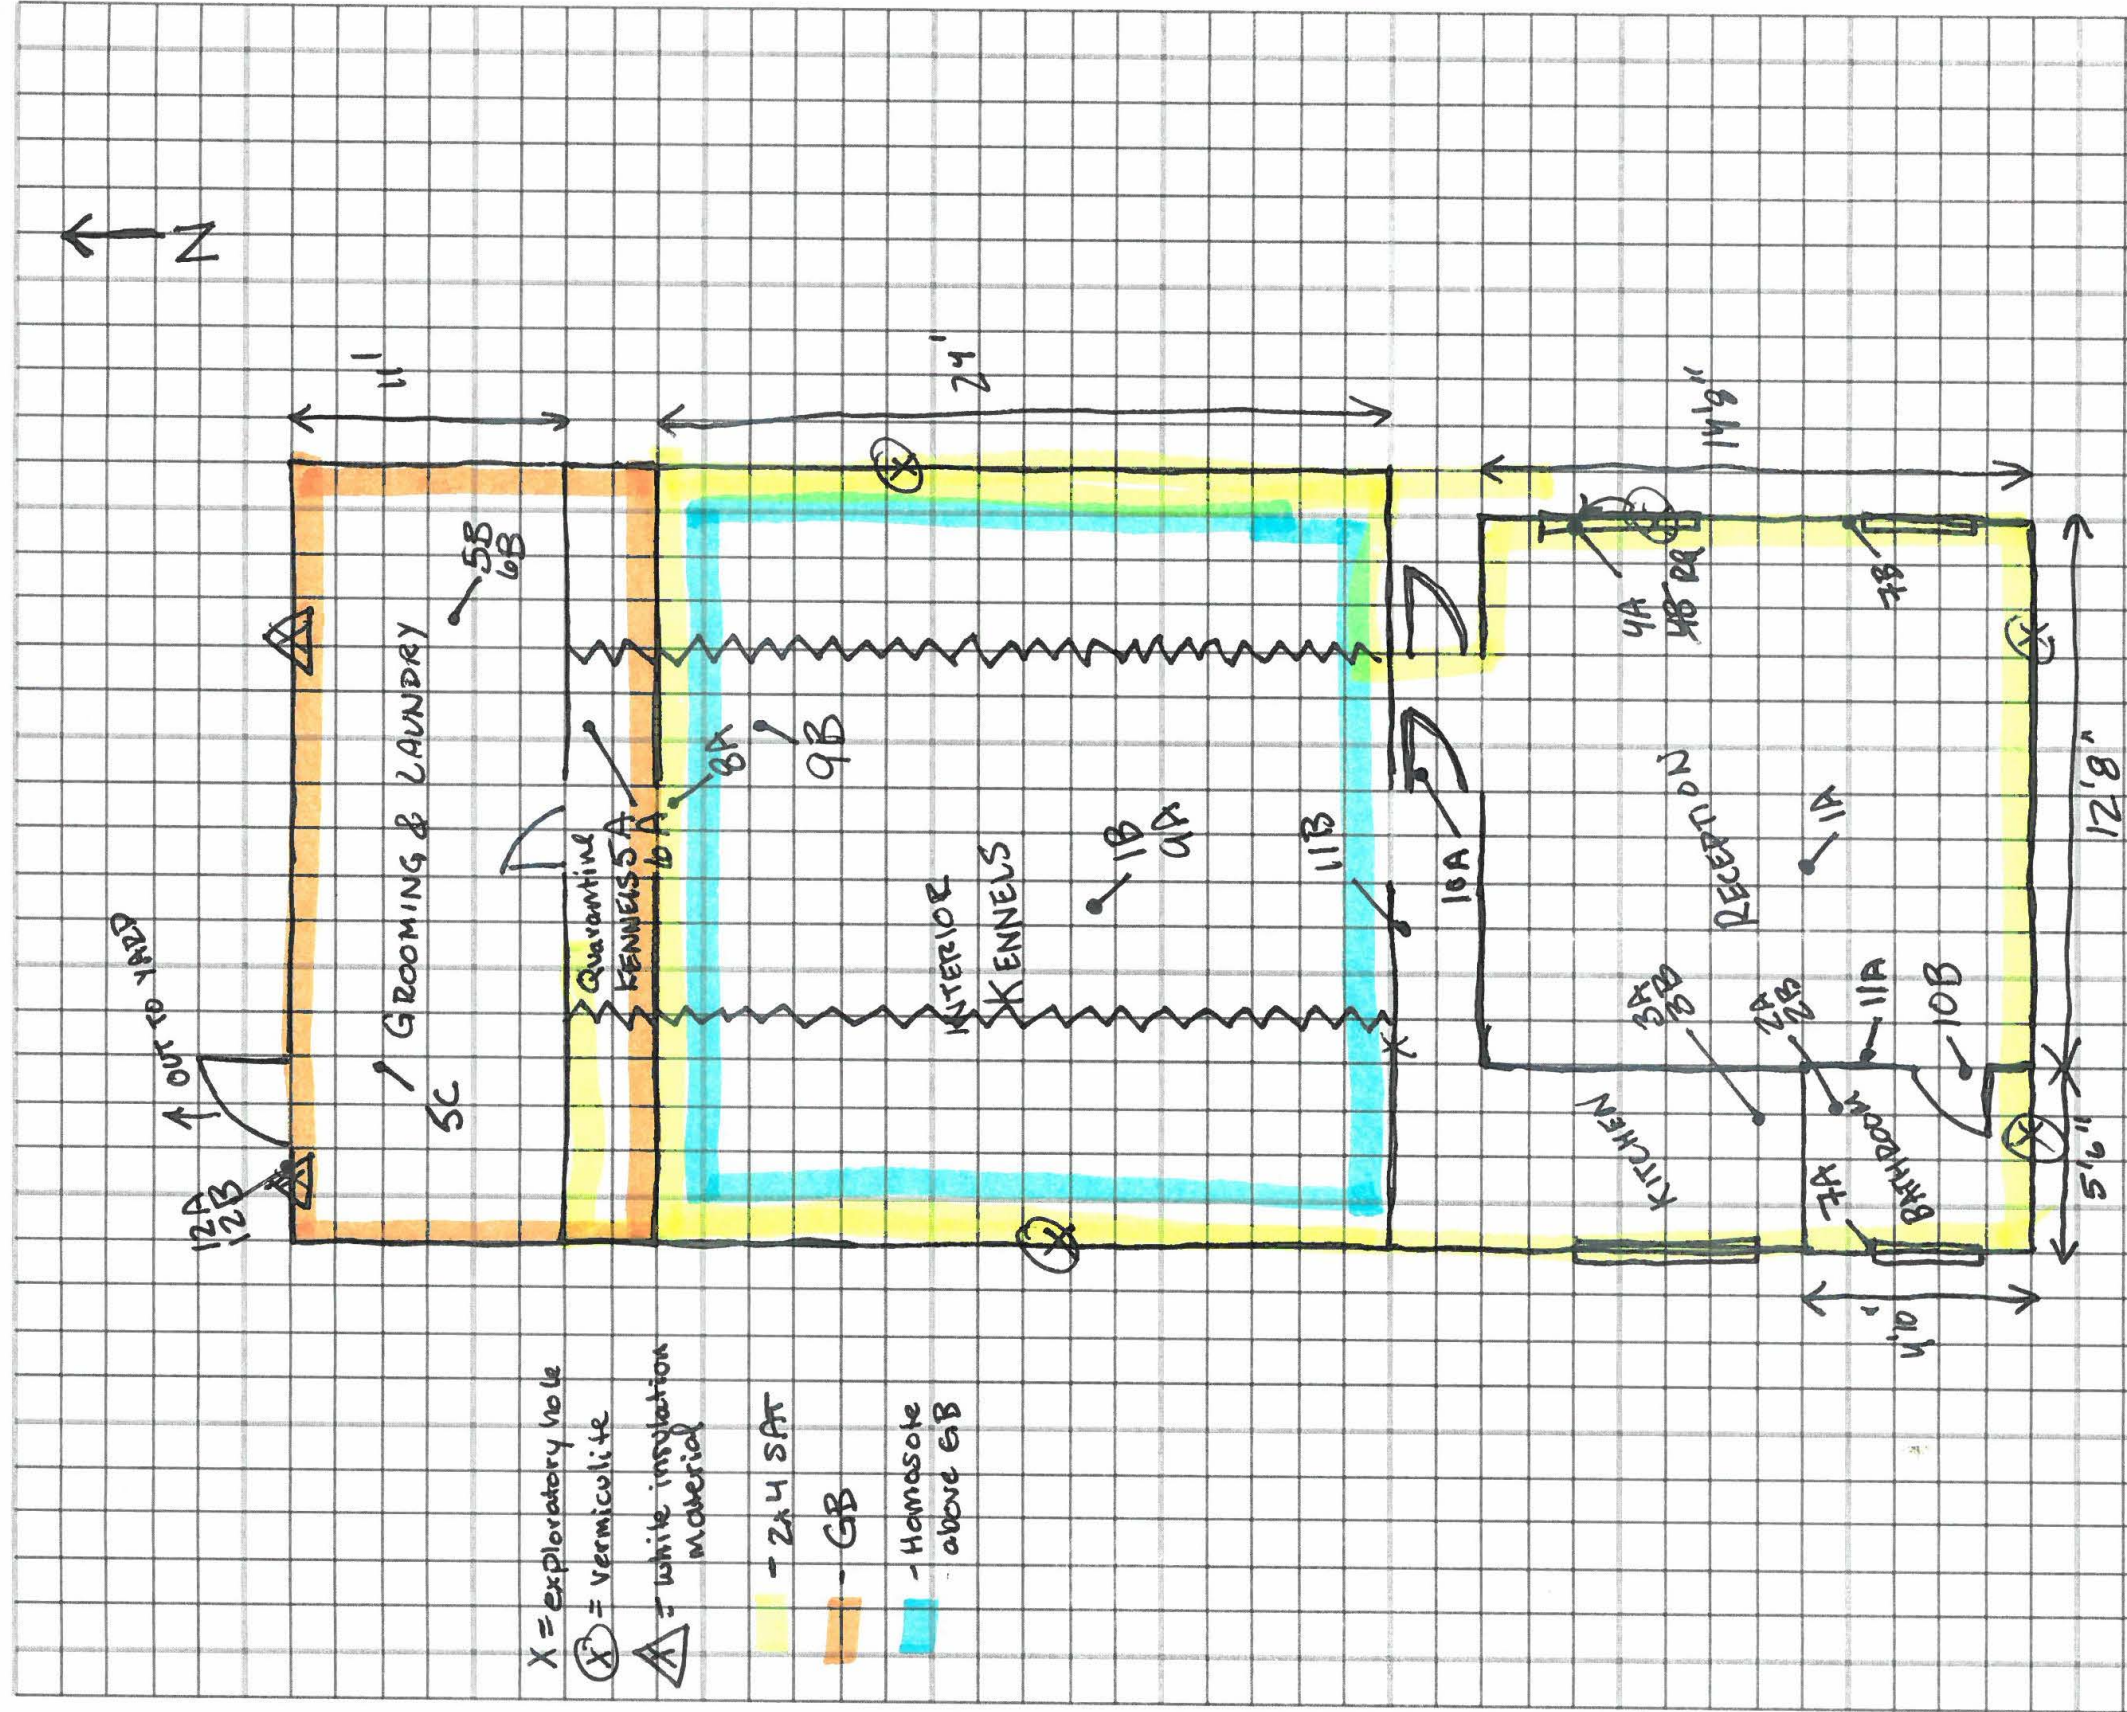
## Sample Locations Sketch

Name: CITY OF Woonsocket Animal Shelter Assignment: 2022221 Date: 12-15-22 Period: \_\_\_\_\_
