Corrective Action Plan Petroleum Impacted Media

719 River Street
Woonsocket, Rhode Island

City of Woonsocket

September 2022

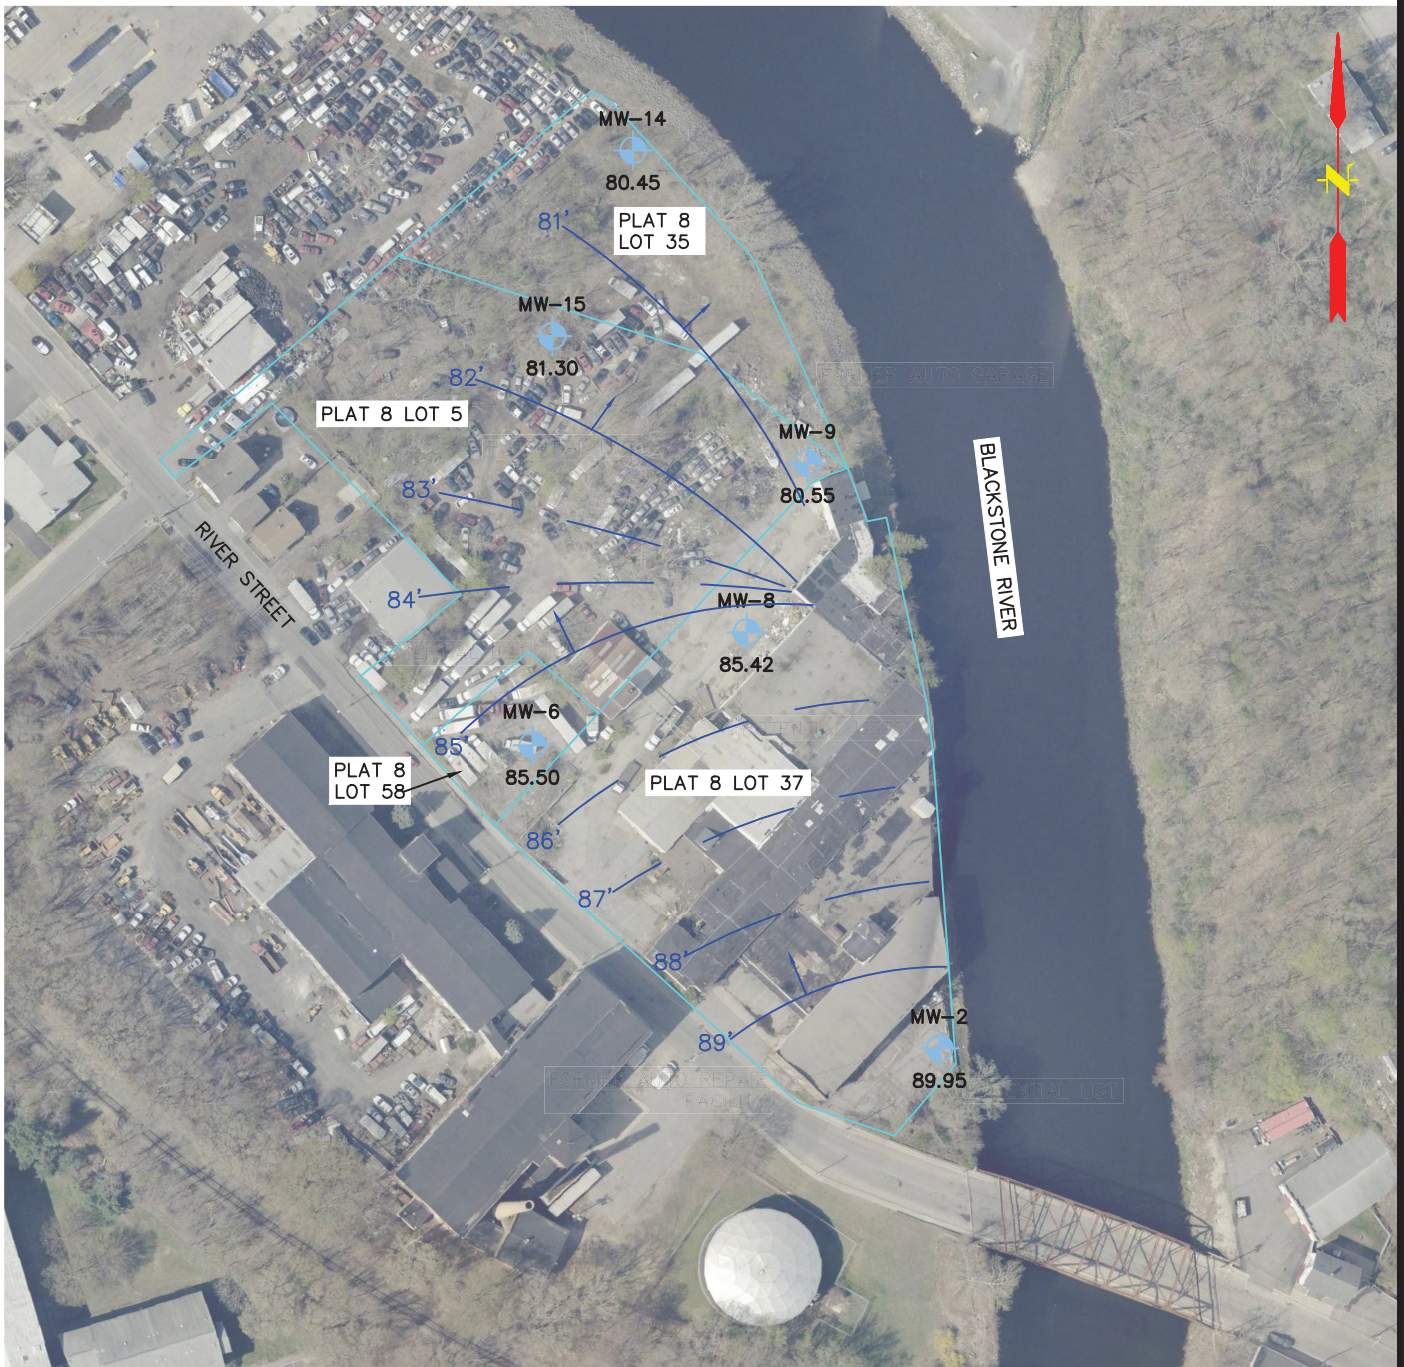
PROJ. No.: 20181545.B10
 DATE: NOVEMBER 2021
FIGURE 3

CITY OF WOONSOCKET
 GROUNDWATER CONTOUR MAP
 719 RIVER STREET
 WOONSOCKET RHODE ISLAND

Based on USGS mapping, field observations, and groundwater gauging, the groundwater flow direction was calculated to flow to the east towards the Blackstone River. Groundwater depths in five monitoring wells gauged by Fuss & O'Neill during the July and September 2021 Site Investigation ranged from approximately 8 to 16 feet below grade (fbg). Groundwater equipotential contours generated from field data collected during July 2021, are depicted on *Figure 3*

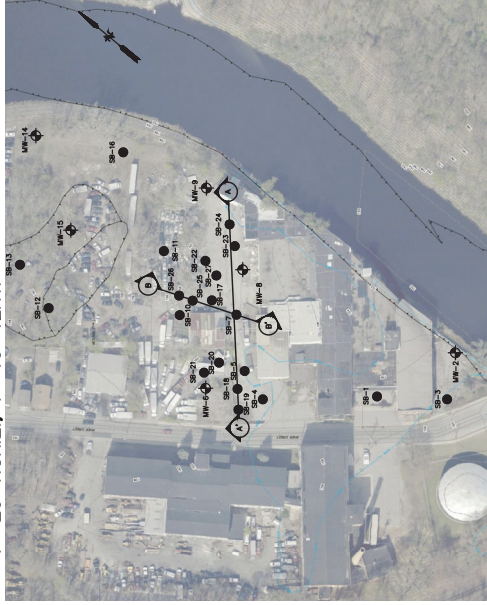
SUBSURFACE PROFILE A
1"=20' HORIZ., 1"=10' VERT.

SUBSURFACE PROFILE B
1"=20' HORIZ., 1"=10' VERT.

SUBSURFACE INVESTIGATION & PROFILE OVERVIEW
NOT TO SCALE

4. DEPTH OF STRATUM SHOWN IN THE SUBSURFACE PROFILES WERE INTERPOLATED BETWEEN BORING LOCATIONS AND SHOULD BE UTILIZED FOR GENERAL REFERENCE. ACTUAL SITE CONDITIONS MAY VARY.

During site investigation activities, petroleum contaminated soil was observed from approximately 5 to 20 fbg in several soil borings, as depicted in *Figure 5*. Based on these site investigation findings, approximately 12,000-14,000 cubic yards of petroleum impacted soil has been identified within the release area. However, the vertical extent of petroleum impacted soil may be exaggerated due to downward smearing of free product during geoprobe advancement through petroleum impacted zone. The volume of free product is considered to be concentrated within the vadose zone and the smear zone near the water table.
