**City of Woonsocket
Sewer Collection System**

Annual Report

2011

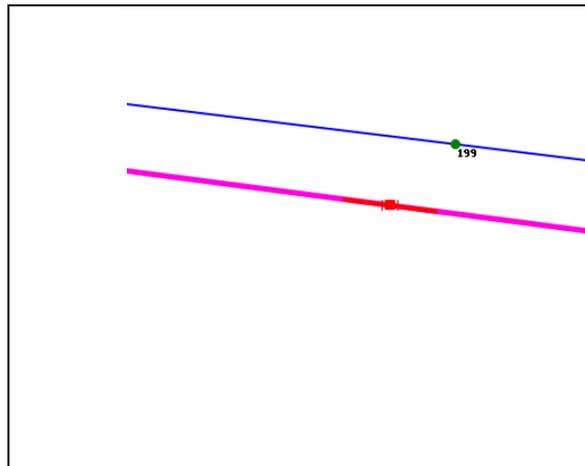
SSO occurred in this manhole

Roughly 2500 gals of sewage flowed to this catch basin which flows into the pond next to the pump station.

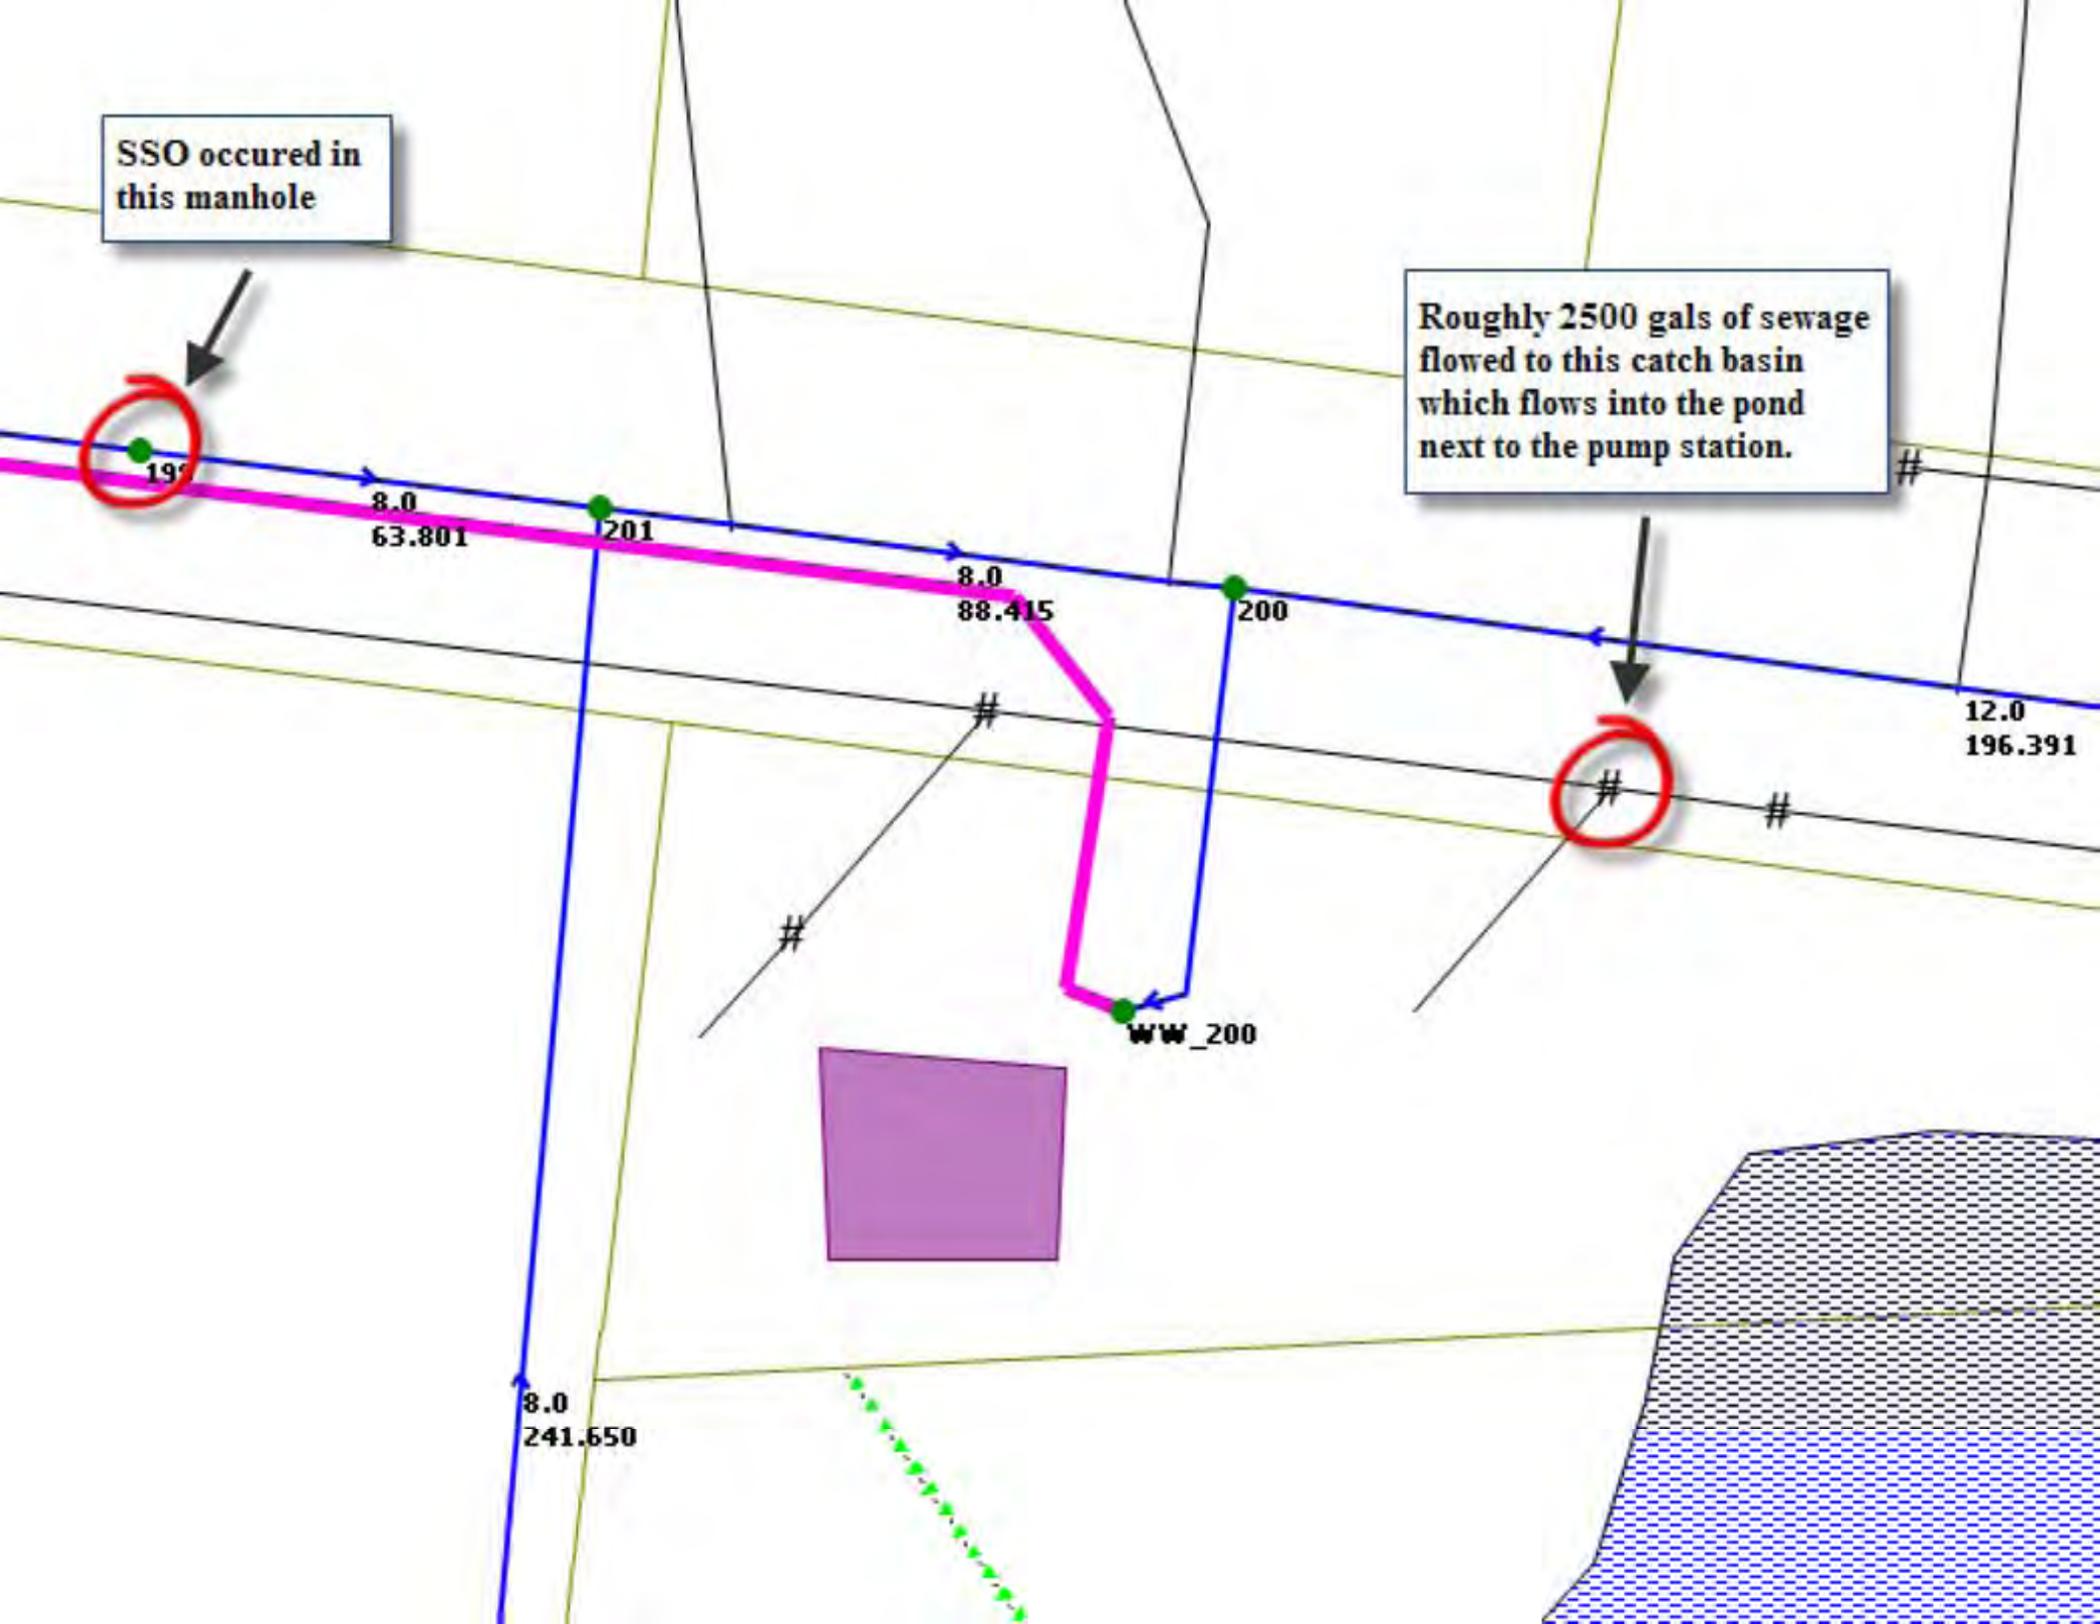
The VWNA Management personnel utilized the 2007 CDM/ADS Flow Monitoring Study in Woonsocket to calculate the daily flow rate of this particular flow area. Coincidentally there was a flow meter installed downstream of the broken pipe during the study period. It was determined that 920,000 gallons was released during the 51 hour SSO event.

12:00 p.m. By-pass pumping and excavation begins. 1:45 p.m. The remains of the damaged 12" VCP pipe are removed and a new 8' section of 12" PVC is set in place and attached to the existing pipe with two (2) Fernco Couplings. 2:00 p.m. The new PVC repair is CCTV'd and found to be sound, also showing no further damage of the existing pipe. 2:45 p.m. Backfilling of the trench is complete with a 2ft bed of crushed stone and 3ft layers of processed gravel at which point Boyle &

Fogarty and the septic haulers are released from the site. 3:00 p.m. Two members of the UGAM crew remain on site to vacuum any remaining standing water as a result of the SSO. The remaining foundations of the mill had captured large amounts of over flowing sewage that needed to be vacuumed and disinfected prior to leaving the site. 6:00 p.m. The crew has finished on site and returned to the plant.
