## **LIMITED STRUCTURAL EVALUATION**

### **162 MAIN STREET WOONSOCKET, RHODE ISLAND**

October 18, 2012

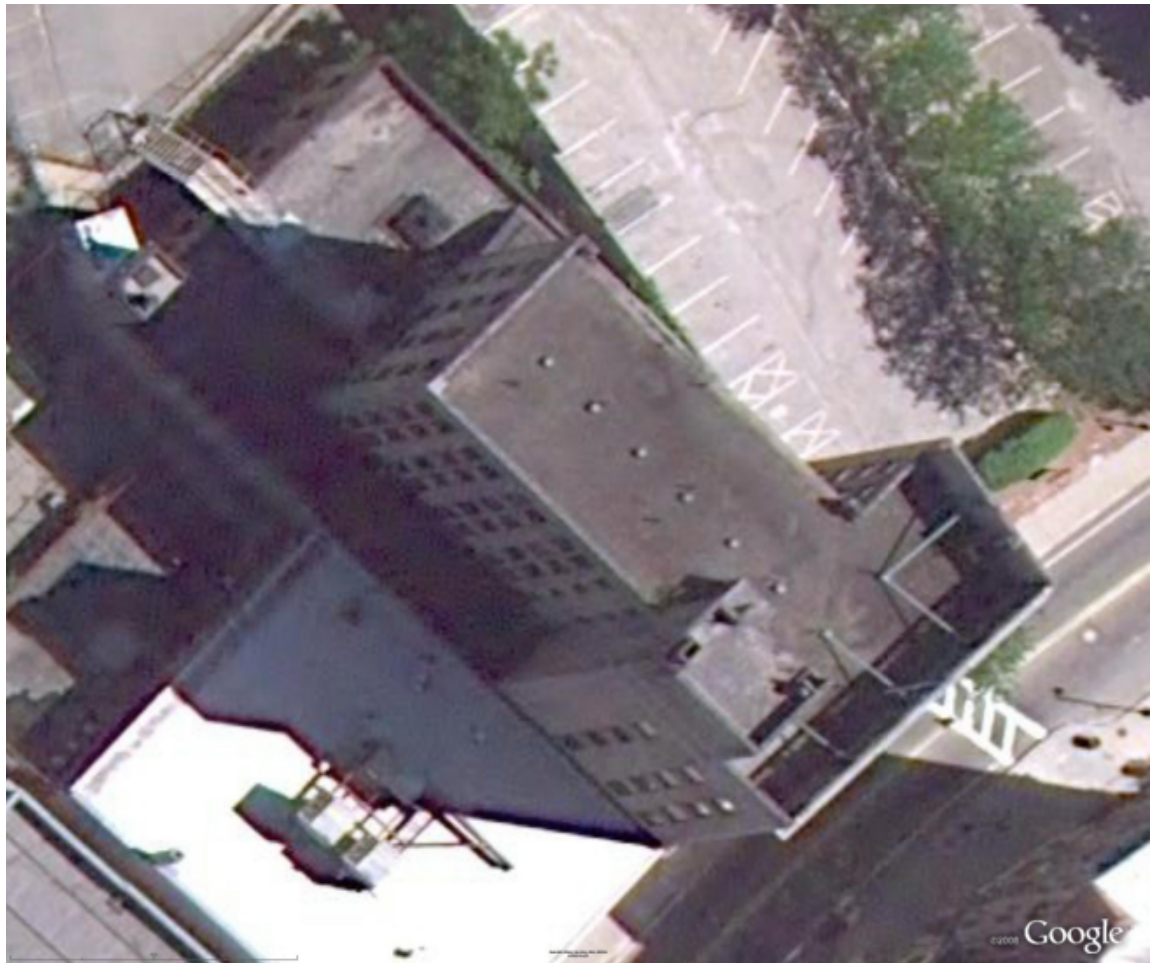
*Figure 1: This aerial photograph of the former RI Hospital Trust Company building located at 162 Main Street in Woonsocket, Rhode Island is oriented such that north is vertically up in this image.*
